THE USE OF EPOXY RESIN FOR SEALING  
CRACKS IN A REINFORCED CONCRETE BRIDGE

Milton Evans, Jr.  
Research Engineer

Highway Materials Research Laboratory  
Lexington, Kentucky

July, 1959

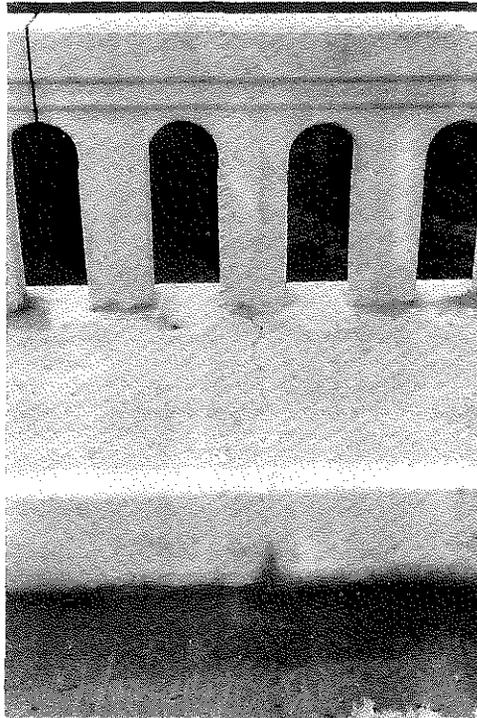
**Fig. 2.** A Crack Typical of the Wider Cracks in the Safety Walk, Before Treatment. The crack was filled with moisture from a light rain. The presence of any moisture such as this in a crack to be treated with epoxy would be unacceptable.

Unfortunately, before the cracks were treated, the bridge was opened to traffic. Traffic passing over the bridge filled the open cracks with dust and dirt, making rigorous cleaning necessary. Thorough cleaning was accomplished with chisels, brushes and compressed air, so that no foreign particles, greases, or moisture would interfere with the bond between the epoxy resin and the concrete and steel. When the cracks were clean and dry, the two components of the formulation were mixed, starting the chemical reaction which would result in rapid hardening of the material. The resinous mixture was then carefully poured from a cup, with a spout, onto a crack so that a fine bead slightly larger than the crack opening was formed over the crack, Figs. 6 & 7. Resin from this bead immediately began to penetrate into the cracks. Additional material was applied within a short period of time until no further penetration occurred - indicating that the cracks were filled. Small bristle brushes and putty knives were used to work the material into the cracks where necessary.

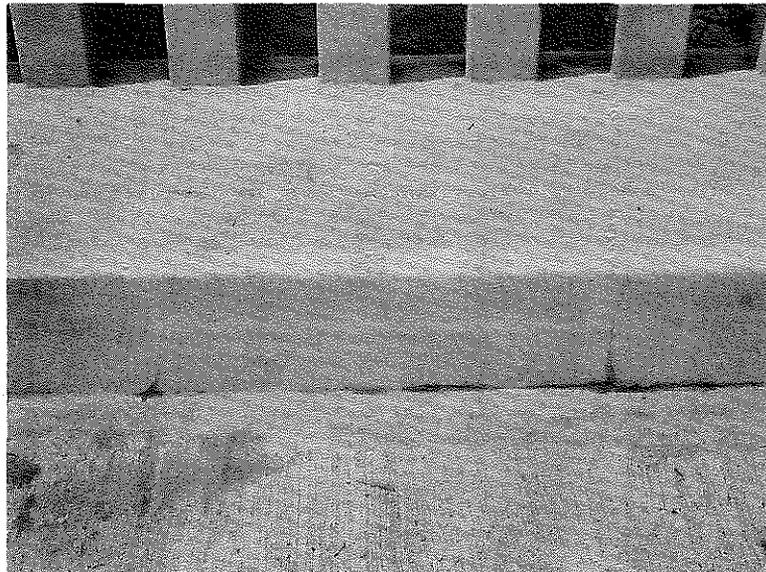
**Fig. 3.** Typical Hairline Cracks in the Safety Walk before Treatment. These cracks had moisture in them from a light rain and it was necessary to wait for a period of dry weather before treatment.

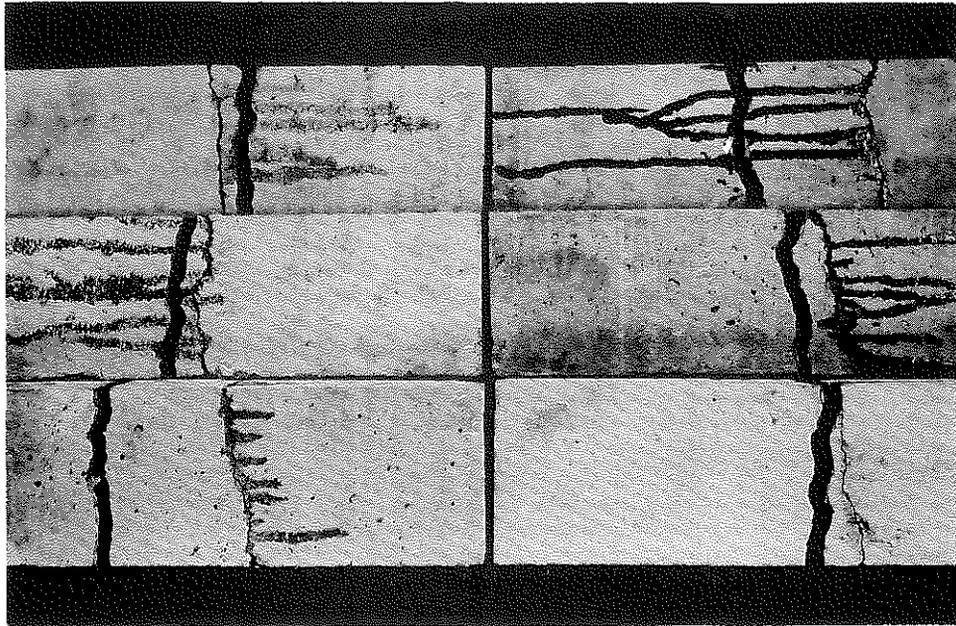
Fig. 4. These Six 3" x 5" x 30" Flexural Strength Test Beams were Broken and then Welded Back Together with the Epoxy Resin Used on the Bridge. Twenty-four hours later they were subjected to flexure test again, and the breaks occurred at a different place. The cementing material thus withstood an average of 850 psi in flexure.

After conducting laboratory investigations to test the flexural and bonding strengths and penetrating ability of the epoxy formulation, "Reliance Relcote 6.0", Figs. 4 and 5, it was concluded that this material would be suitable for sealing cracks in structural concrete (2). The resin's strength and resistance to water, weather, and corrosion were considered sufficient to protect the concrete and steel exposed by the cracks.

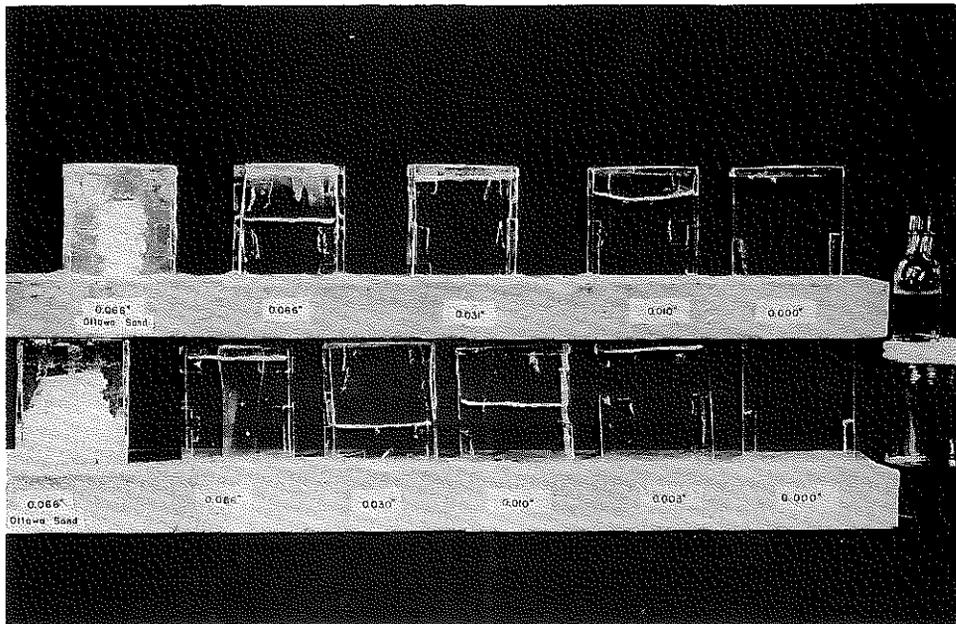
Fig. 5. Glass Plates were Spaced as Labels Indicate. Epoxy resin was poured into the cracks thus formed to test its penetrating ability. The resin penetrated to the bottoms of the cracks and filled them up to the lines marked on the plates. The cracks formed by the plates on the left were filled with graded Ottawa sand before epoxy was applied. Penetration into the sand-filled cracks was also good.

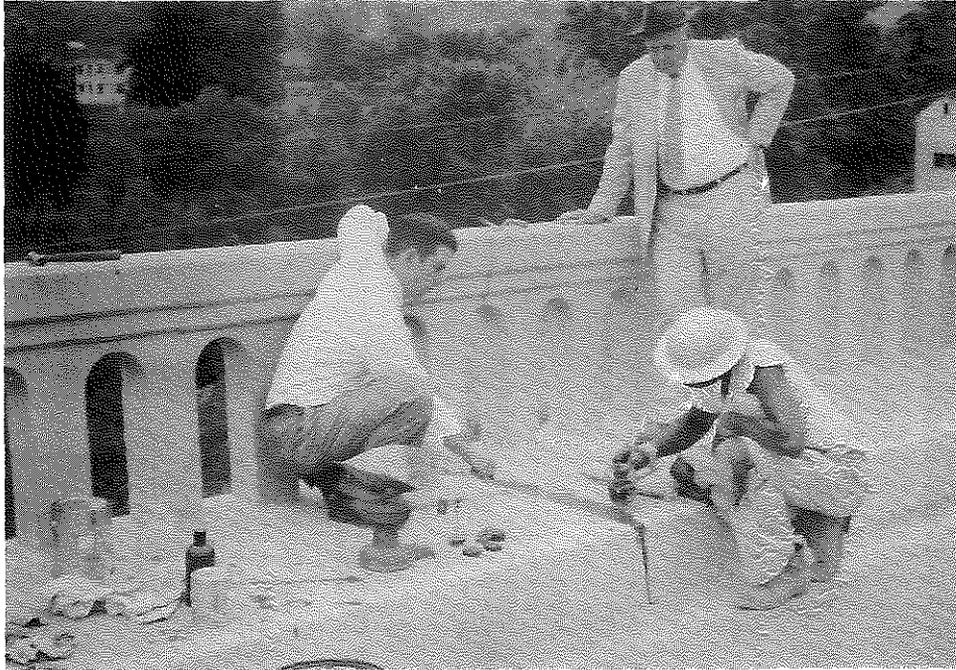
Fig. 6. The Mixed Epoxy Resin is Being Poured into a Clean Dry Crack.

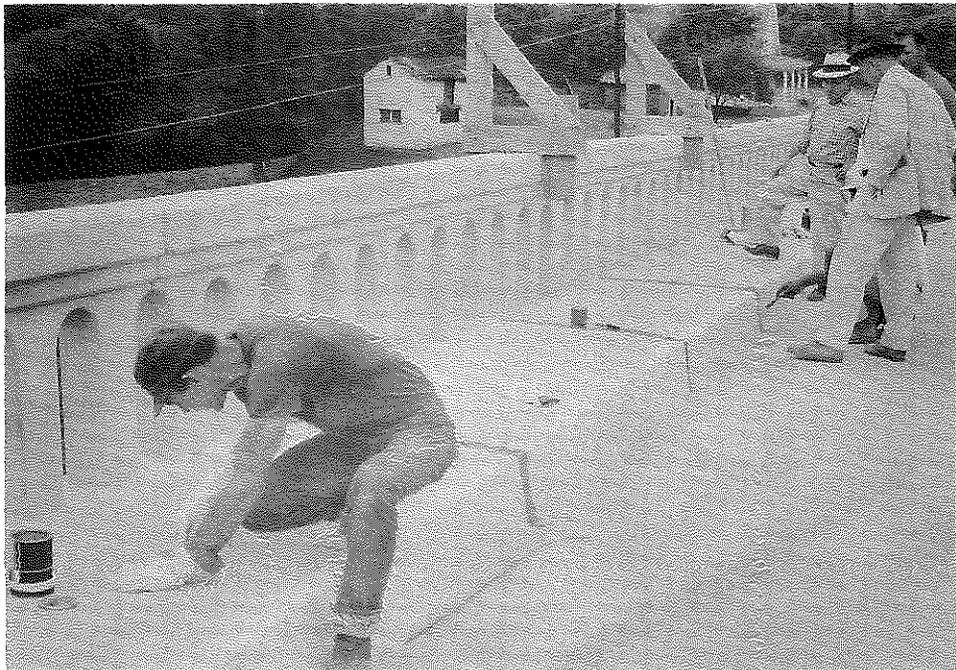
Fig. 7. The Resin is Being Worked into the Cracks with Brushes and Putty Knives.

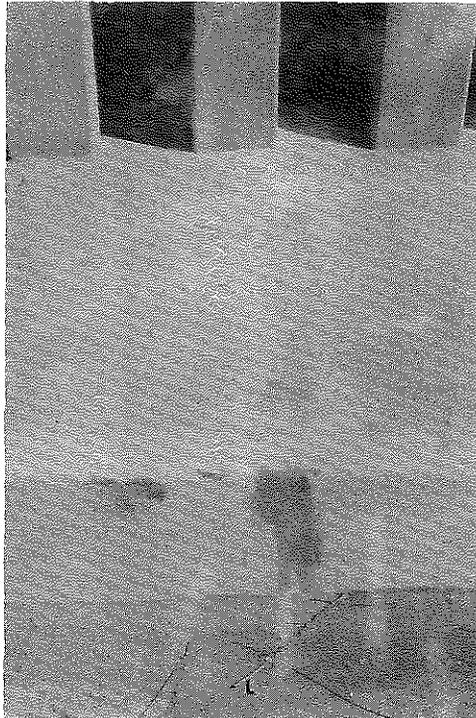
Fig. 8. This is a Typical Crack After the Resin and Sand has been Applied and the Mixture Flattened out to Fit the Contour of the Existing Concrete.

It was considered desirable to give the sealing material a color and texture as much like that of the adjacent concrete as possible. Since the resin was an amber color, a fine white silica sand was sprinkled on the crack surfaces to obtain a concrete color and a durable non-skid finish. Then the mixture of sand and resin covering the crack was smoothed out with a putty knife and brush to conform with the finish of the concrete, Figs. 8 and 9. This completed the application phase of the crack sealing and the material was allowed to harden and cure for several weeks. After hardening, the swath of resin and sand covering the cracks was rubbed vigorously with a carborundum block to obtain a non-glossy concrete-like surface, Figs. 10, 11 and 12.

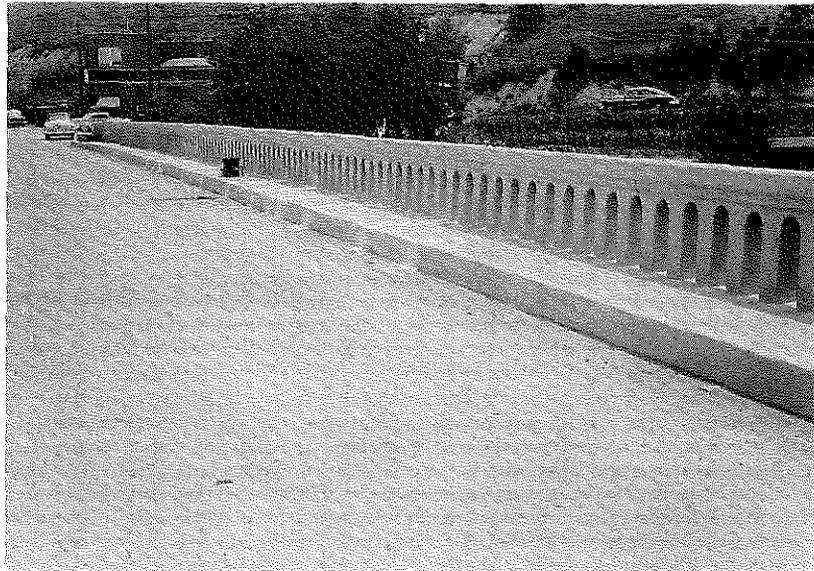
Fig. 9. This is a View of the Cracks in the Safety Walk on One Side of the Bridge Over One Center Pier. The cracks have been filled and the sand applied and the material was curing.

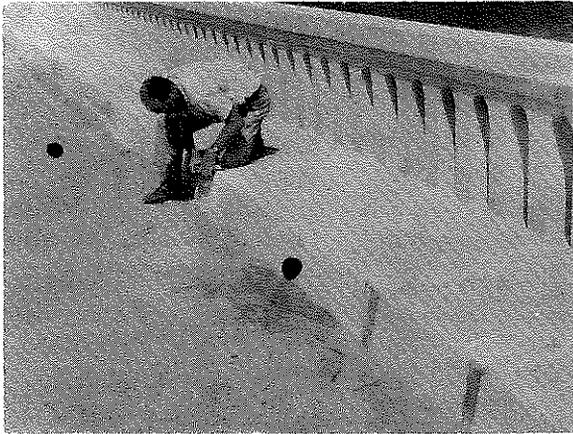
Fig. 10. The Material Used in Repairing the Cracks in this Figure has Cured and a Carborundum Finishing Stone is being Used to Obtain a Non-Glossy Concrete-Like Finish.

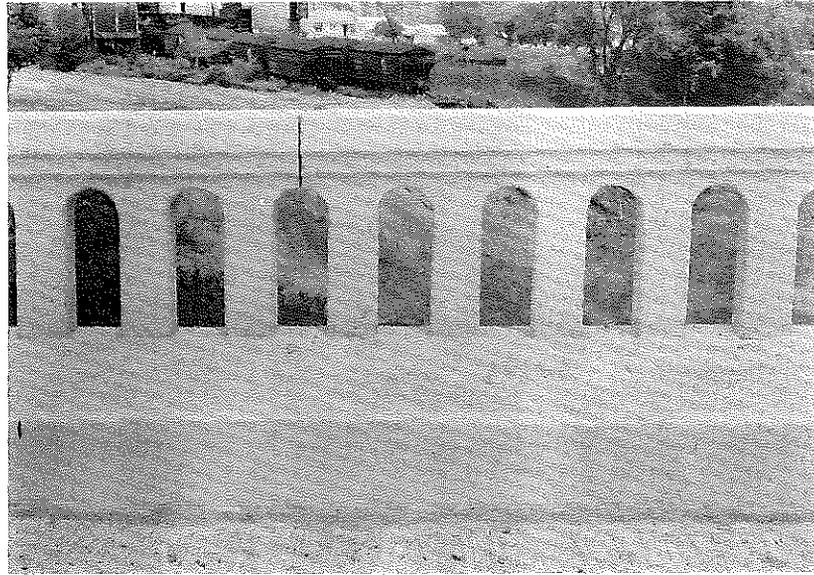
Fig. 11. These are 2 Typical Cracks Just After Rubbing With a Carborundum Block.

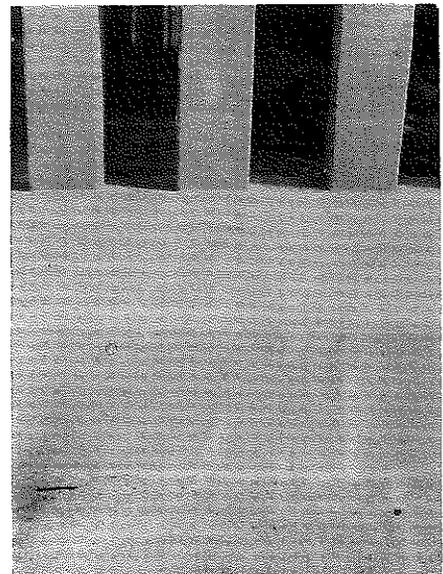
Fig. 12. The Treatment of this Crack had been Completed and it was Ready for Service.

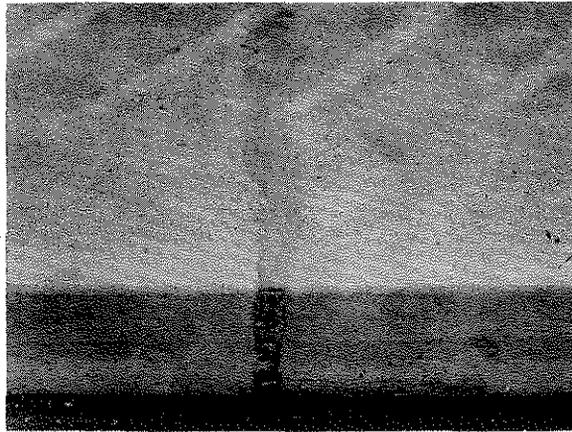
Inspections have been made subsequent to filling these cracks, and no changes have been observed. The most significant inspection was made in January of 1959, about 6 months after completion of the work. At that time, the temperature was approximately 30°F, some 45° to 65° below the temperatures at which the cracks were filled, and it was estimated that this reduction in temperature would cause sizeable stresses in the slabs because of thermal contraction. Even under these conditions no failures in the treated cracks were observed, Figs. 13, 14 and 15.

**Fig. 14. This Crack Appeared to be in Good Condition after 6 Months Exposure.**

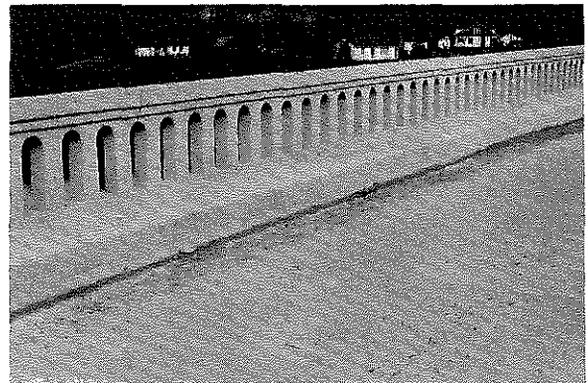
**Fig. 15. The Appearance of These Cracks Hadn't Changed after 6 Months Service.**

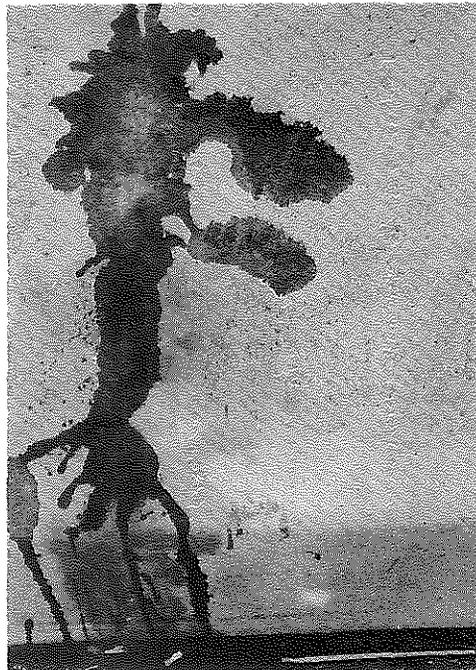
In order to test the cracks for water tightness, they were flooded with water, Figs. 16 and 17, and watched closely to detect any water seepage. None was apparent. The wetted cracks were also observed when nearly dry, and it was apparent that water had not entered the cracks because there was no water remaining in the cracks after adjacent surfaces had dried, Fig. 18.

Fig. 17. This Close-up of a Flooded Crack Showed the Effect Obtained with a Thicker Coating of epoxy and sand. The crack was well sealed as evidenced by its refusal to allow ingress of water.

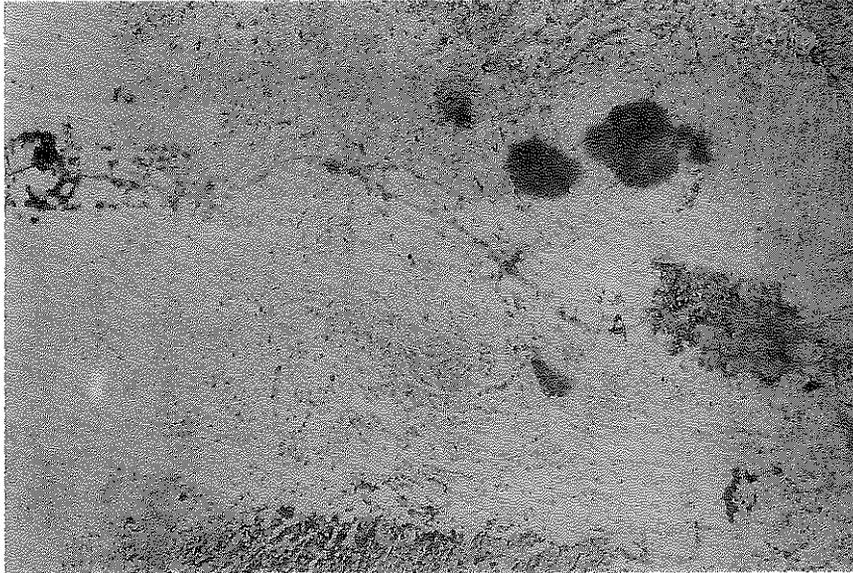
Fig. 18. This was the Appearance of One of the Flooded Cracks when it was just Barely Surface Dry. Apparently, no moisture was trapped in the crack where it would have evaporated more slowly and would have been detected.
