A Metal Fabrication and Finishing Foreman Dies After 25 Foot Fall at a Commercial Building Site

Incident Number: 13KY042

**Kentucky Fatality Assessment and Control Evaluation (FACE) Program
Incident Number: 13KY042
Release Date: February 10, 2014
Subject: A Metal Fabrication and Finishing Foreman Dies after 25 Foot Fall
at a Commercial Building Site**

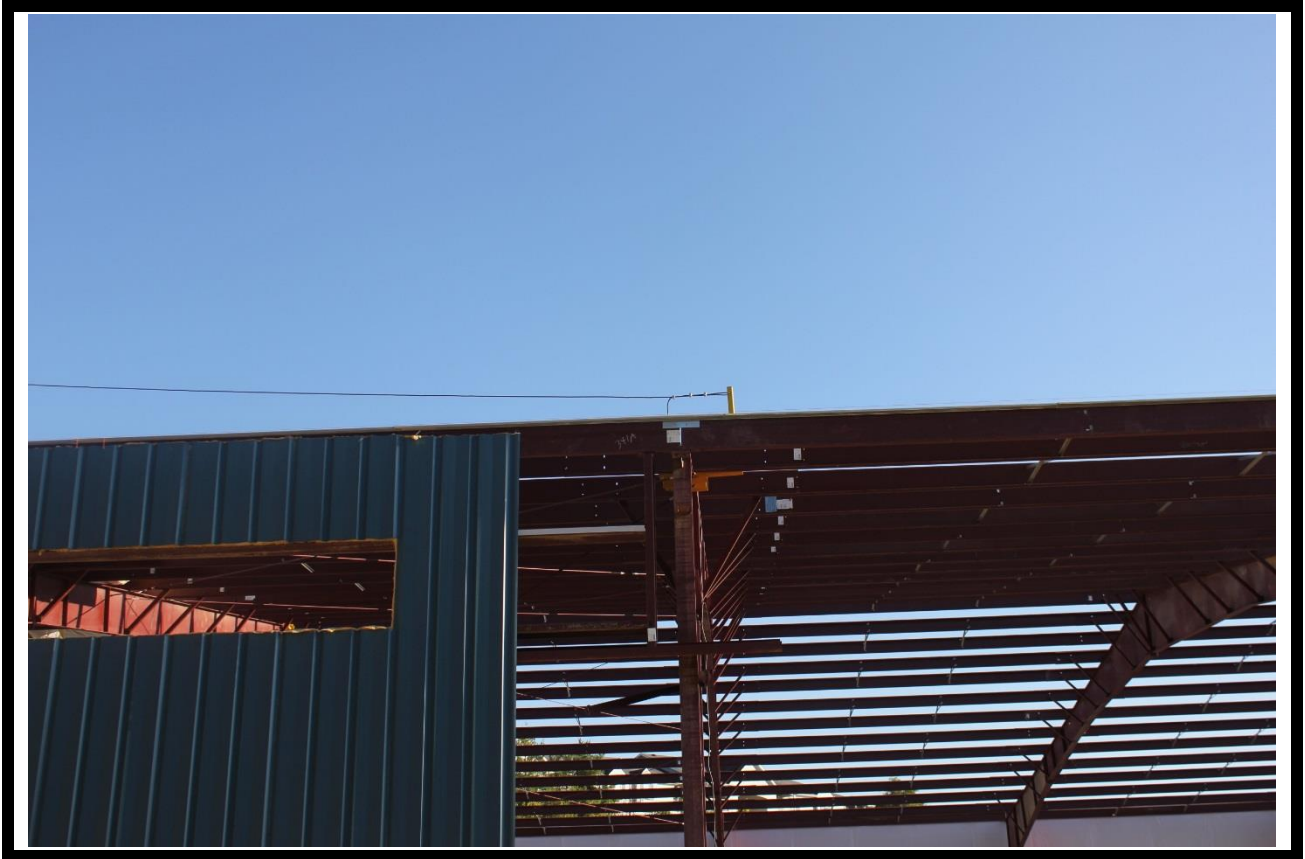
Picture of the steel building with zip line tie-off point. Photograph courtesy of KYOSH

A fourth employee of the same company was also on the roof doing clean-up work. All four (4) company employees were wearing fall protection harnesses. The employee doing clean-up work and the employee on the South side were tied off on the roof. They had a life line running across the North and the South sides of the roof. The tie-off stand in the North West corner of the roof had been moved at some point, because it was interfering with the stacking of the decking materials. The employee on the South end tied off to the life line, but the other two (2) employees, the foreman and the North side employee, could not reach the zip line that ran across the length of the roof, and were not tied off.

They thought they were doing the last deck of the day, but two of the three employees on the roof edge could no longer reach the tie-off stand to tie off. Their normal action was for the three employees at the end of the roof to be about four (4) feet from the end of the decking (while tied off), grab the end of the insulation sheet and pull it back taut, then take a step forward while going down to one knee and lay the insulation forward, about two feet beyond the end of the decking. Then the insulation would be pulled tight by two employees on a lift.

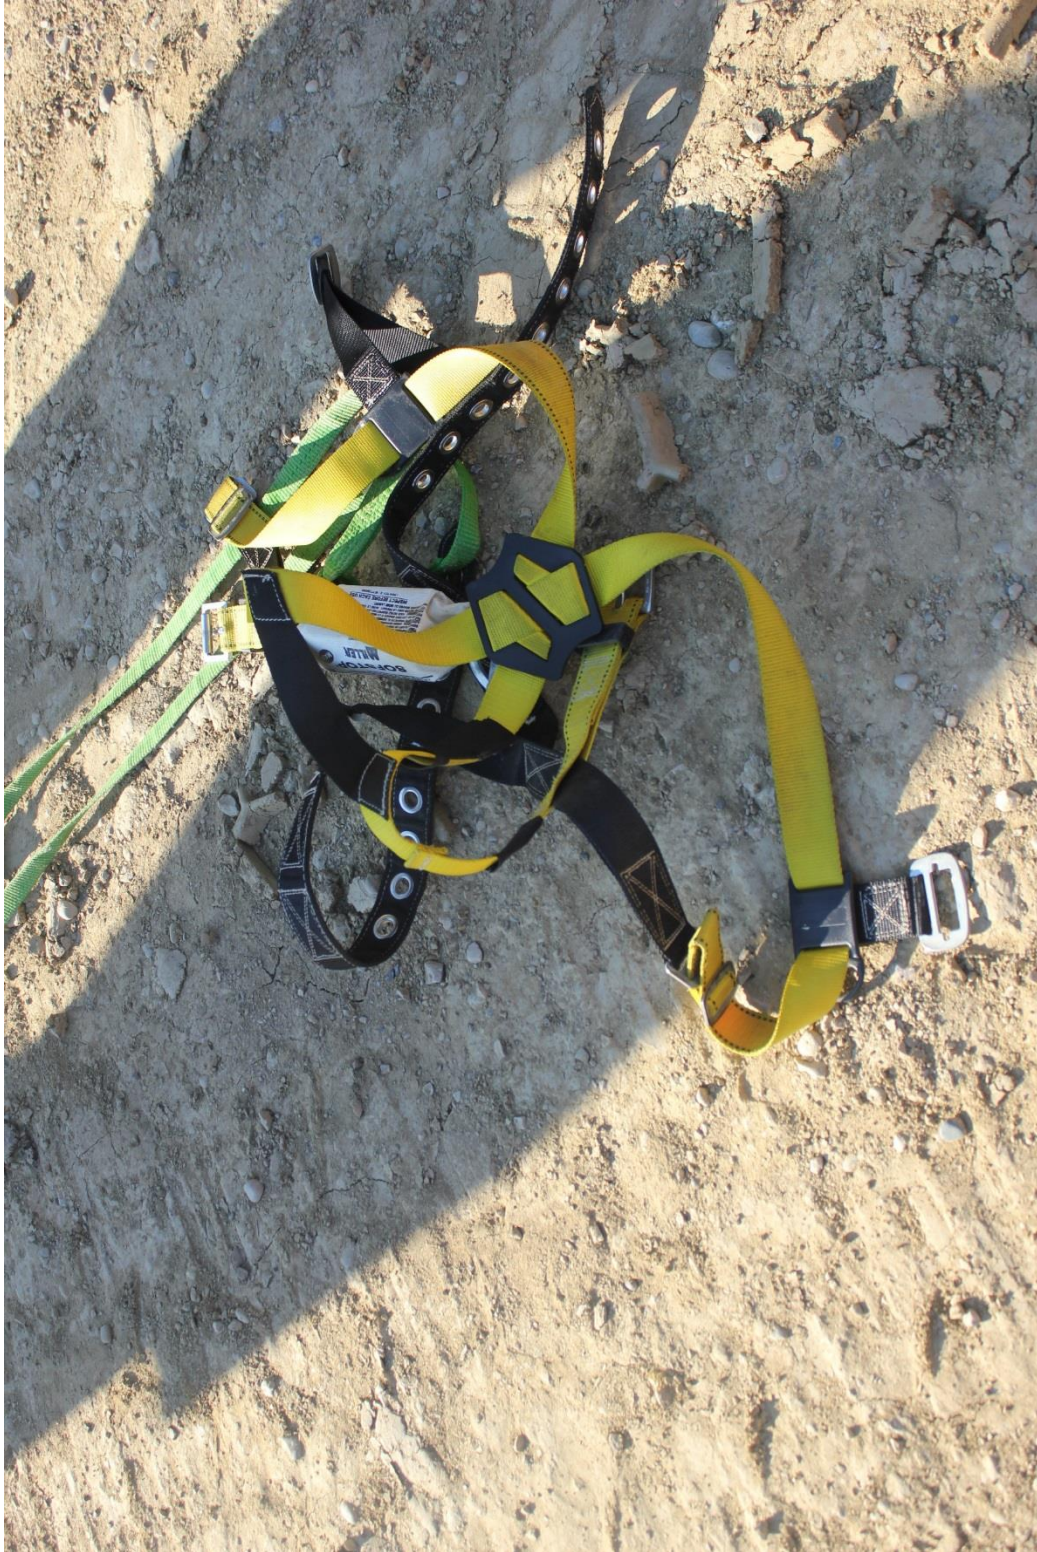
Picture of harness worn by foreman. Photograph courtesy of KYOSH
