Report of Investigations–KGS

Kentucky Geological Survey

Ground Motions Induced by the March 11, 2018, Implosion of the Capital Plaza Tower, Frankfort, Kentucky

N. Seth Carpenter, Michael J. Lynch, Brandon C. Nuttall, Zhenming Wang,
and Andrew S. Holcomb

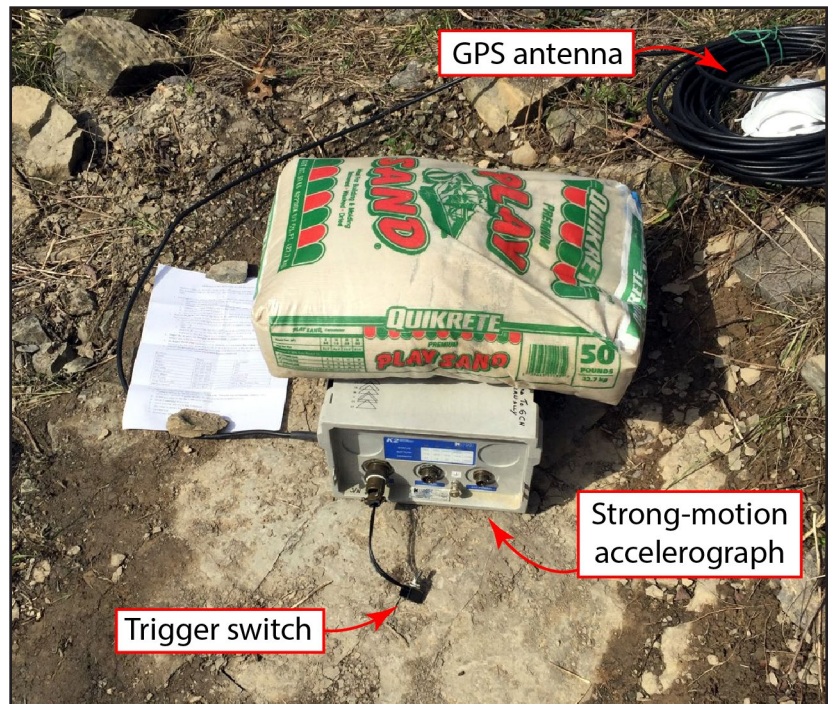
Figure 2. Instrumentation at station CPT3. Photo by Zhenming Wang.

Table 1 gives the instrument locations, which were at horizontal distances of 404 to 432 m from the center of the Capital Plaza Tower, prior to its demolition, and at variable azimuths. All sites were instrumented with strong-motion accelerographs, each of which was oriented to record motions in the vertical, horizontal radial (away from and toward the tower), and horizontal transverse (perpendicular to radial) directions. Bags with 50 to 100 lb of sand were placed on top of the strong-motion accelerographs to enhance the sensors' coupling with the ground, and to prevent differential motion between the accelerograph and the ground in the event of strong shaking (Fig. 2).

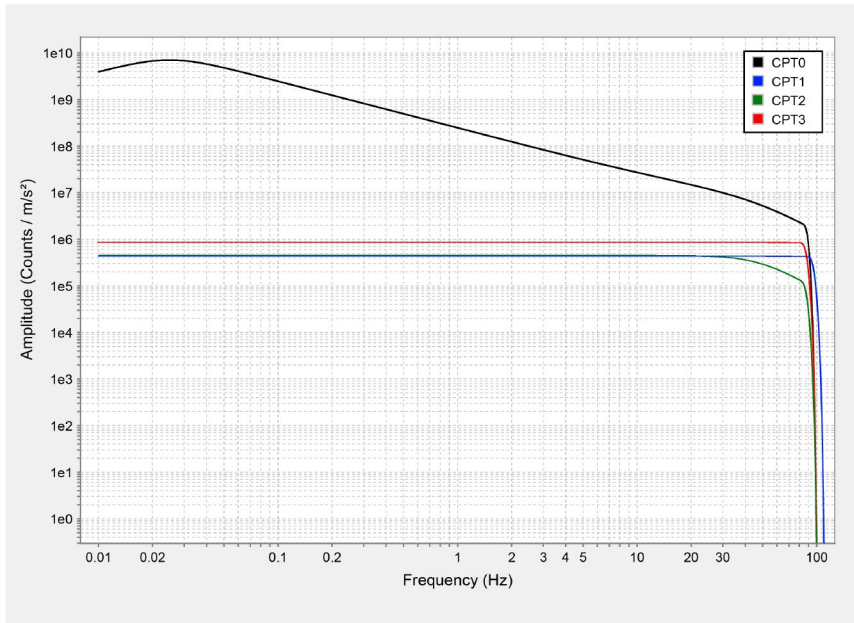
Figure 3. Amplitude responses from input ground acceleration for the instruments used at each site. Differences between the responses of each orthogonal component for a particular instrument are indistinguishable on this plot, and only the vertical-component frequency responses are shown.

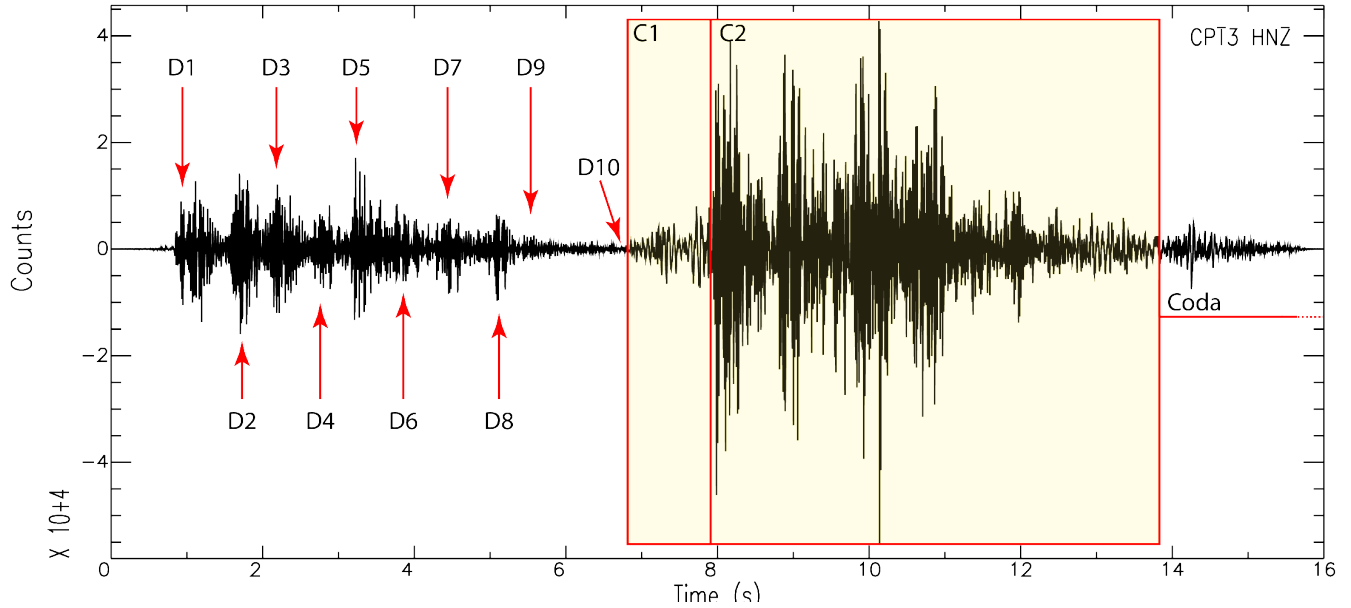
Figure 5. Ground-motion time history recorded at CPT3. The ground motions from the blast detonations in or under the Capital Plaza Tower are labeled sequentially (D1–D10), and the seismic wave arrivals from the collapse of the tower are highlighted in yellow. The collapse began (C1) with the final detonation (D10) and the nearly simultaneous collapse of the southeastern side of the tower’s foundation or ground floor; collapse event C2 includes the prolonged impact of the collapse of the remainder of the tower. The coda—the series of scattered waves arriving after the primary arrivals—is composed of reflected seismic waves and is not related to direct seismic arrivals.

All three strong-motion accelerographs recorded the entire demolition process, from the first detonation through the entirety of the collapse of the tower. The recordings also captured reflected or trapped waves within the Kentucky River Valley sediments. Figure 5 shows the ground-motion time series recorded at CPT3, annotated with the major events of the demolition.

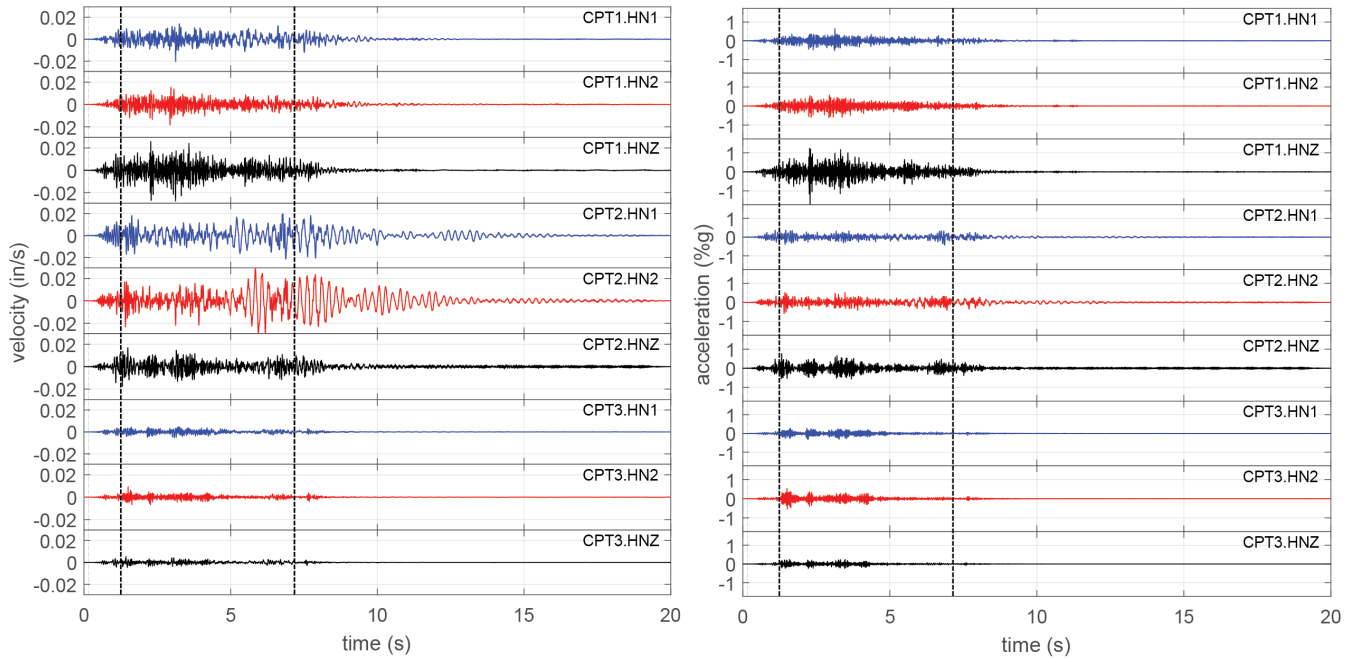
Figure 6. Ground-velocity (left) and acceleration (right) time histories of the Capital Plaza Tower collapse (preceding detonations not included). The same vertical scale is used for each trace. Traces are labeled by station name and component (HN1 = radial, HN2 = transverse, HN3 = vertical). The vertical dashed lines delineate the C1 and C2 time periods shown in Figure 5.

Time histories of the ground motions induced by the tower collapse recorded by each strong-motion accelerograph are shown in Figure 6 and the peak ground-motion levels are given in Table 2. The peak velocities (in inches per second to be consistent with the Explosives and Blasting Branch's recordings and regulations) and accelerations recorded at the soil sites exceeded those recorded by the corresponding components at the rock site: 0.027 in./s and 0.029 in./s were observed at soil sites CPT1 and CPT2, respectively, and 0.009 in./s was observed at rock site CPT3.

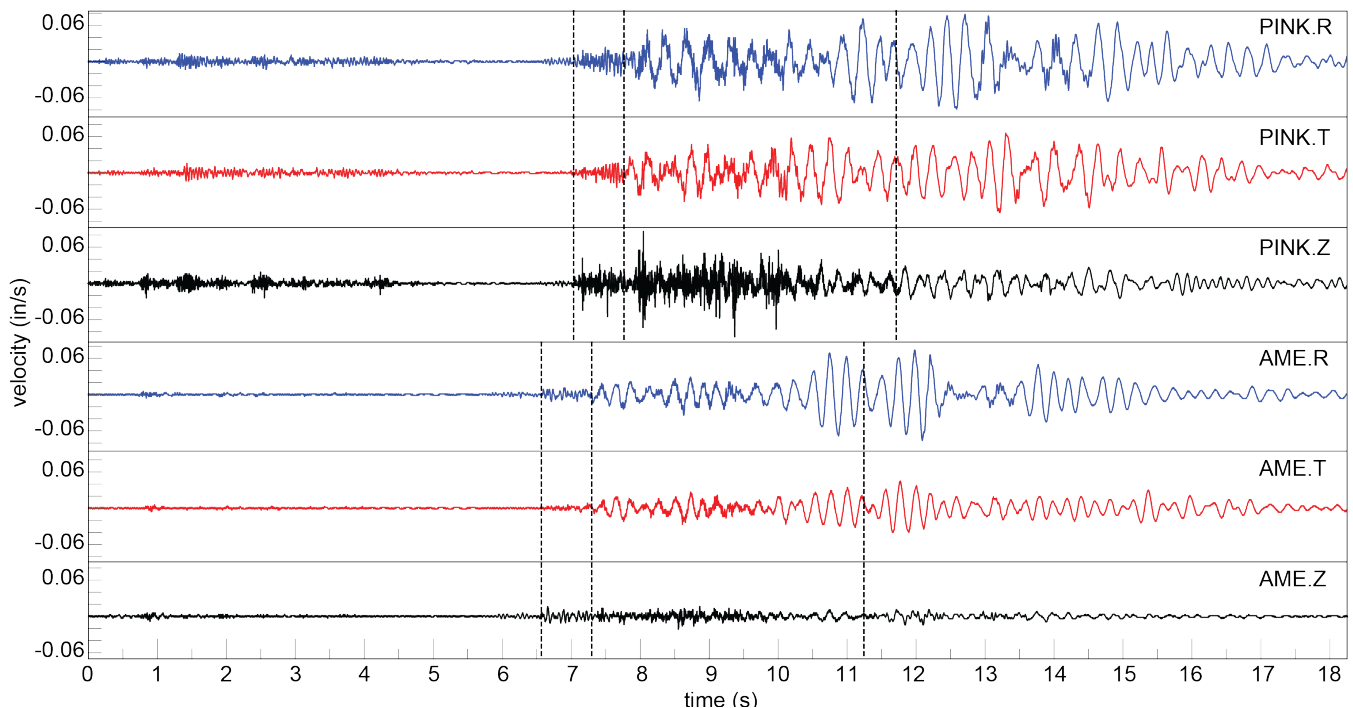
Figure 7. Ground-velocity recordings by seismographs deployed by the Explosives and Blasting Branch (Fig. 1). The same vertical scale is used for each trace. The vertical dashed lines approximately delineate the C1 and C2 time periods shown in Figure 5.

Recordings from Explosives and Blasting Branch stations PINK and AME are shown in Figure 7. Ground motions from the explosives are apparently captured in these recordings (absolute timing is unavailable), as well as ground motions from the tower collapse. Because the Explosives and Blasting Branch sites, which are also on Kentucky River Valley sediment, were significantly closer to the tower, the peak velocities they recorded were expected to be higher than those from the KGS stations, and this was in fact the case: 0.078 in./s and 0.075 in./s were recorded on the radial components at the PINK station (203 m from the tower) and AME station (293 m from the tower), respectively.

from the Explosives and Blasting Branch stations, the predominant frequencies at each site were estimated from the transverse-component seismograms shown in Figure 7: 3.7 Hz at the PINK site and 4.8 Hz at AME.

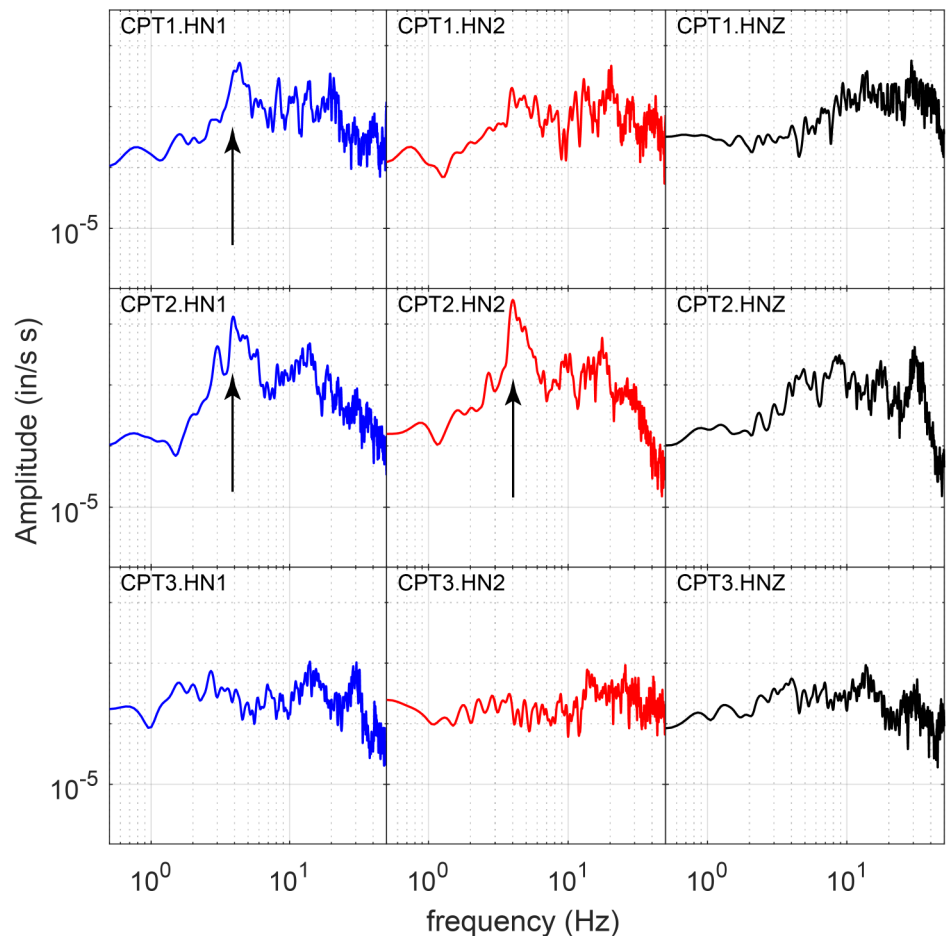
Figure 8. Amplitude spectra of the velocity time histories from Figure 6. The predominant peaks, indicated by arrows on the velocity spectra, at soil sites CPT1 and CPT2 are evidence of seismic-wave resonance in the underlying soils. Spectral plots are labeled by station name and component (HN1 = radial, HN2 = transverse, HNZ = vertical).

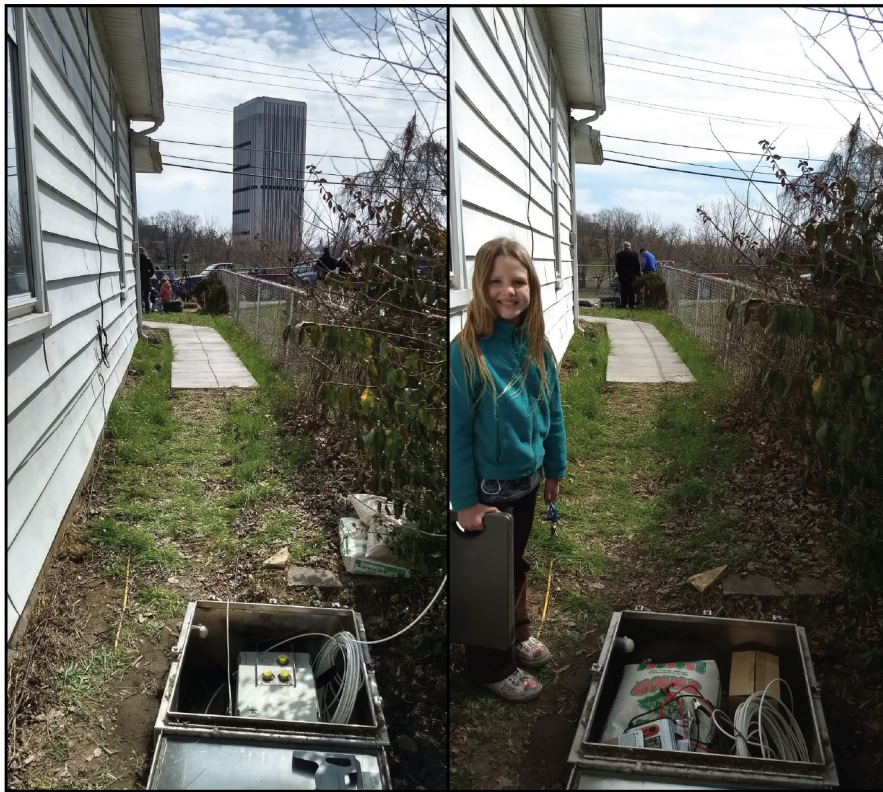
Figure 10. (Left) Capital Plaza Tower from the location of station CPT1 shortly before the implosion. (Right) The same view, shortly after the building's demolition, with a student observer next to the instrument. Photos by Seth Carpenter.

The demolition of the Capital Plaza Tower changed the skyline of Frankfort forever (Fig. 10) and provided a unique opportunity to observe seismic waves from a known energy source in the downtown Frankfort area. The Kentucky Geological Survey deployed three strong-motion accelerographs at approximately equal distances around the tower to record ground motions induced by the tower's collapse. The KGS instruments were installed at sites with different underlying geology: one on bedrock and two on Kentucky River Valley sediment.
