Lessons learned from six different structural health monitoring systems on highway bridges

Journal of Low Frequency Noise,
Vibration and Active Control
0(0) 1–15
© The Author(s) 2018
DOI: 10.1177/1461348418815406
journals.sagepub.com/home/lfn

Abheetha Peiris, Charlie Sun and Issam Harik

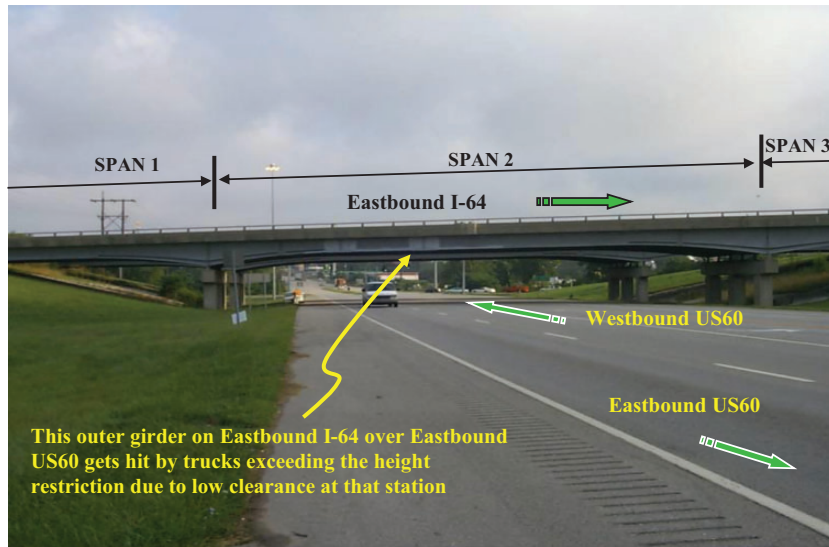
Figure 2. I-64 over US 60 parallel bridges.

state and other transportation officials as they occur as well as to identify trucks over the posted height limit. Instrumentation continuously monitors the bridge for possible impacts to the girders resulting from trucks that exceed the posted height limit. The three-span parallel eastbound and westbound bridges (Figure 2) are composite steel-concrete with overall lengths of 90 m. Their 190 mm-thick concrete decks are supported by six continuous plate girders of varying-and-constant depth type. The underside of an exterior girder—which has the least height-to-ground distance—of the eastbound bridge has exhibited signs of impact. It is suspected that impacts are caused by certain truck types traversing on the eastbound route of US 60 beneath the bridge. Remote sensing technology, which monitors the behavior and response of the I-64 bridges over US 60 for potential impacts, was installed at various locations. The data are transmitted to a computer at KTC, where they are analyzed, compared, and viewed, in elapsed or real time. The parallel bridges over US 60, along with the impact location, are shown in Figure 2.

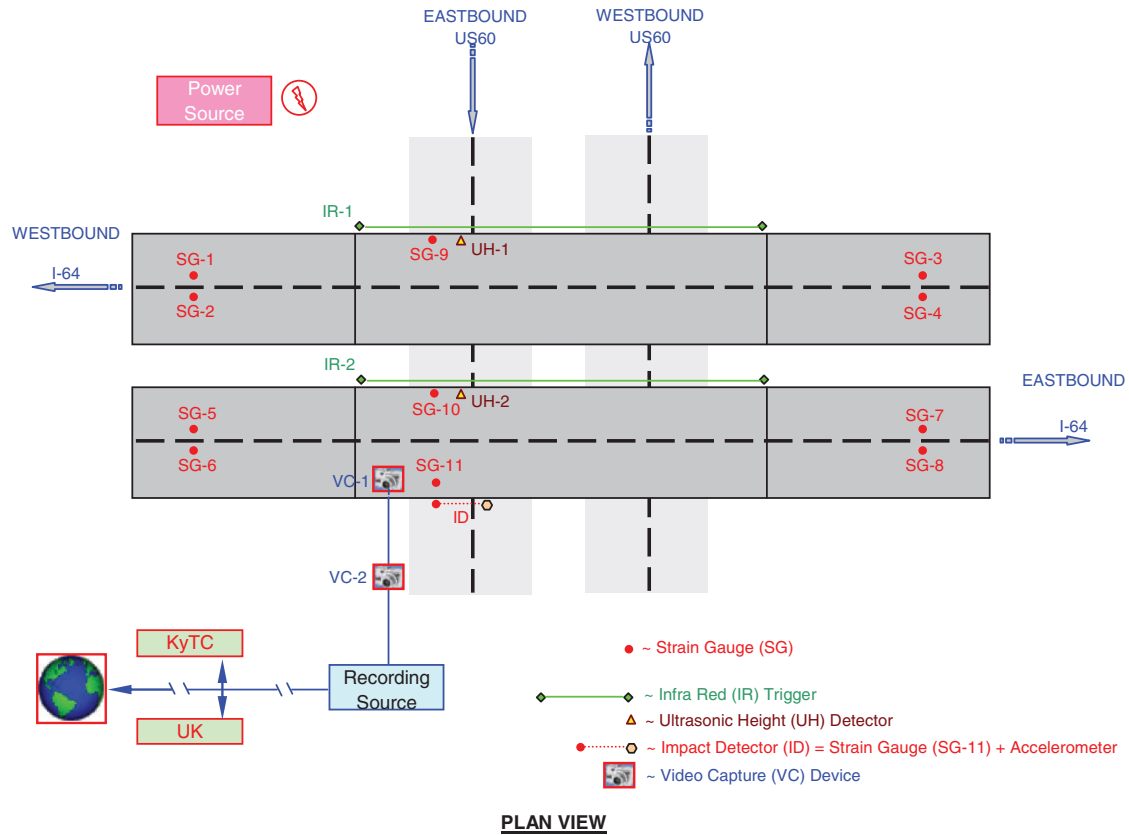
Figure 3. Sensor layout on I-64 parallel bridges.

Since the bridges are similar in terms of dimensions and expected loading, the effects from the potential impact on the eastbound bridge (i.e., the subject) can therefore be compared to the westbound bridge (i.e., the base). Figure 3 indicates the locations on the bridges of various devices employed in this project. Included among the devices are strain gauges (SG), temperature gauges, infrared sensors, ultrasonic height (UH) detectors, accelerometers, and video cameras (VCs). Strain gauges are installed at 11 locations (indicated as SG-1 to SG-11).

Five strain gauges are in the westbound I-64 bridge, and the remaining ones are in the eastbound bridge. SG-1, SG-2, SG-3, and SG-4 on the westbound bridge and SG-5, SG-6, SG-7, and SG-8 are placed on the vertical face of the bottom flange of the two interior girders of the six plate girders. Each pair of gages (SG-1/SG-2, SG-3/SG-4, SG-5/SG-6, and SG-7/SG-8) is placed on the two girders facing each other. SG-1 to SG-8 study the strain effects under ambient conditions and compare the differences between the two ends of each bridge. The strain effects due to potential impacts are studied through SG-9 to SG-11. SG-9 and SG-10 are on the vertical face of the bottom flange on the inside of the first exterior girder facing traffic within the center span of westbound and eastbound bridges, respectively. SG-11 is on the vertical face of the bottom flange on the inside of other exterior girder on the eastbound bridge. The mounting tabs for the strain gauges were adhesively bonded to the steel beams. The wires were standard sheathed wires provided by the sensor manufacturer. These were bundled and run through a polyvinyl chloride (PVC) conduit leading to the data acquisition system.

The infrared sensors (IR-1 and IR-2) detect trucks that would impact Girder 1 on the eastbound I-64 bridge. Each sensor unit consists of an emitter and receiver mounted on a cross frame erected between the first two girders facing oncoming traffic within the center span of each bridge. When the infrared mechanism is interrupted—presumably due to a truck—the sensor simultaneously triggers its adjacent UH detector and VC to measure the truck height and capture images of the truck, respectively. A UH detector functions by sending a pulse-wave of specific frequency. When the pulse-wave encounters a solid surface (e.g., hood of a truck), the wave will reflect and return to the source. A single triaxial accelerometer is also employed on this project, with one axis oriented along

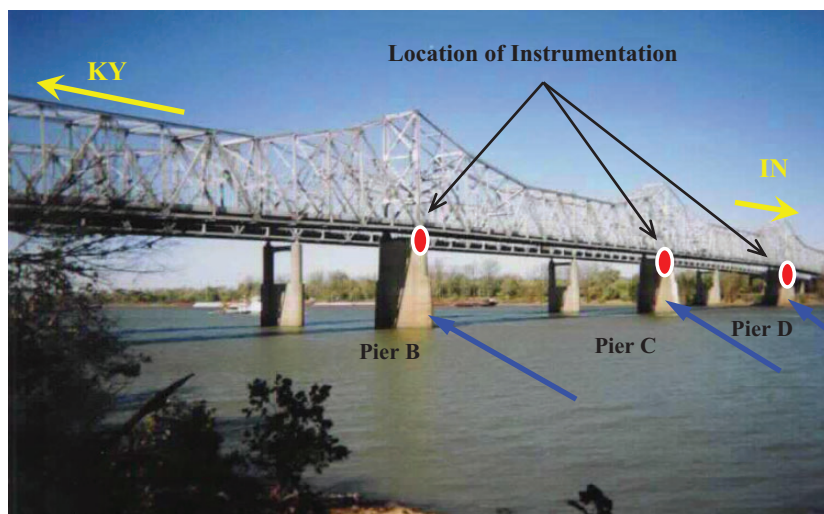
Figure 4. Instrumentation locations on NB US 41 bridge over the Ohio River.

Kentucky has over 1600 km (1000 miles) of navigable waterways. The Ohio River accounts for close to 70% those. Barges are the primary means of transporting goods on the Ohio River. With the amount of waterways traffic, accidents caused by barge impacts at times are inevitable. While barges travel at a slow speeds (<3.09 m/s or 6.91 mile/h), their size can be enormous (31 m (100 ft) in width by 366 m (1200 ft) in length), making maneuvering oftentimes challenging. The NB US 41 bridge over the Ohio River in Henderson County, Kentucky, is a cantilever through-truss bridge. The total length of the bridge including approach spans is 1950 m (5395 ft). The NB US 41 bridge was instrumented with sensing technology to monitor the piers from afar for impacts from a barge or barge flotilla. The implemented SHM was expected to quantify impacts and transmit information regarding their severity to the Transportation Operation Center at KYTC, the US Coast Guard, and other selected personnel. Triaxial accelerometers were mounted on the top of Piers B, C, and D to detect and measure impacts. In addition, linear variable displacement transducers (LVDTs) were mounted on the expansion bearings atop Pier B. Figure 4 depicts the bridge and indicates where instruments are located. The SHM is also equipped with video equipment to record visual evidence of vessels, barges, or flotilla, impacting the pier during any ambient condition (e.g., day, night, rain, and fog).

Typical data collected include acceleration, displacement, and visual (video and still) records. A plot of the time history for the accelerations and displacements immediately prior to (≈ 2 to 5 s) and following impacts (≈ 15 to 30 s), as well as maximum hourly acceleration and displacement data, is accessible through the project website. Video and photographic records are stored for 10 min prior to an event and 10 min following an event. Due to the need to store a large amount of data, including video files, separate data acquisition systems were set up on each pier. The three systems operated independently when detecting impacts on any of the three piers. Each had its own cellular data connection for information transmission. The power required to operate the equipment was obtained via a large array of solar panels set up on the steel trusses. Various acceleration and displacement limits or thresholds were set to identify severe and/or critical impacts. The threshold limits in the longitudinal, transverse, and vertical directions relative to the axis of the bridge were selected based on a previous study of multi-barge flotilla impact forces on bridges.¹² An impact causing an acceleration over $0.2g$ was considered as severe, only an acceleration exceeding $0.05g$ was required to activate the system data storage prior to and immediately following an impact. A severe impact is defined as the limit or threshold of impact that would cause possible damage to the piers in question. A critical impact is defined as the limit or threshold of impact that damages the pier, an impact whose magnitude would also require closing the bridge for further inspection. Critical and severe impacts are defined for each structure based on limits for displacement at expansion joints and/or acceleration and/or strain measurements.

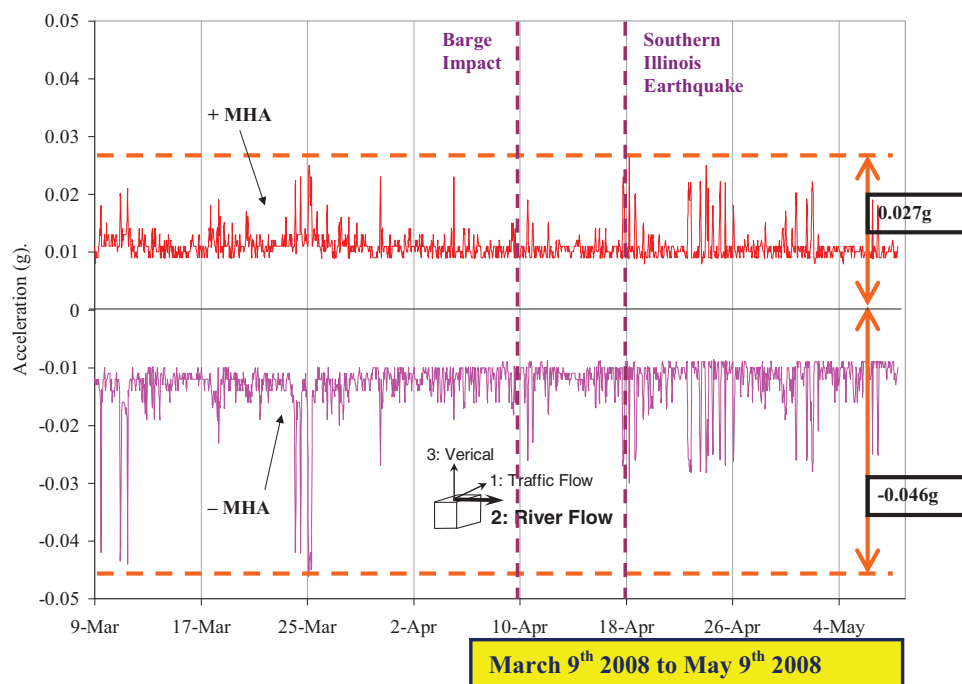
Figure 5. Maximum hourly acceleration at Pier D in direction 2 (River Flow) MHA: Maximum Hourly Acceleration.

The SHM system was installed by a private company following a bidding process and then transferred over to KTC research team following a three-year maintenance period. Following the transfer, communication with the data acquisition system via remote access through the cell modem was found to be sporadic. This was identified as being due to differences in communication protocols following a change in the cellular data service provider. Due to the available funding limits, following the three-year implementation period, upgrades to the system were not feasible. In addition, the system's effectiveness in detecting barge impacts was thrown into doubt following a barge impact that occurred on 10 April 2008. The magnitude of the accelerations produced by the barge impact on 10 April 2008, reported by the US Army Corp of Engineers, and the Southern Illinois Earthquake on 18 April 2008, was less than 0.05g in all three directions. Consequently, since the trigger for data capture and storage is 0.05g, only the maximum hourly acceleration is saved. Had either one of the events triggered the threshold acceleration in any direction; the event history would have been saved in place of the hourly maximum acceleration. As seen in Figure 5, the maximum hourly accelerations were less than the trigger acceleration of 0.05g.

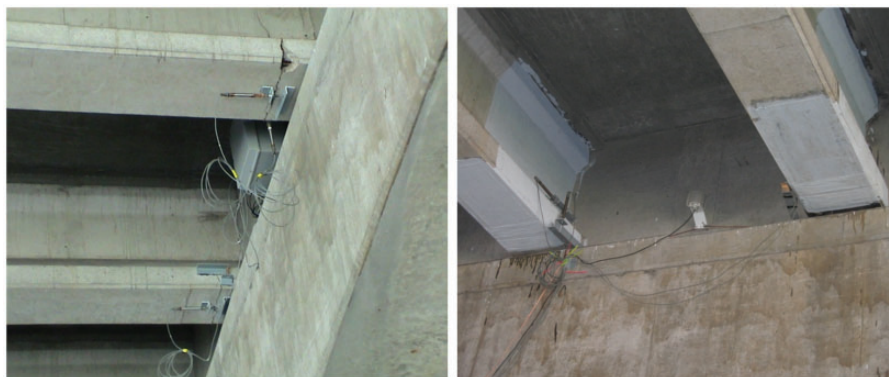
Figure 6. Instrumentation on Beams 6 and 7 before and after strengthening with CFRP sheets/fabric.

To investigate the liveliness of the cracks, two girders (Girders designated as Beams 6 and 7) were instrumented with LVDTs in the horizontal and vertical directions to measure their respective movements. Figure 6 shows the LVDTs mounted over the cracks before and after they were strengthened with CFRP. Instrumentation was installed on 16 February 2004 and the maximum daily movement and temperature measured until 27 June 2005. Data collected over this period were used to design the retrofit measures, and once the repair was complete the LVDTs were reattached at the same locations to assess the retrofit's effectiveness. Prior to the retrofit, the SHM indicated that the cracks, though active, were within acceptable limits. This permitted the use of CFRP fabric to strengthen the girders, avoiding the more expensive alternatives of extending the pier cap support or construction of new piers. Monitoring following the retrofit confirmed that a significant reduction in horizontal movement attributable to the retrofit (Figure 7), while in the vertical direction, the retrofit prevented the further increase of vertical movement. It should be noted that the crack measurement following the retrofit, starting on 3 September 2006, was initiated at the final measurement recorded prior to the retrofit (27 June 2005).

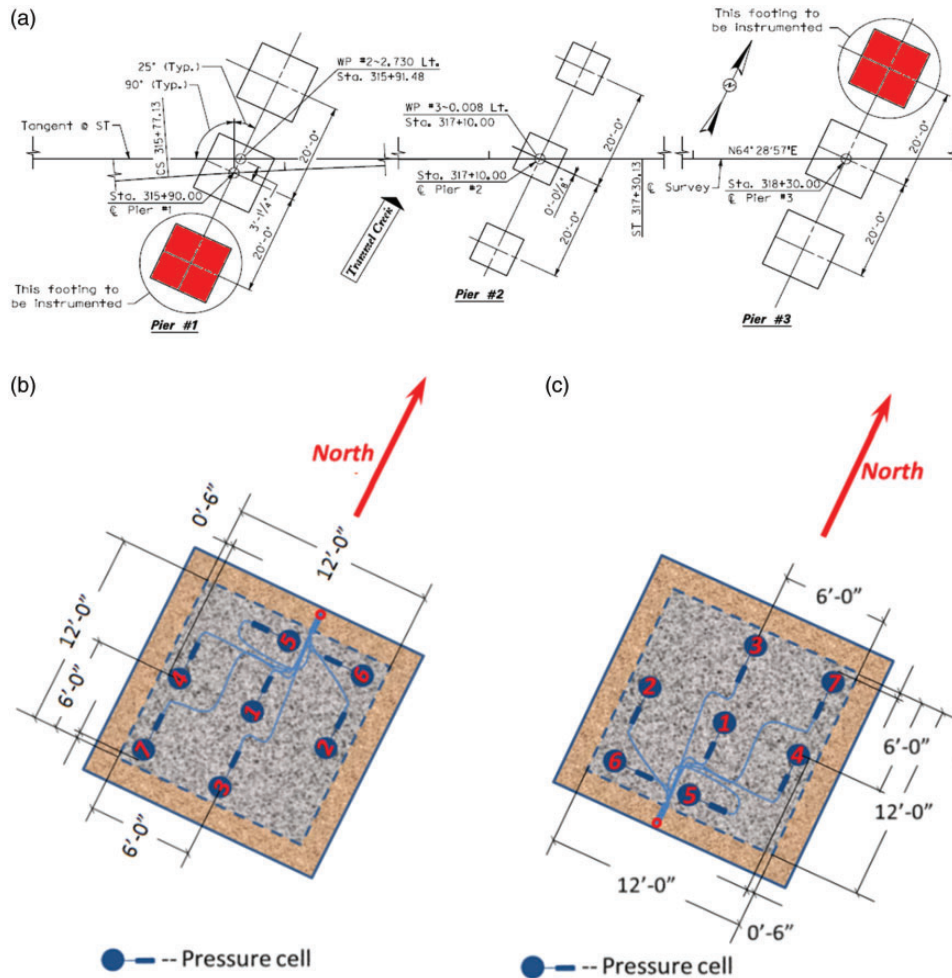
Figure 8. Pressure cell instrumentation: (a) Plan view of pier foundations showing instrumented footings, (b) pressure cell layout beneath Pier 1, and (c) pressure cell layout beneath Pier 3.

Each pier column span terminates below on thick reinforced concrete spread footings. To achieve the research objective, the bridge was fitted with pressure cells at select foundation locations (Figure 8).

Tiltmeters were installed on the outermost faces of pier caps. After the PC superstructure girders were installed and reinforced concrete diaphragms poured atop each pier, thermocouples were affixed to the south face of the superstructure rails, where placement locations lie directly above Piers 1 and 3. Continuous data collection began in May 2011 and continues today.

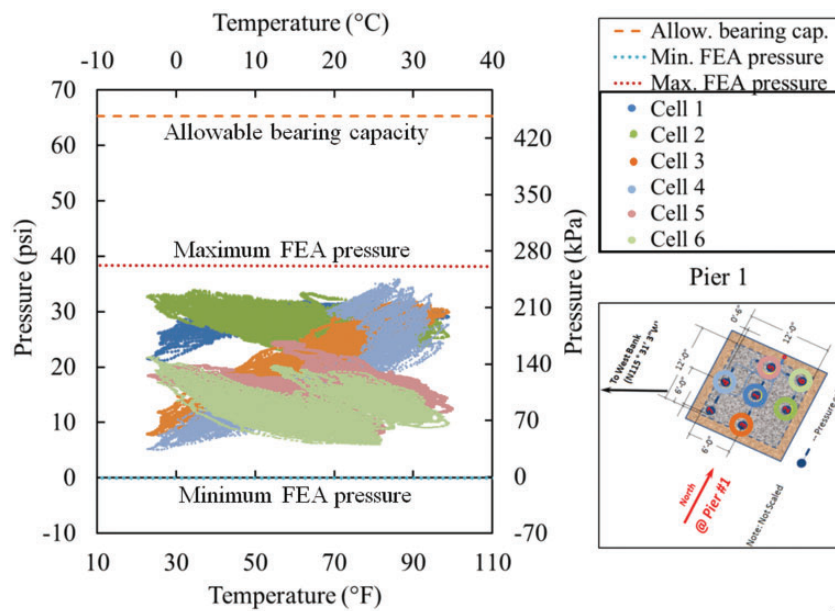
Figure 9. Pier 1 foundation bearing pressures versus temperature. Note that Cell 7 is defective. FEA: finite element analysis.

Finite element (FE) modeling and analysis of temperature loadings on the bridge were used to estimate the bridge pier motion and foundation pressures using methodologies provided in AASHTO design provisions. Estimates were compared to physical measurements obtained at the bridge site. This established a foundation to assess the merit of current AASHTO provisions related to temperature-induced response for the study site. Data records for Pier 1 (Figure 9) indicated that the pier footings were designed to limit pressures to approximately one-half of the allowable bearing capacity for the bridge site (450 kPa or 65 psi). Comparing the FEA-derived pressures generated by introducing extreme temperature values specified in the AASHTO provisions and field data indicates that the AASHTO design provisions produce conservative estimates of foundation design pressures.

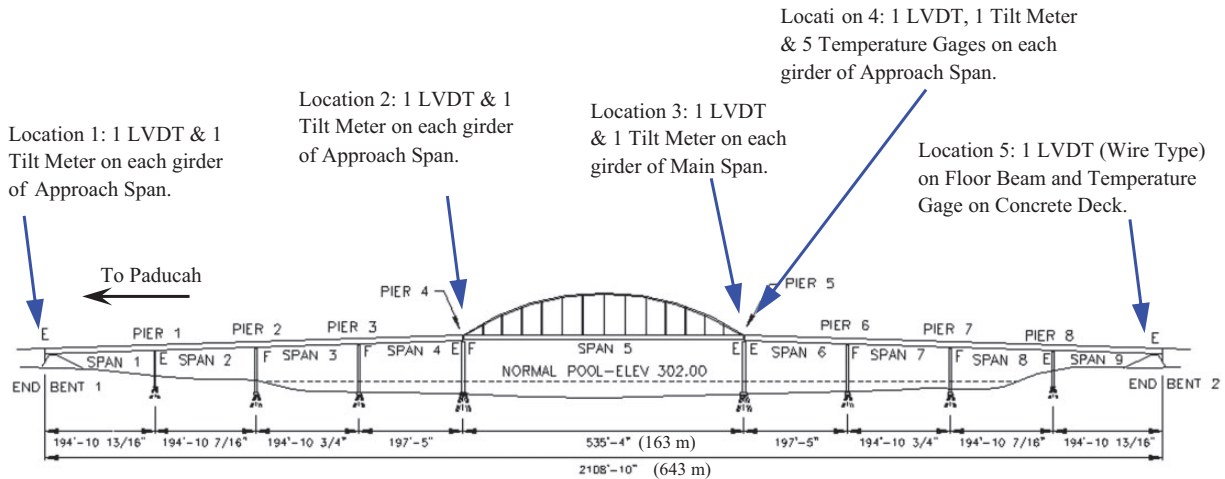
Figure 10. Instrumentation locations of Eastbound I-24 Bridge. LVDT: linear variable displacement transducer.

The parallel Tennessee River Bridges on I-24 in western Kentucky are steel plate-girder bridges. Each bridge consists of nine spans symmetrically located on either side of the tied-arch main span and has a total length of 643 m (2109 ft 10 in). The main spans of each bridge are a single span steel-girder tied-arch with a span length of 163 m (534 ft 4 in). Five locations that were free to move were instrumented along the length of the eastbound bridge (Figure 10). Two of these locations (Locations 1 and 5) were the abutment ends of the two approach spans. Locations 2 and 4 were the other ends of the approach spans, where they meet the main span, over Piers 4 and 5. The final place instruments were installed (Location 3) was the free end of the main span over Pier 5. The SHM setup on the eastbound I-24 Bridge was designed to collect data on temperature and displacement. Parameters measured by the instruments include the expansion and contraction as well as the inclinations of instrumented bridge ends. The temperature of the bridge girders is also monitored. The instrumentation included LVDTs to measure longitudinal displacements of the girders in the approach and main spans. A total of nine LVDTs were installed. Eleven temperature sensors recorded the temperature of the steel girders and concrete deck. Eight tilt meters recorded the inclination of the steel girders in the two approach spans as well as the main span. The layout of the locations and the type of instrumentation used at each location are provided in Figure 10. Data loggers were installed at each abutment and the two piers to gather data on displacement, tilt, and temperature. Additional instrumentation was set up for remote monitoring and periodic data backup. The instrumentation readings at each location are transmitted wirelessly to a transmitter at one location, from where the data are periodically uploaded to the KTC servers using a phone modem via a cellular data connection.

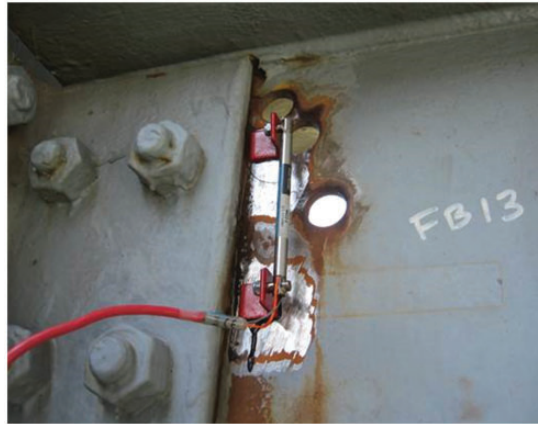
Figure 12. Crack gauge setup.

A routine KYTC inspection of the I-275 Bridge over the Ohio River revealed cracks in similar locations on the webs of several floor beams in the main span. The 1235 m (4051 ft) bridge is a continuous steel arch-shaped truss, with a main span of 229 m (750 ft). The cracks were near the top of the web, at the end of the floor beam. Holes were drilled at the crack tips with the expectation of arresting crack growth. Prior to repair work, it was deemed necessary to evaluate if the cracks were widening over time. A vibrating wire micro crack meter was placed across a selected crack and the movement measured in real time (Figure 12). The data acquisition system

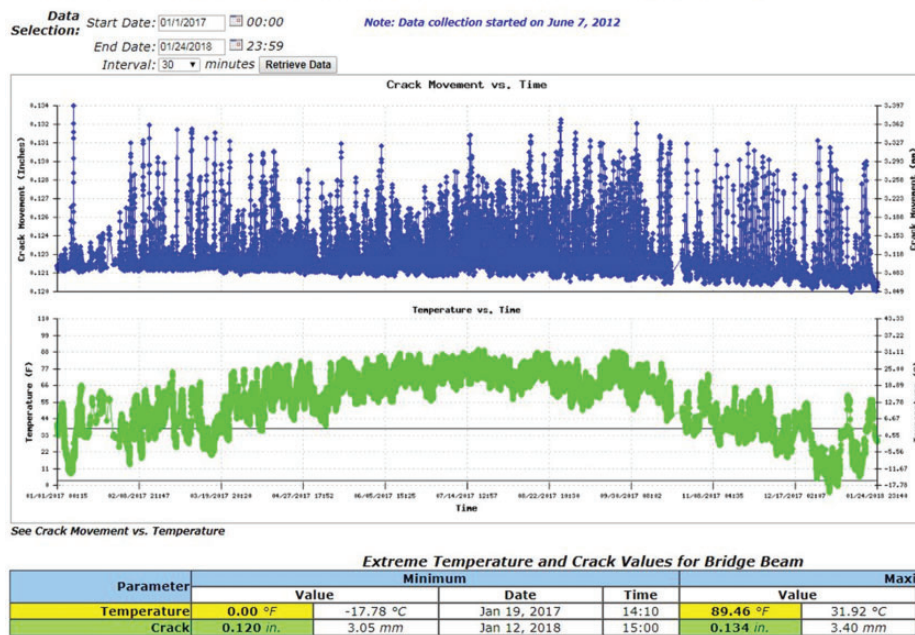
Figure 13. Crack gauge setup.

transmits the crack data to a server by cell modem every 10 min. Crack opening thresholds were established; once threshold values were exceeded, stakeholders received an immediate email notification.

The simple SHM, set up in 2012, has been continuously operational and verified that the crack growth has been arrested. With cracks not progressively growing, additional costly repairs were deemed unnecessary. The crack displacement and temperature data can be retrieved for a given period via the KTC Remote Bridge Monitoring website. Figure 13 shows data for 2017, with a displacements data interval of 30 min. The maximum and minimum crack openings, as well as temperatures and the corresponding dates, are also tabulated by the website for the chosen duration.
