Coal Truck Driver Dies in Rollover After Tire on Trailer Fails Incident Number: 06KY100

Kentucky Fatality Assessment and Control Evaluation (FACE) Program
Incident Number: 06KY100
Release Date: May 12, 2009
Subject: Coal Truck Driver Dies in Rollover After Tire on Trailer Fails

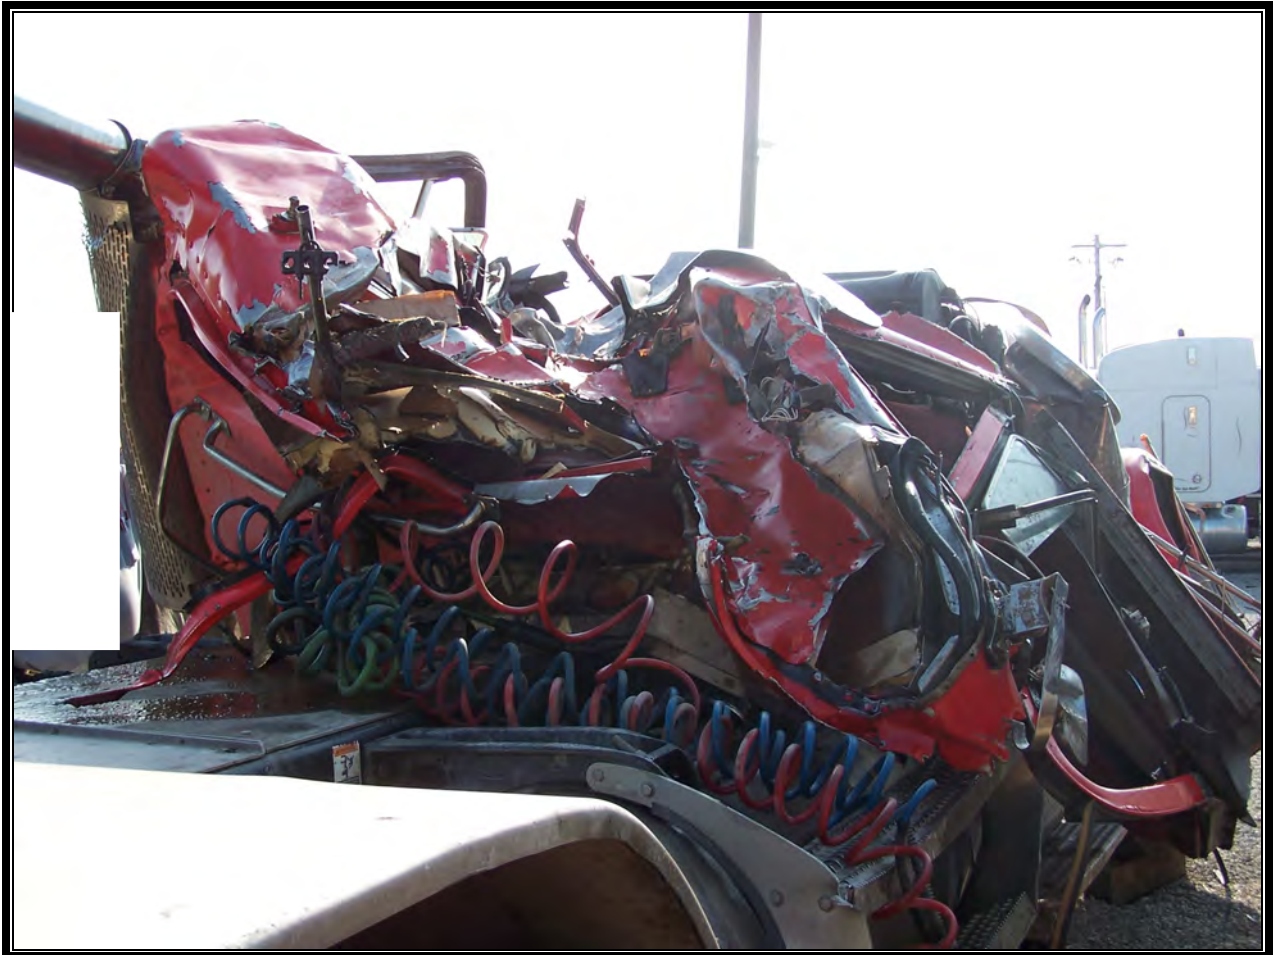
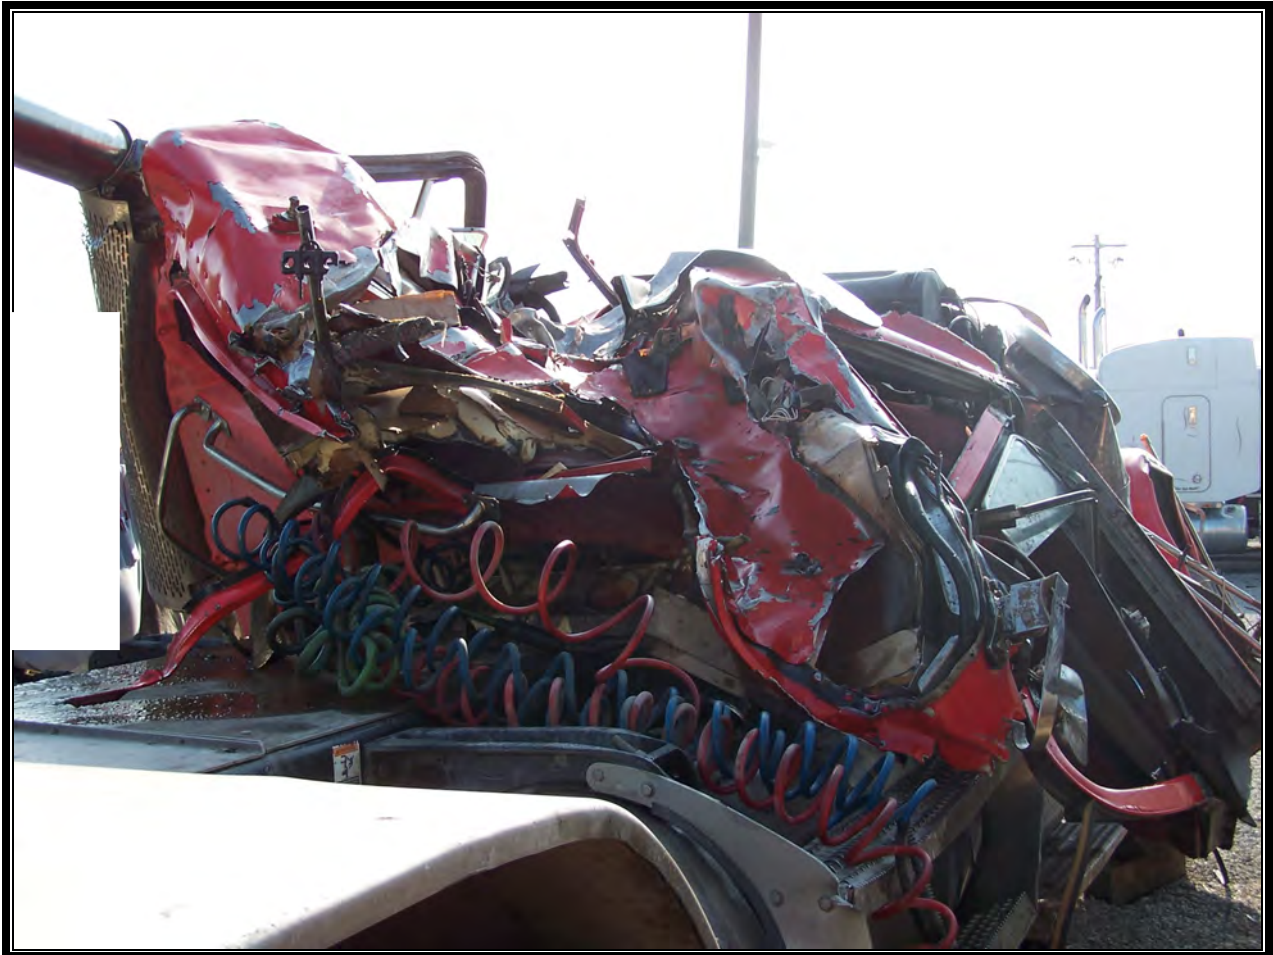
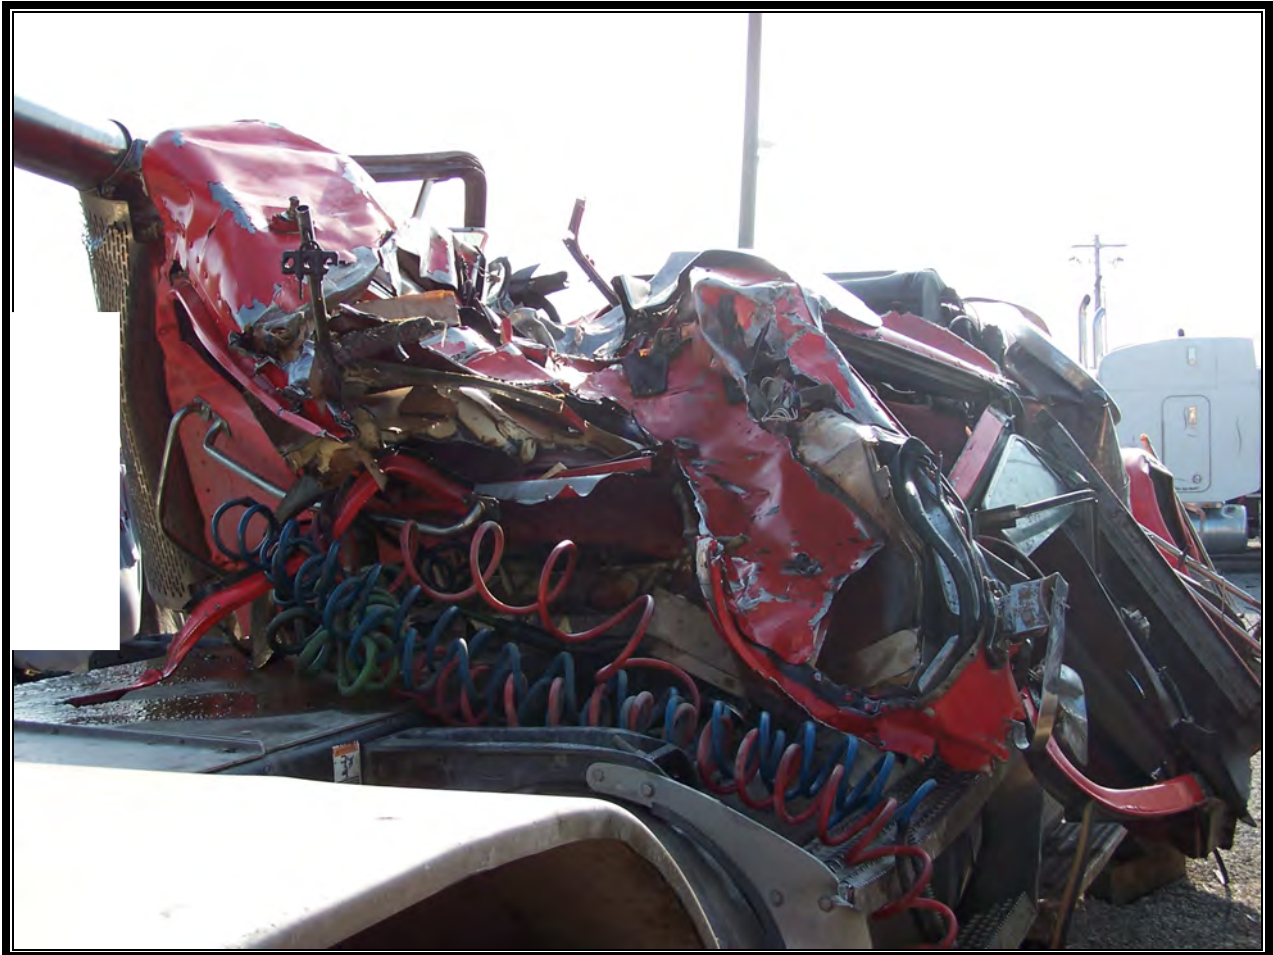
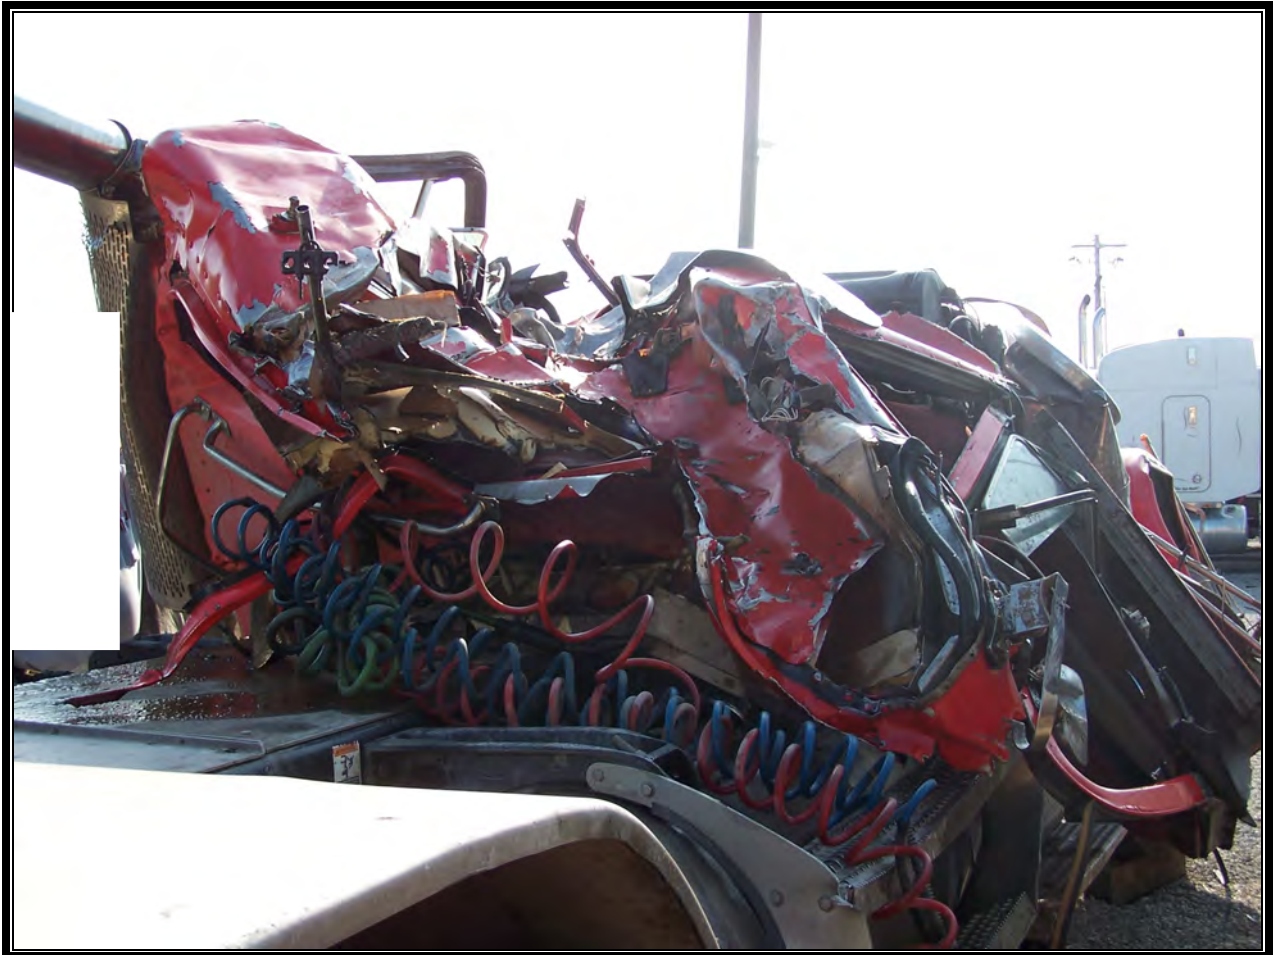
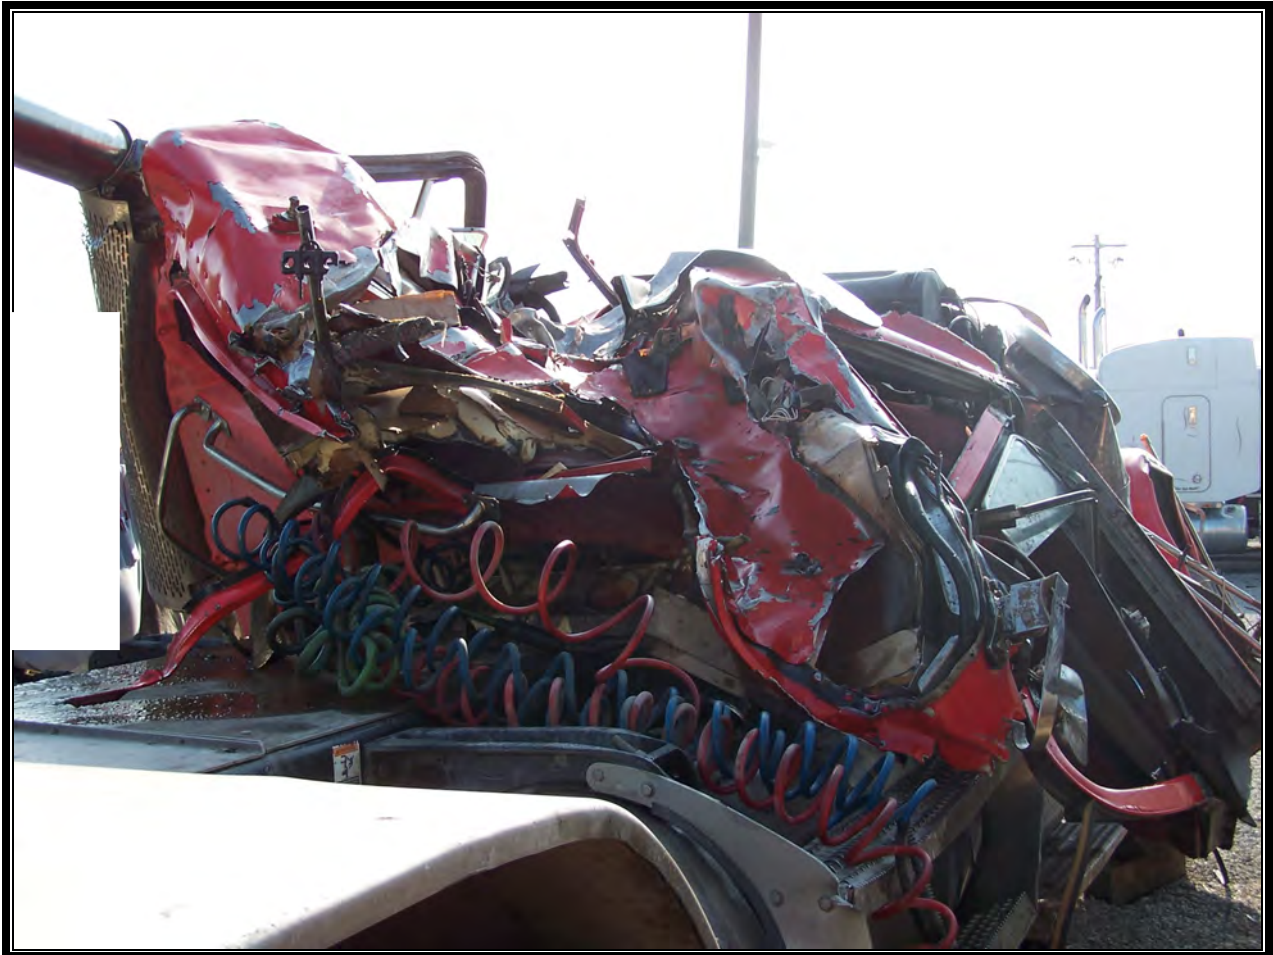
Photograph of semi involved in crash. Photograph taken by KY FACE personnel.

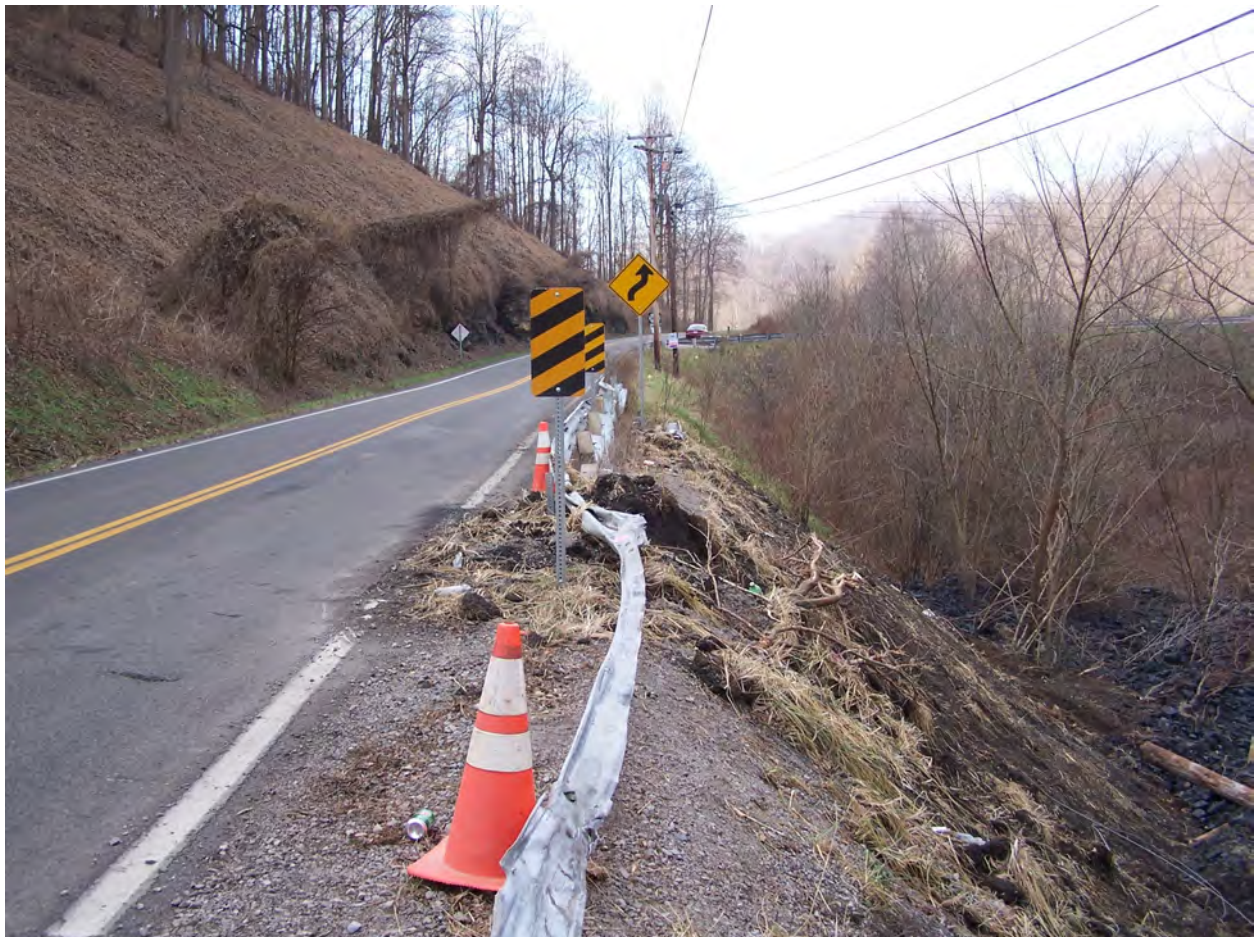
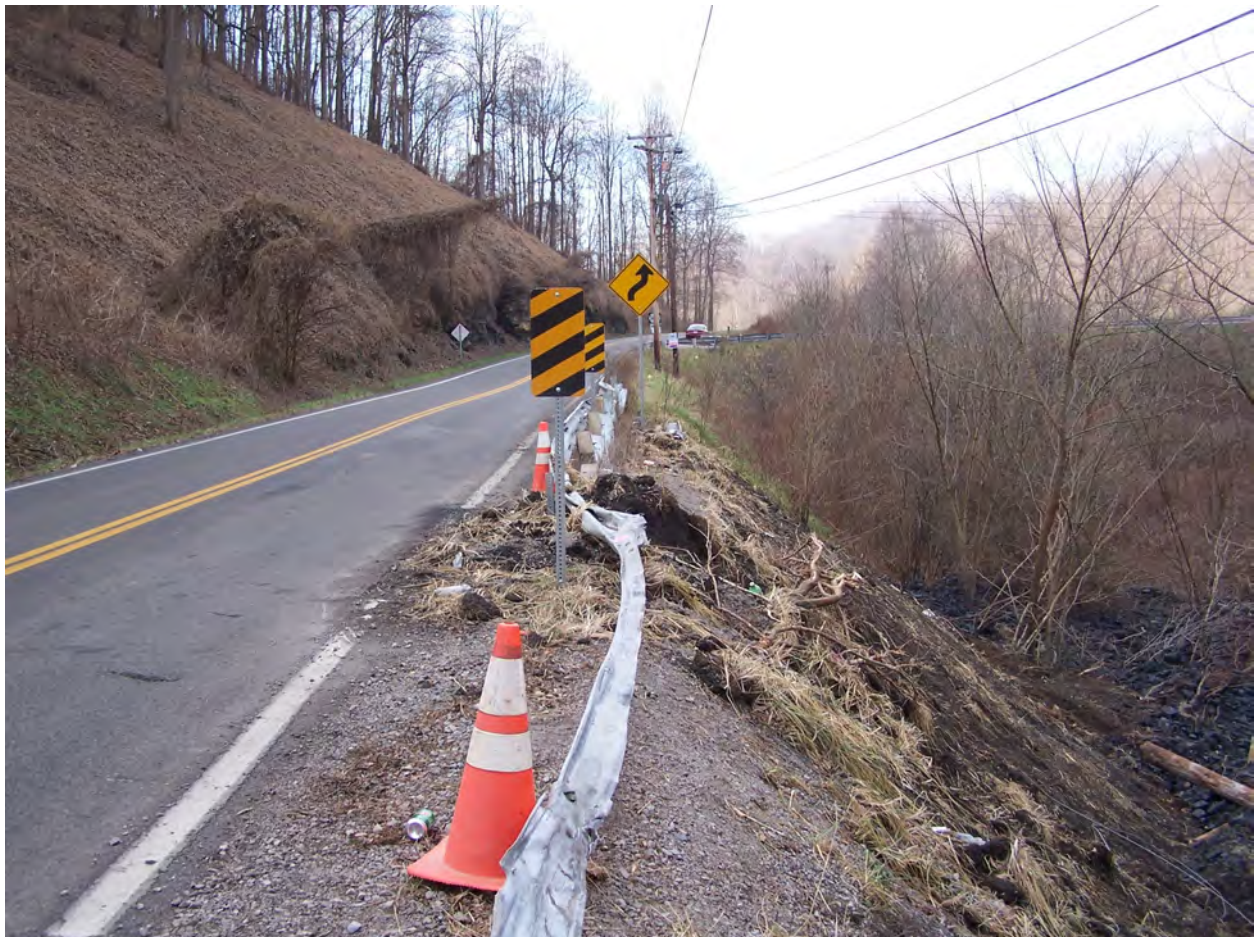
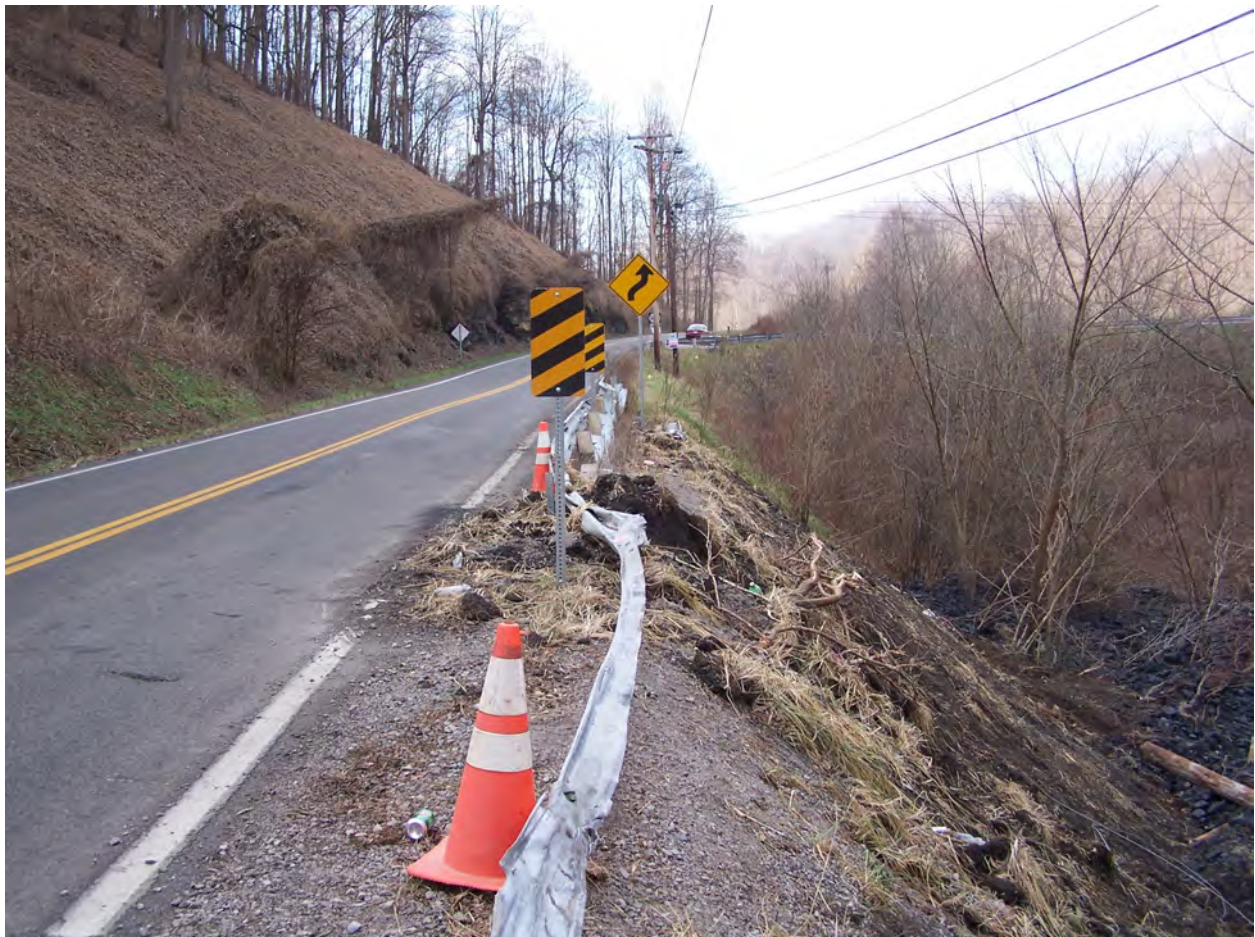
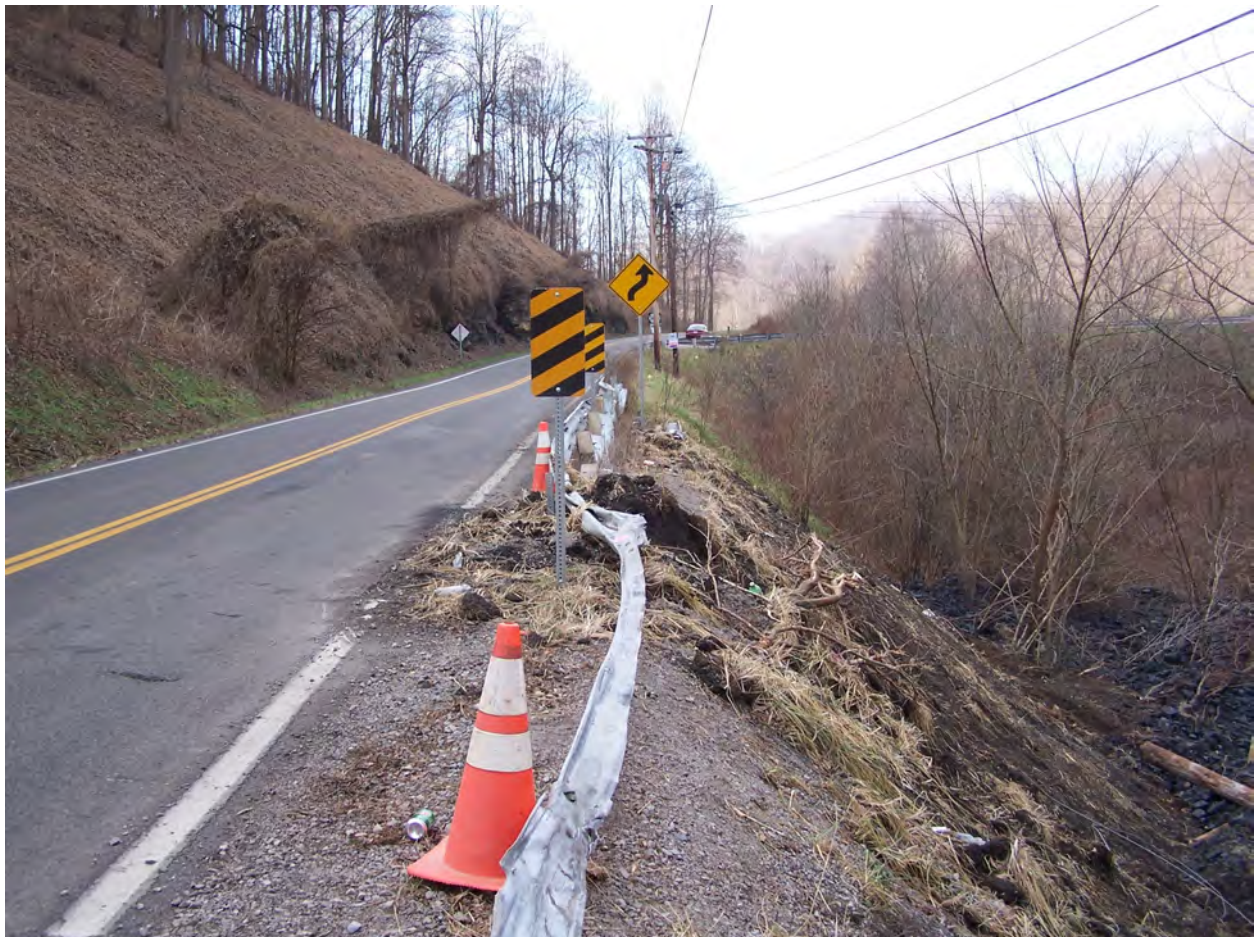
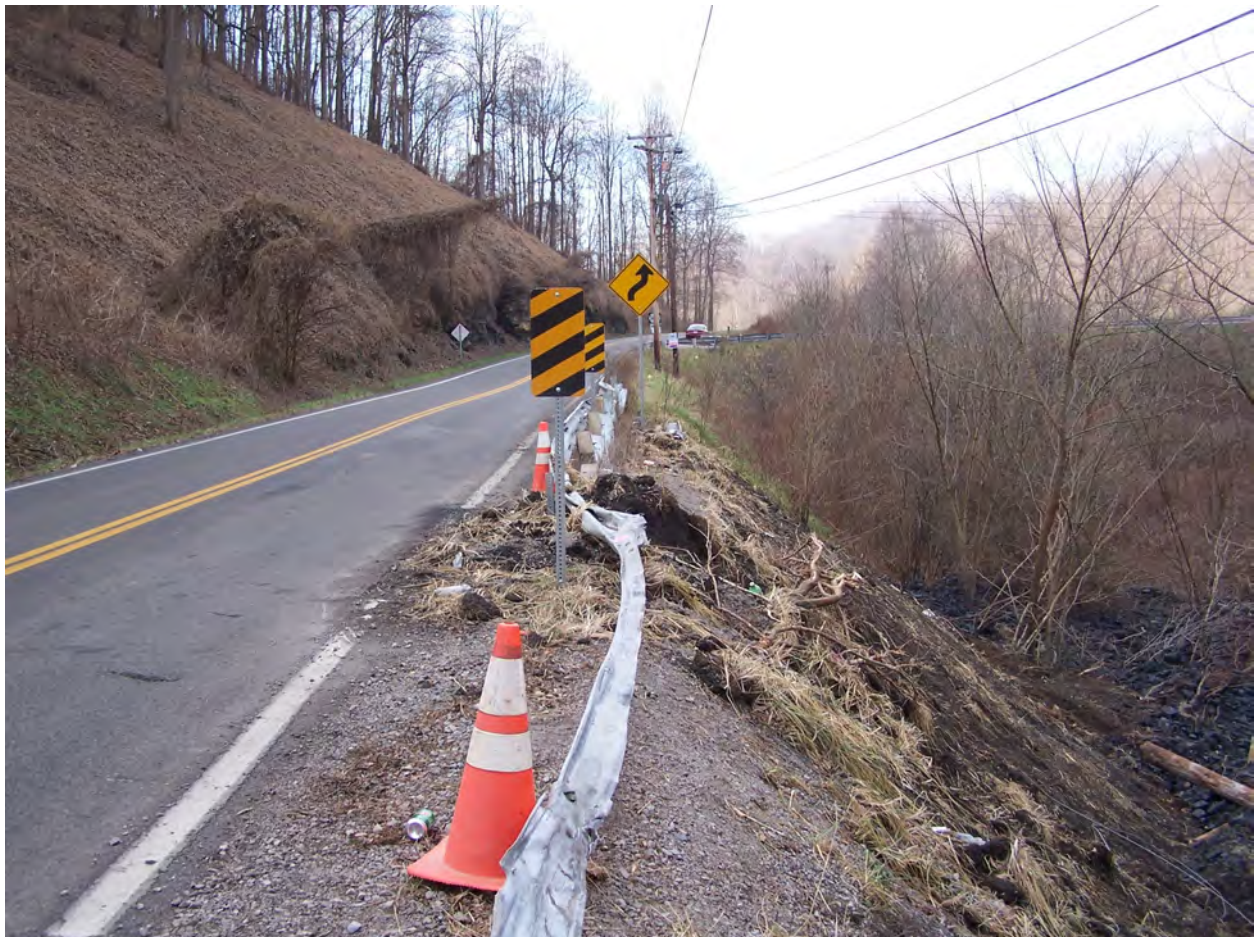
Accident reconstruction conducted by the Kentucky State Police revealed that there were 284 feet of skid marks prior to the point where the tractor overturned. The tractor then skidded approximately 82 feet on its side and top before coming to rest upside down and on top of the guard rail. There was approximately 120 feet of damaged guard rail.

Location where tractor and trailer came to rest. Photograph taken by KY FACE personnel.

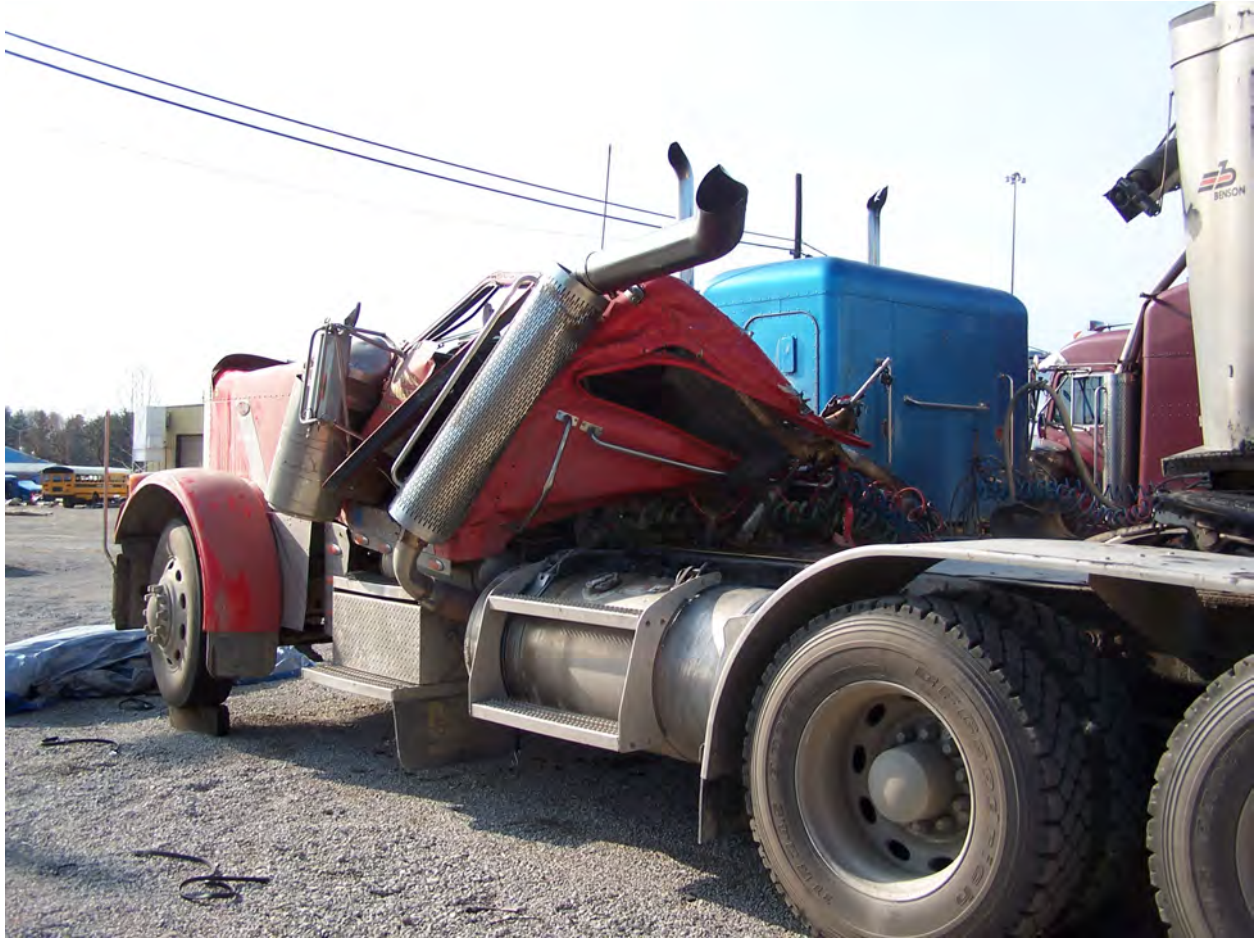
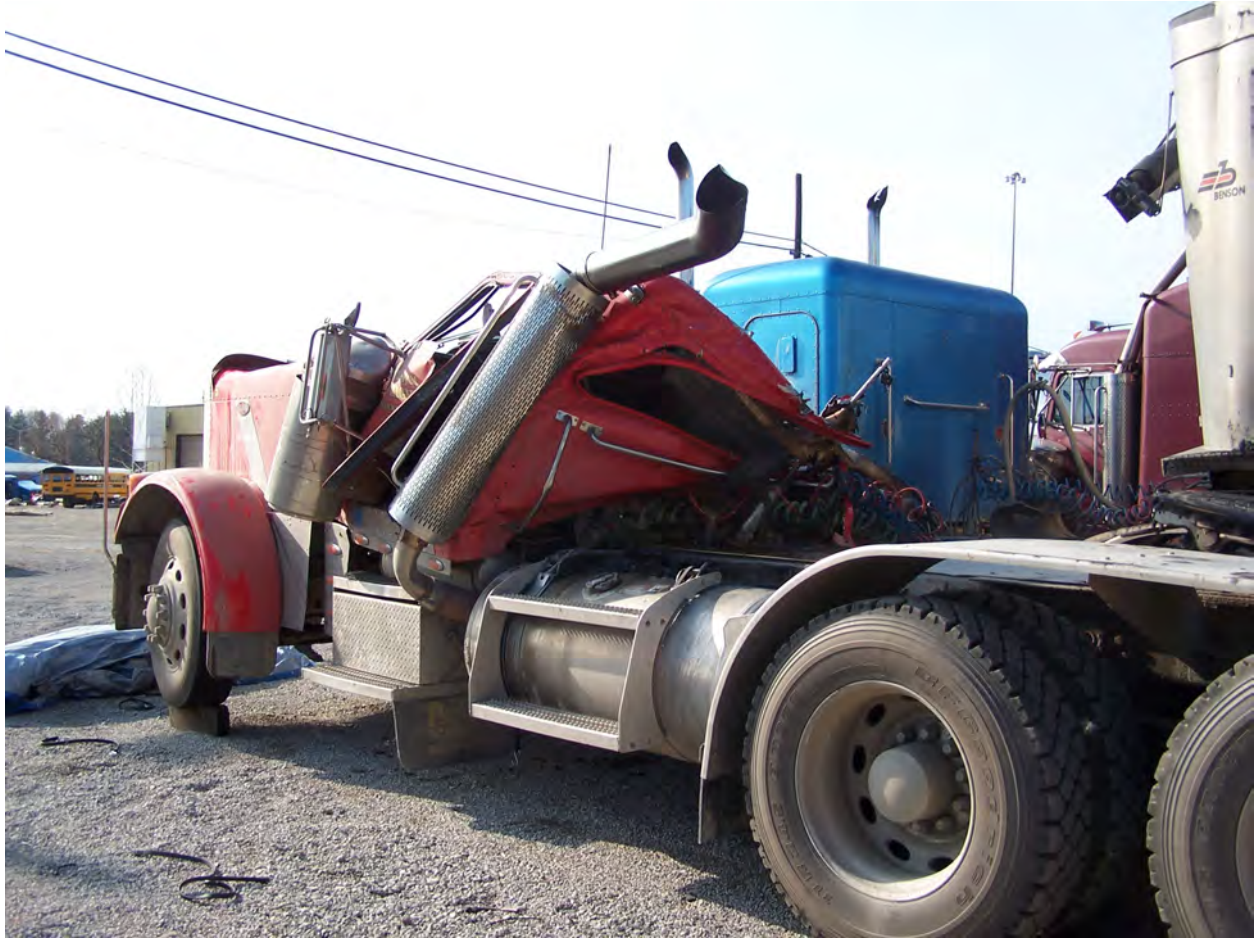
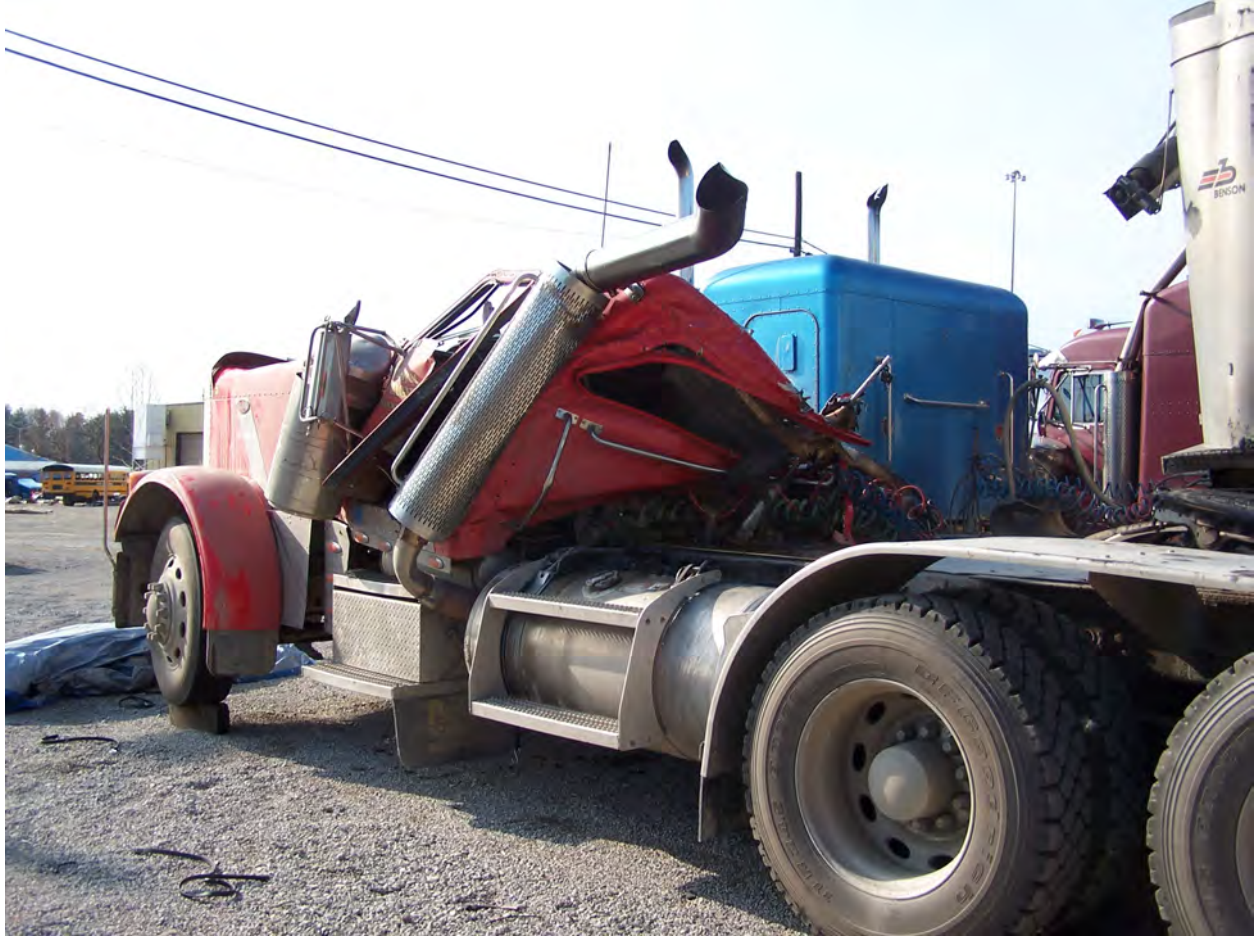
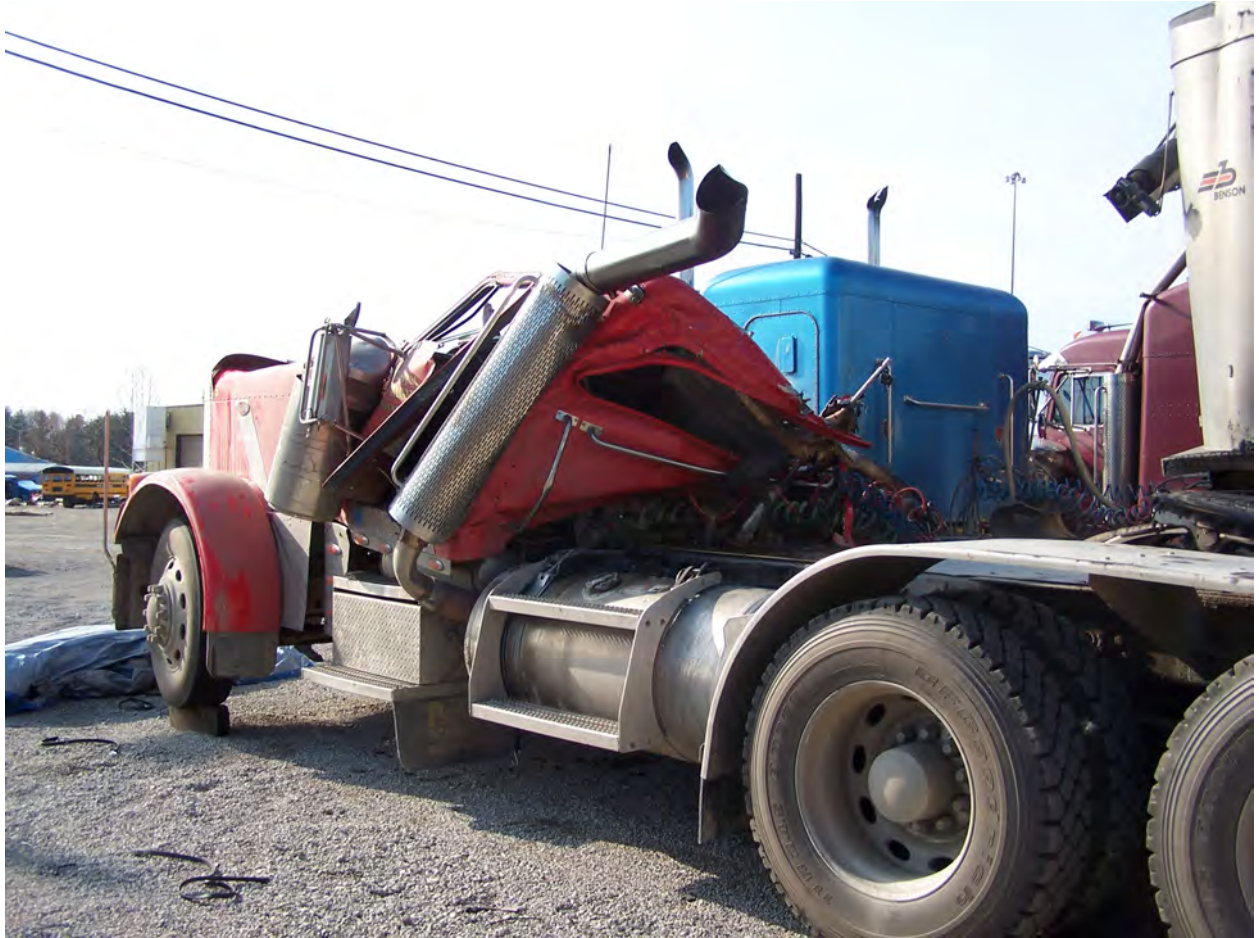
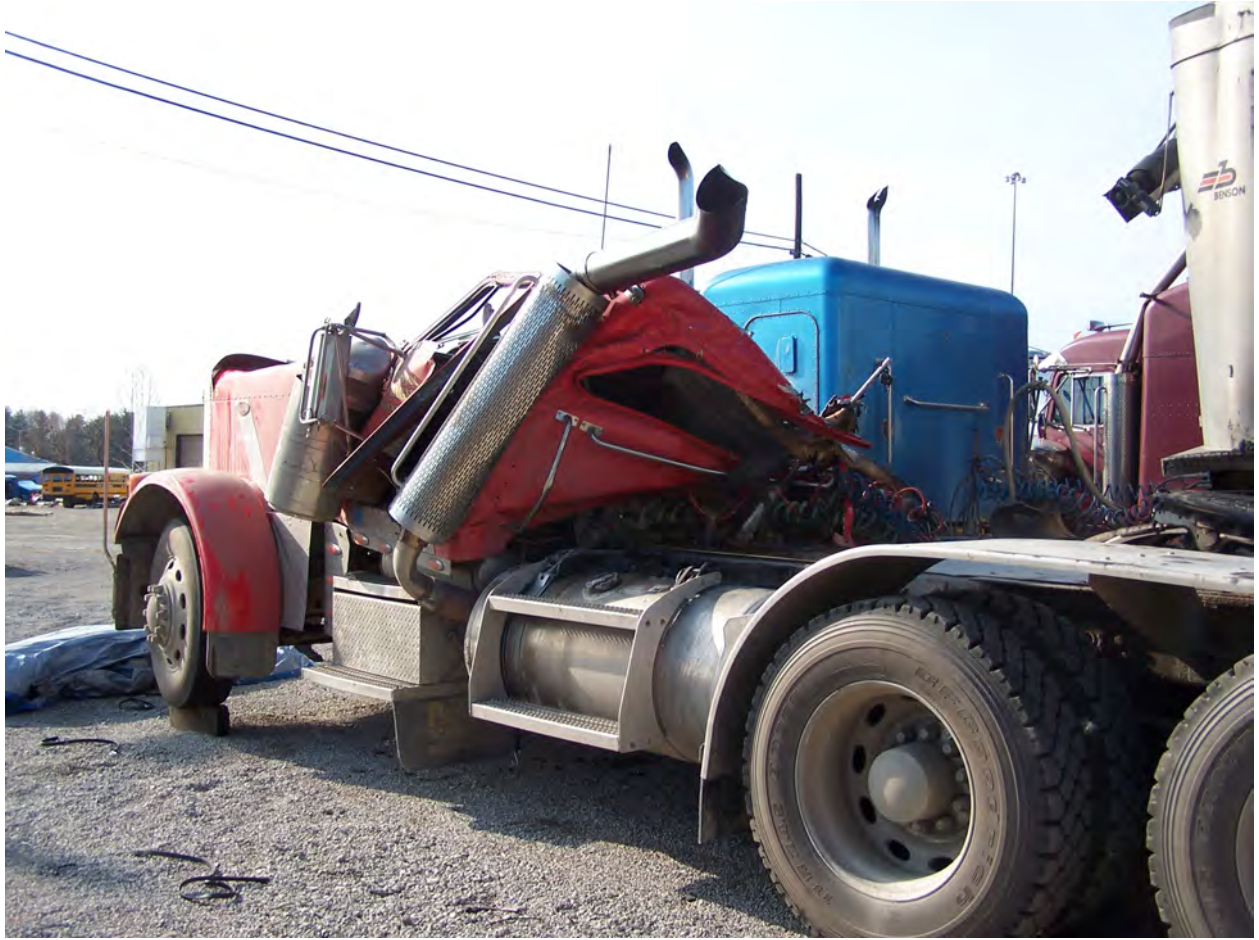
Photograph of tractor involved in MVC rollover. Photograph taken by KY FACE personnel.
