Coal Truck Driver Dies in Rollover After Tire on Trailer Fails Incident Number: 06KY100

Kentucky Fatality Assessment and Control Evaluation (FACE) Program
Incident Number: 06KY100
Release Date: May 12, 2009
Subject: Coal Truck Driver Dies in Rollover After Tire on Trailer Fails

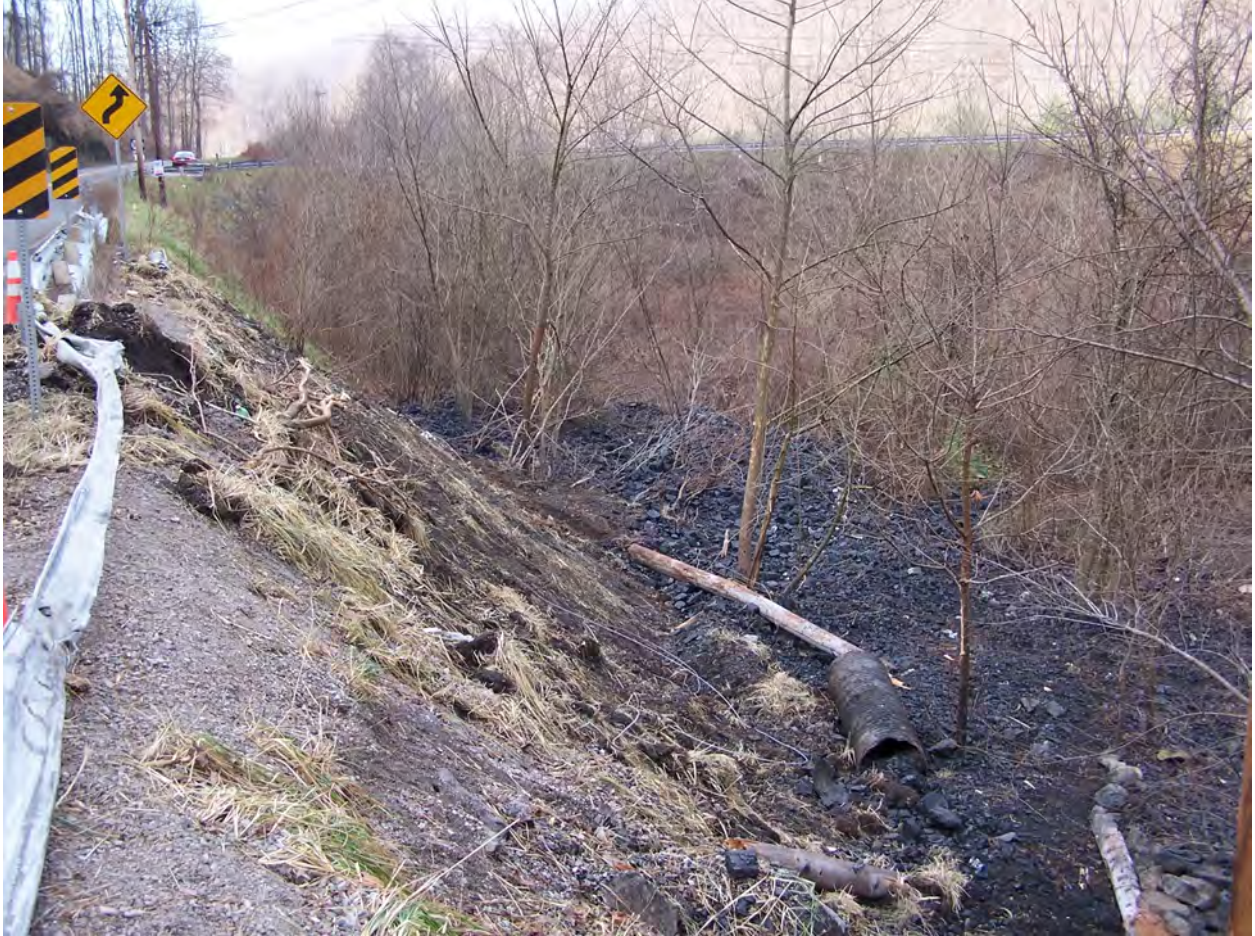
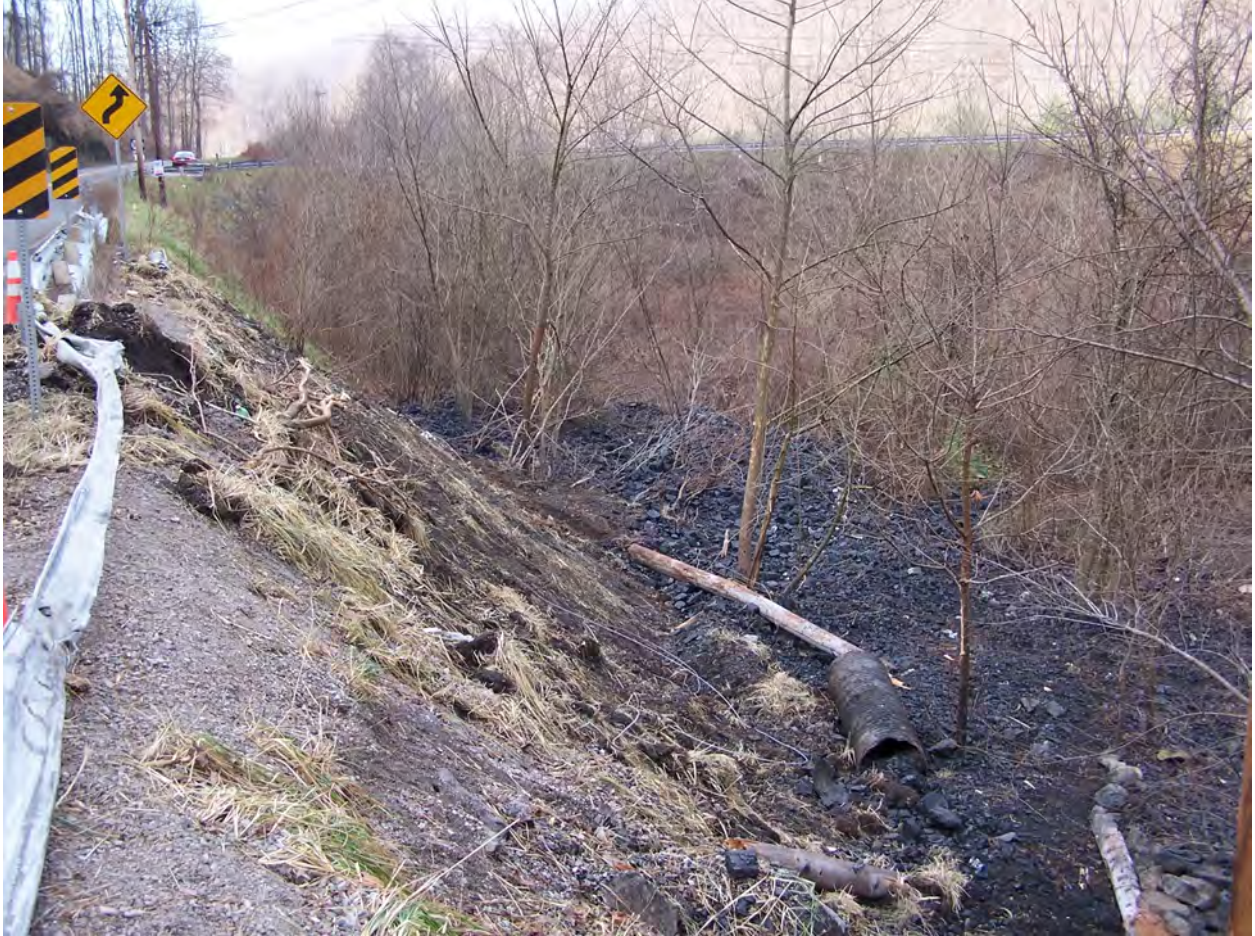
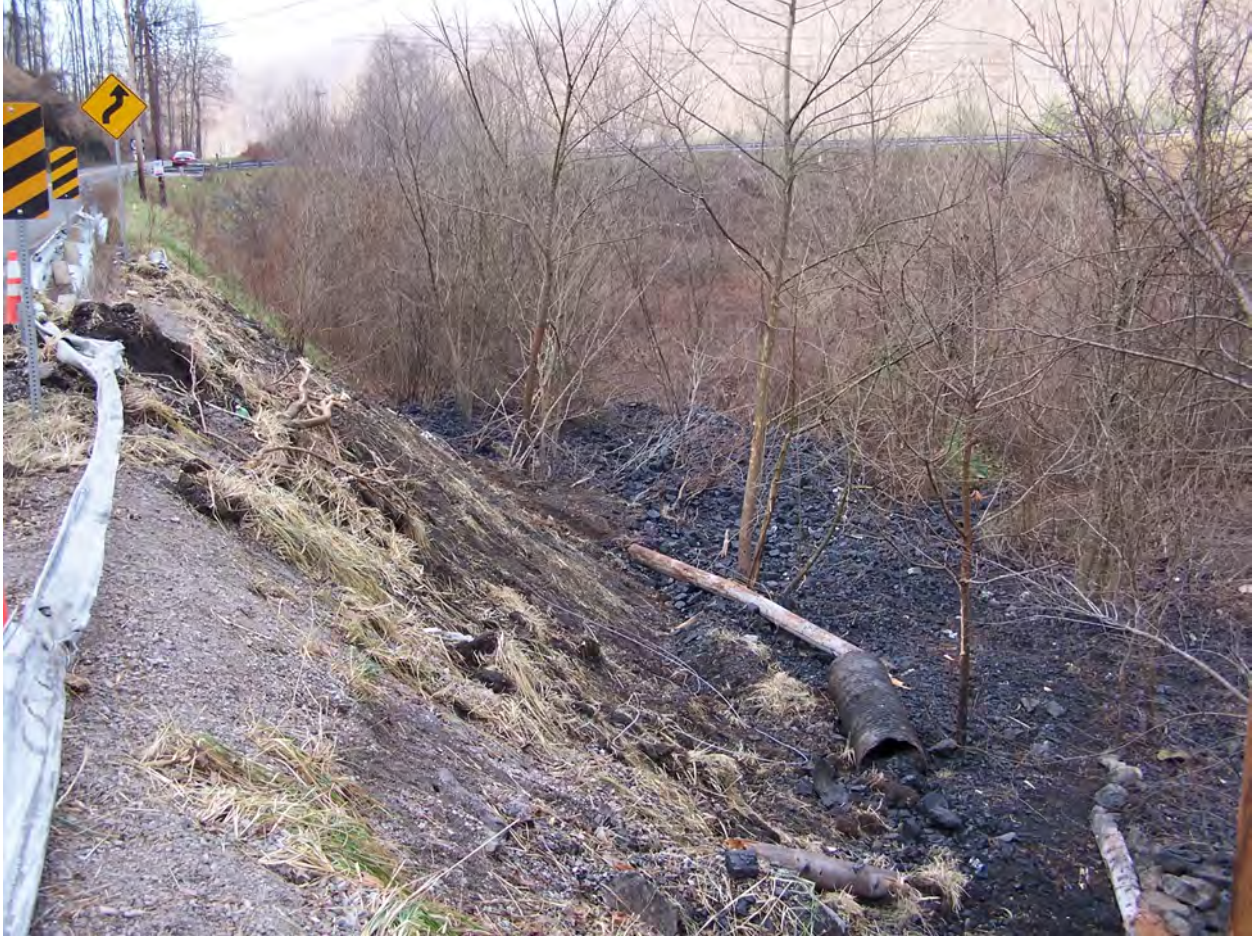
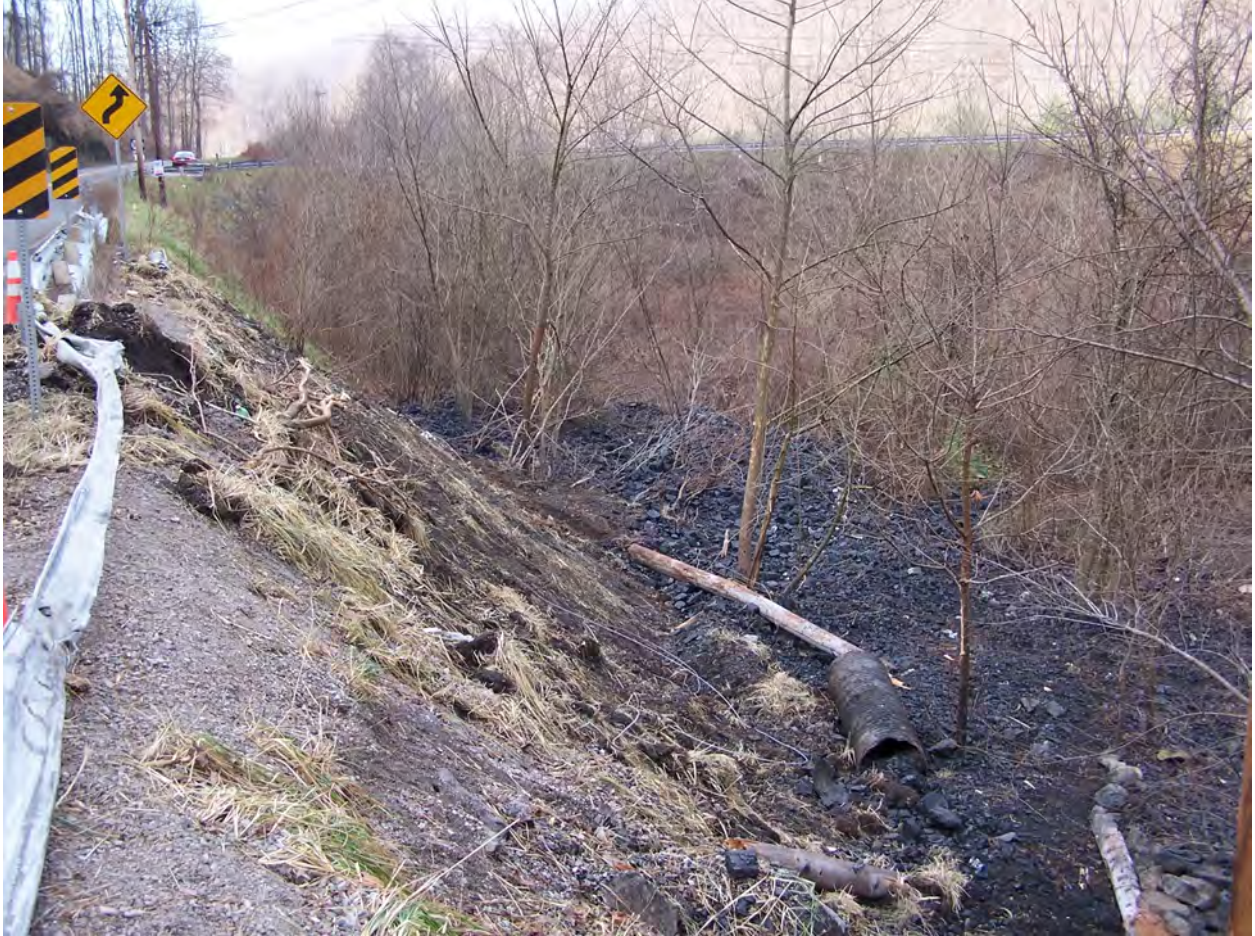
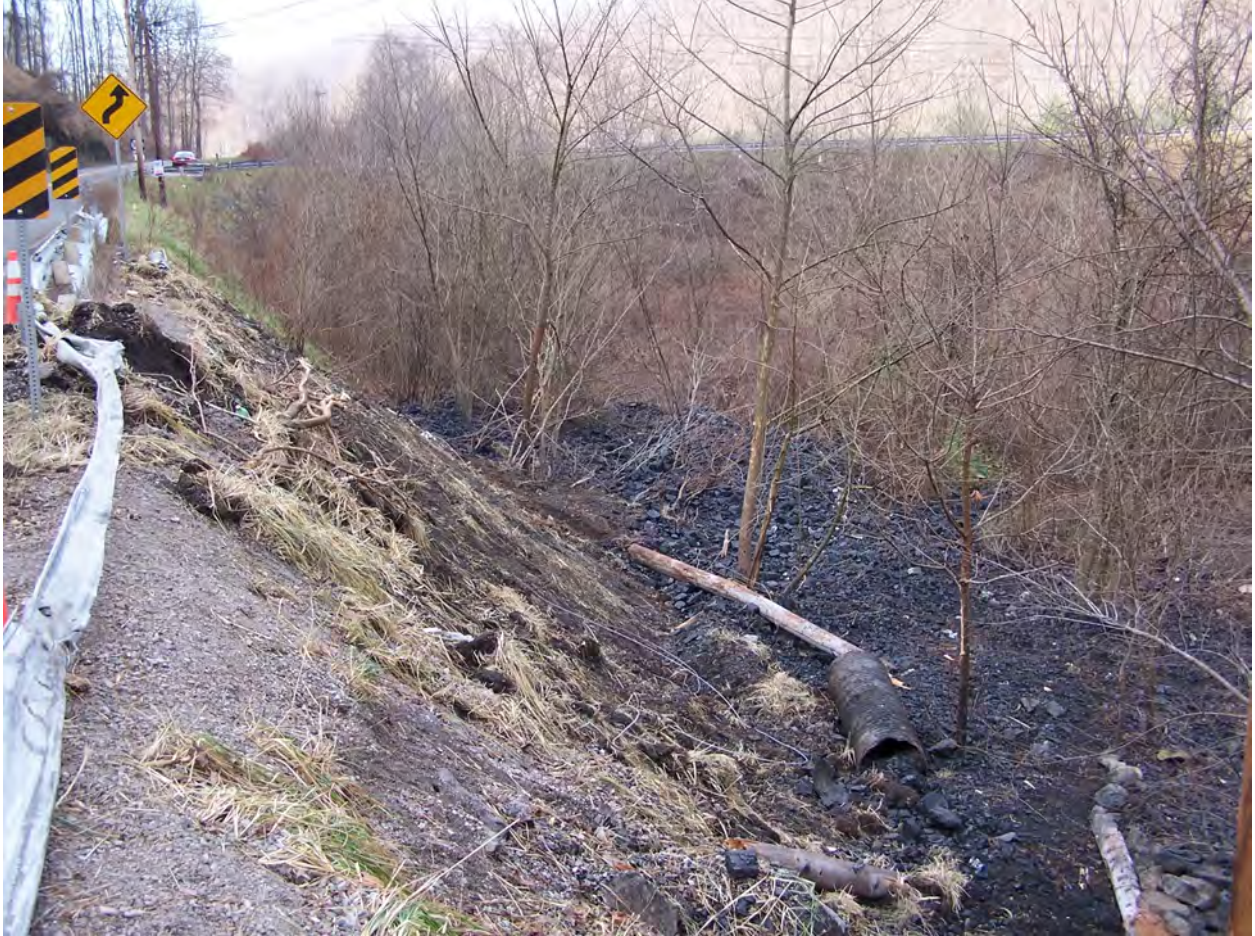
Photograph of hillside and coal dumped from trailer. Photograph taken by KY FACE personnel.

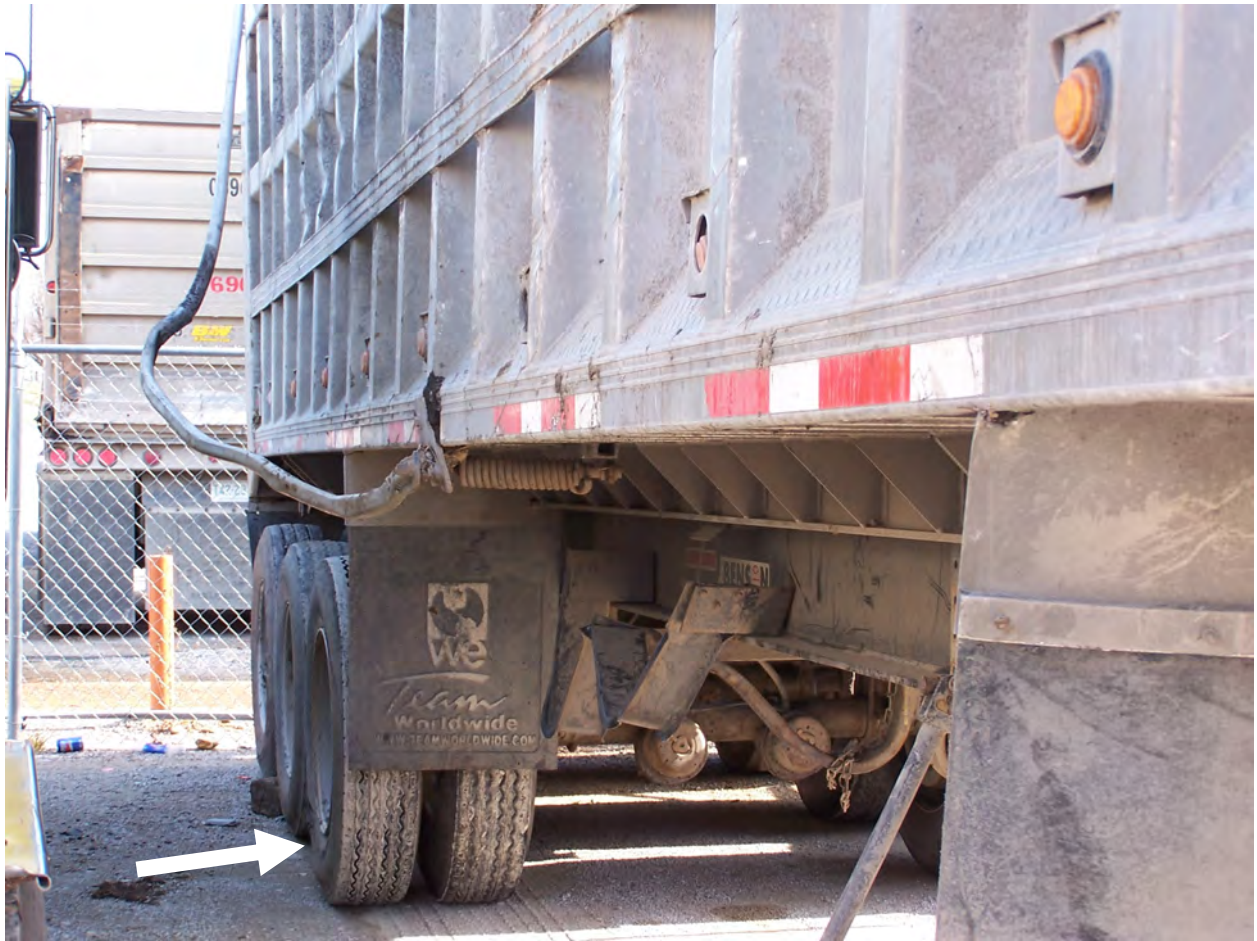
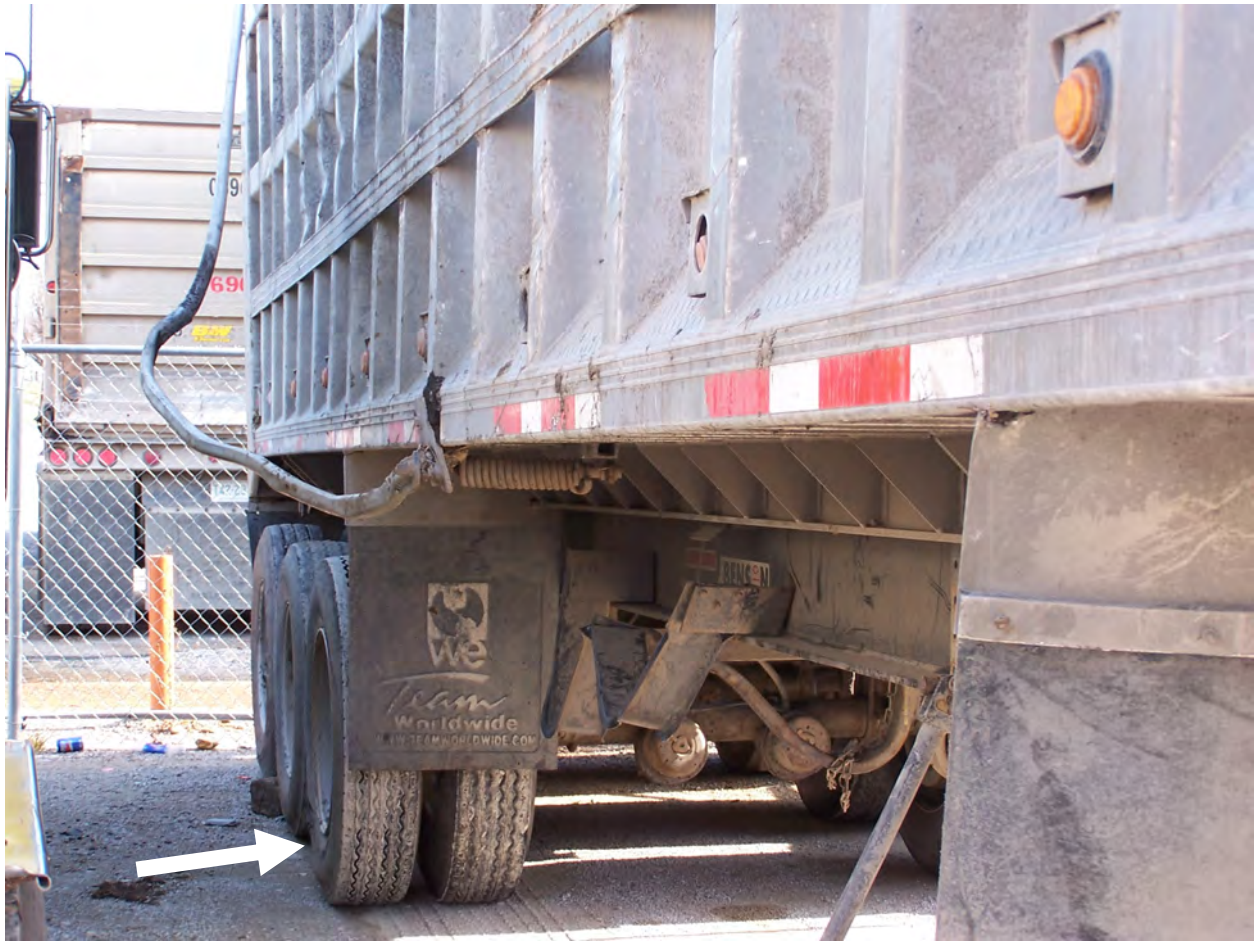
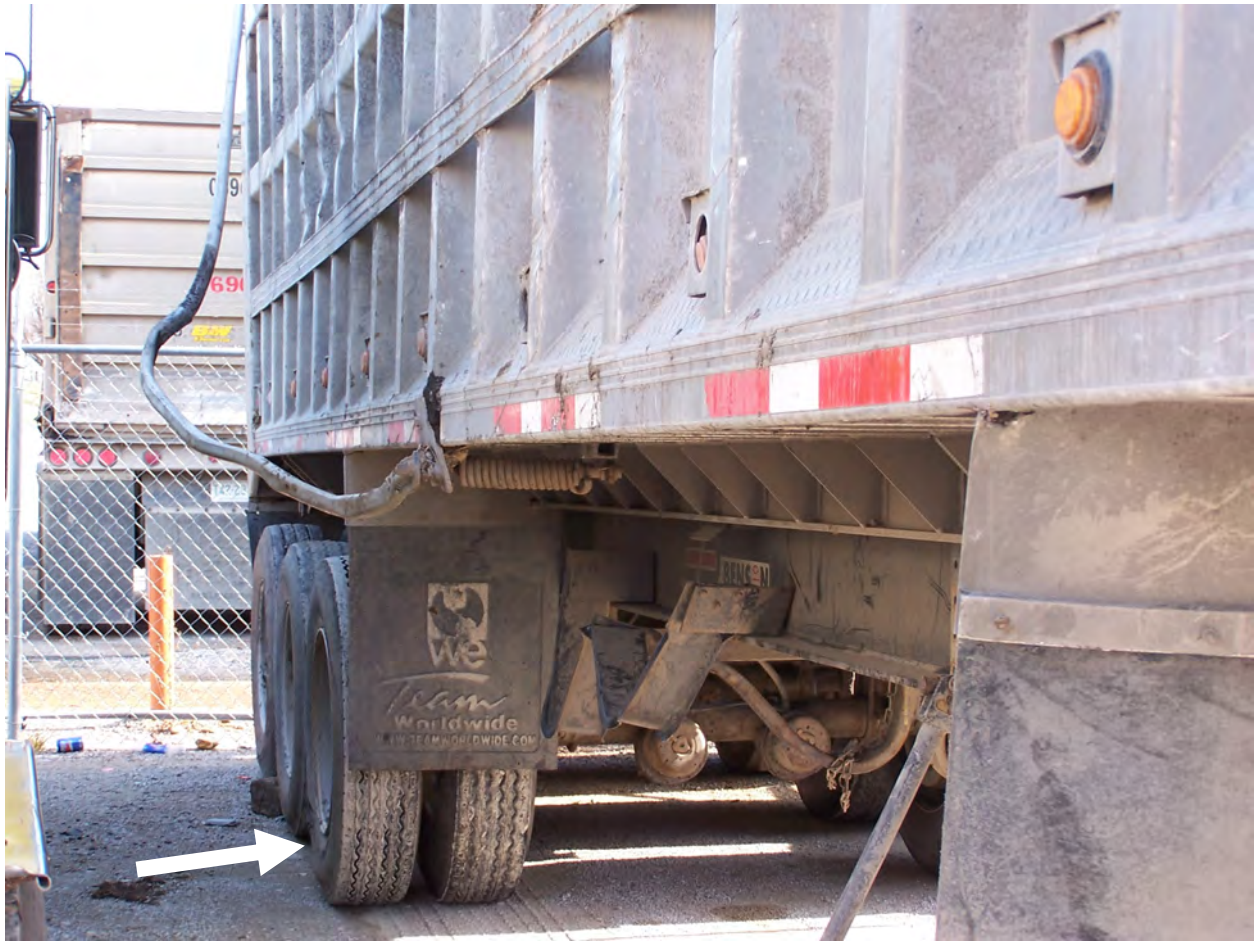
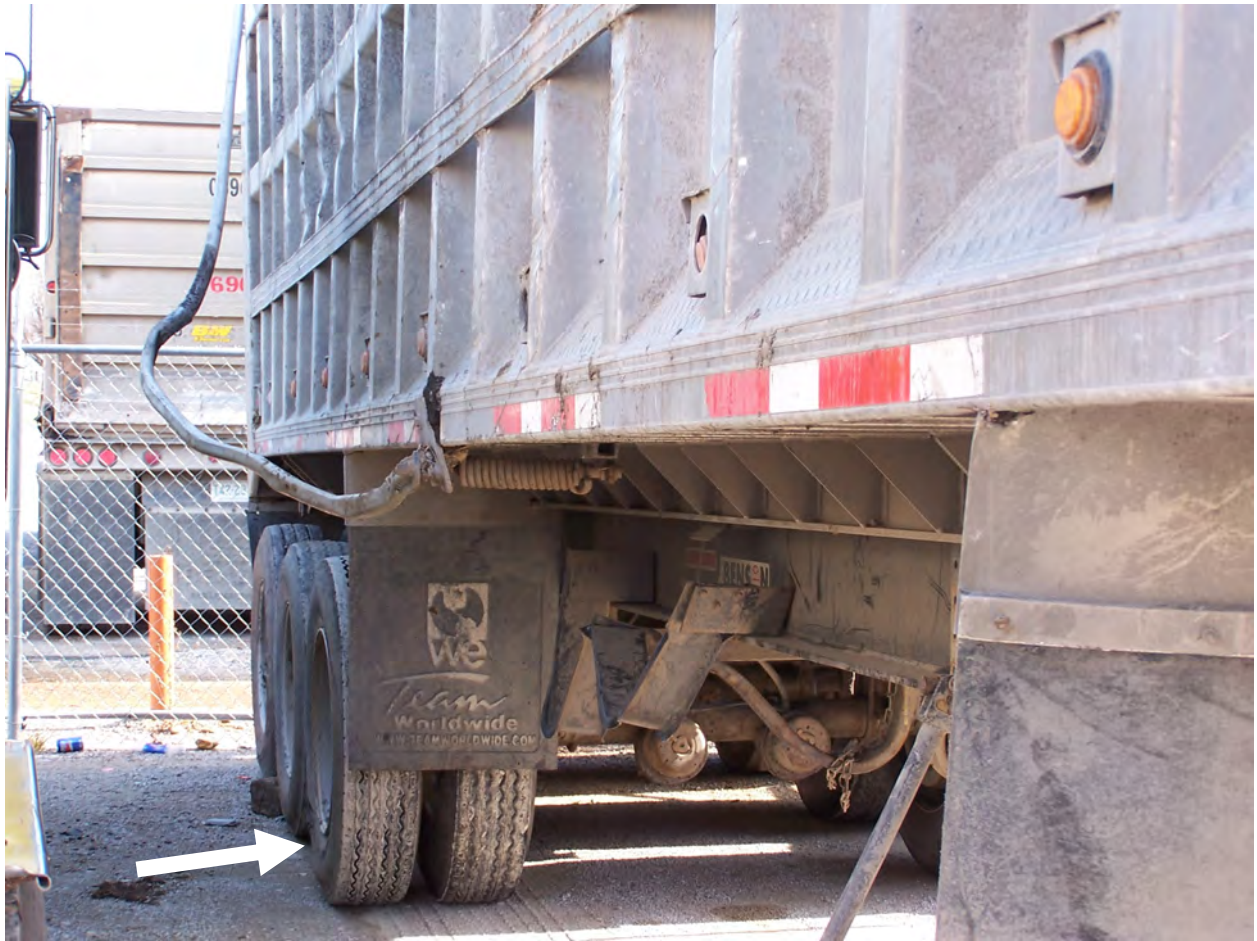
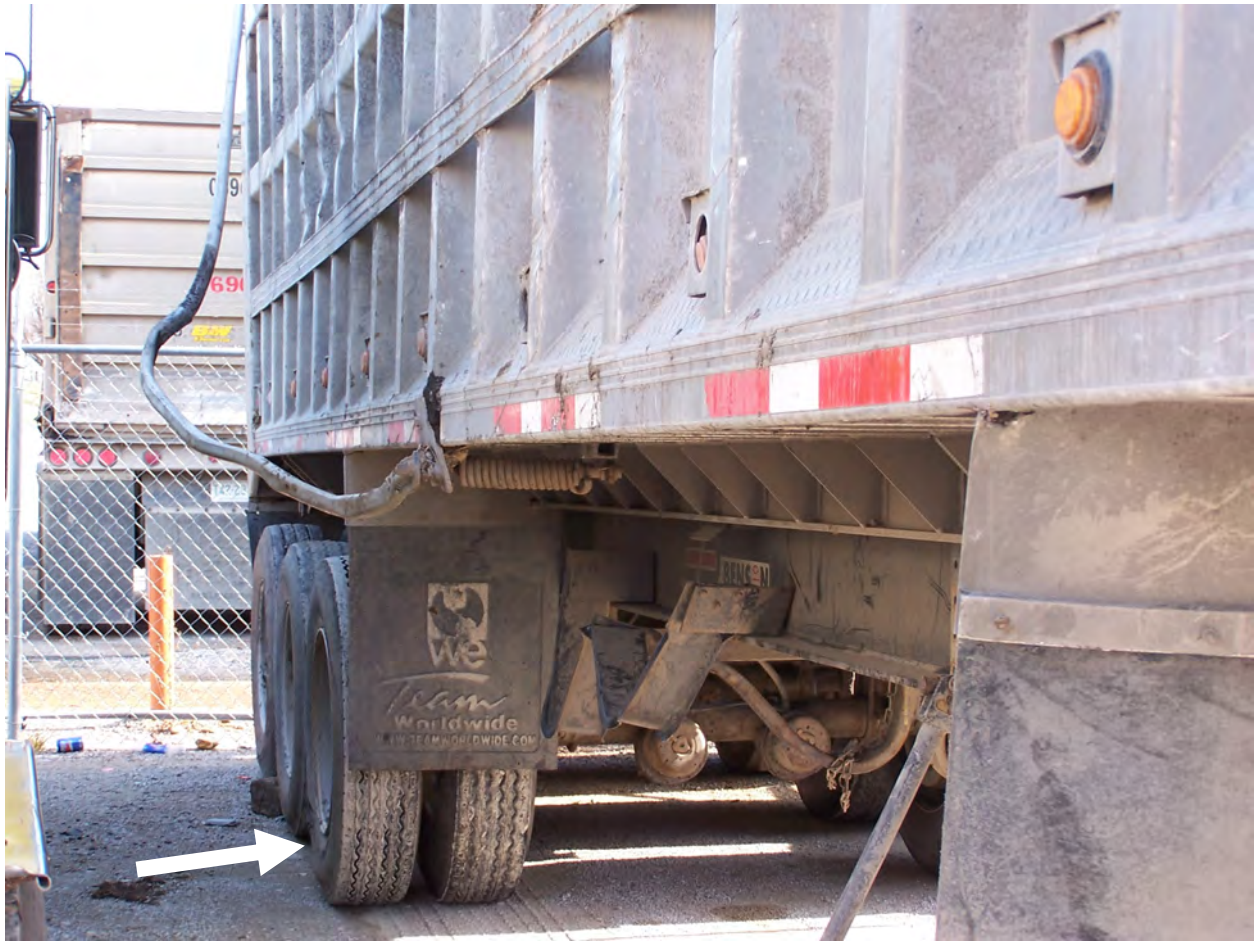
In the fall of 2006, a twenty-three year old male tractor-trailer driver who was hauling coal, died when a rear outer tire on the trailer failed. After the tire failed, the trailer slipped off the right side of the road, overturned, and went over an embankment. The trailer remained attached to the tractor as both went over the embankment, flipping the entire unit upside down. A witness called emergency medical services who arrived and called the county coroner. The coroner arrived and declared the driver dead at the scene. It was determined by Kentucky State Police that the driver was not wearing a seat belt at the time of the incident. Speed at the time of the crash was not listed in the investigation report. Toxicology tests detected tramadol, oxycodone, and hydrocodone in the driver's system at the time of the crash.

Photograph of tire with hole in it. Photograph taken by KY FACE personnel.

Recommendation No. 1: Employers should require drivers to perform pre-trip and post-trip inspections on the tractor and trailer prior to operation.

Federal Motor Carrier Safety Administration regulations CFR 396.13 and CFR 396.11 require commercial motor vehicles to be inspected before driving the vehicle and at the completion of the day's work. CFR 396.3 requires companies to not only inspect every commercial vehicle, but to keep the vehicle properly repaired and maintained. Reports are to be completed and available for the next driver to review as part of their inspection of the vehicle. Companies should require drivers to complete the Department of Transportation Driver's Vehicle Inspection Report, DVIR, (Attachment 1) and to turn them into the office each day. If the driver finds a defect detrimental to safety, it is recommended that the equipment be taken to the proper mechanic for repairs. The report lists important aspects of the vehicle such as tires, battery, body, brakes, clutches, wheels and rims, windshield wipers, etc., which the driver is required to inspect each time the semi is operated. There is a space on the form for the driver to make notes for items not listed on the report that may need to be addressed immediately or in the future. After completing the report, the driver either signs that the vehicle is in satisfactory condition or that defects need correction or repair before the vehicle is returned to service.
