Published in *Journal of Agricultural Safety and Health*, v. 22, issue 2, p. 107-119.

Object Detection for Agricultural and Construction Environments Using an Ultrasonic Sensor

J. S. Dvorak, M. L. Stone, K. P. Self

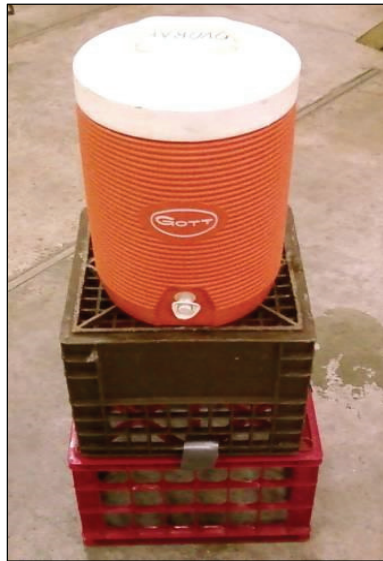
Figure 1. Water jug target object.

The water jug (model 1692, Gott Mfg. Co., Winfield, Kans.) had a diameter of 25 cm and was 40 cm tall (fig. 1). Its 7.5 L capacity was filled with room temperature water. Although water jugs are not often encountered in open agricultural fields, they can be found in areas where humans are working near machinery, such as around barns or in construction sites. The water jug is also similar to many other containers (toolboxes, buckets, crates) that are often found in similar environments in that it is a small, rigid, compact, manufactured object. The water jug was supported on plastic crates so that the center of the jug was located at the same height as the ultrasonic sensor during testing.

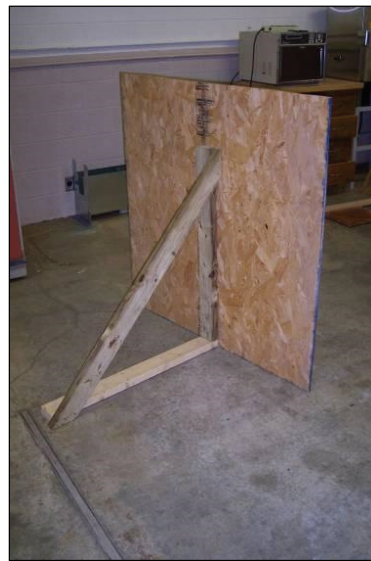
Figure 2. Oriented strand board (OSB) target object (shown from behind so that stand is visible).

The sheet of OSB was 1.2 m × 1.2 m × 1.25 cm. It was held upright by a wooden stand. Figure 2 is a photograph of the OSB target object in which the support stand is visible. During testing, the sheet of OSB was oriented so that the side opposite the stand was perpendicular to the sensor. Thus, this target object appeared to the sensor as a large flat object. Similar flat boards are used for various purposes in construction, so it would not be unusual for a construction vehicle to be operating near such a surface. To a lesser extent, this target object also simulated the characteristics of walls or solid fences that can be found in many places in both agriculture and construction environments. Such walls and fences are often not completely smooth or made of the same material as this target object, but they will still present a large relatively flat surface to the sensor.

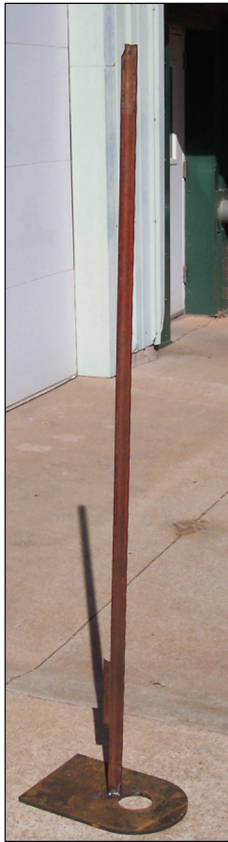
Figure 3. Metal fence post target object.

The metal fence post (fig. 3) was a metal post of the type used in the construction of

fences around agricultural fields. The post was welded to a small metal plate to allow it to stand freely. The post was “T” shaped in cross-section, with the top and center of the “T” both 3 cm in length. The metal fence post was 197 cm tall. This target object was selected to represent the metal posts that are often found in outdoor environments to support fencing, signs, or other objects.

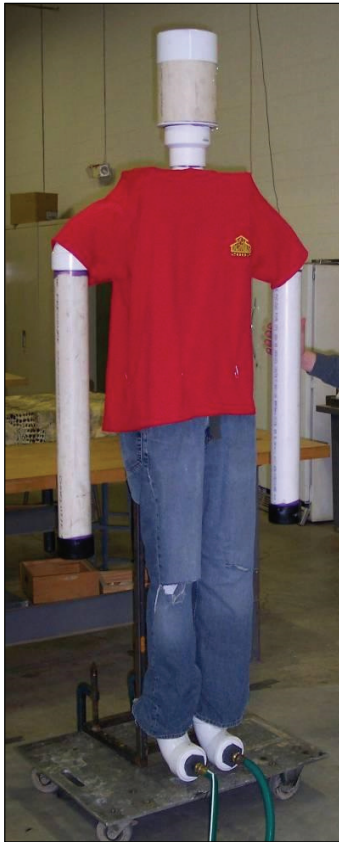
Figure 4. Human model target object.

The human model used for testing was a more complicated object. A model for a human was used rather than actual human test subjects to reduce concerns about human safety and privacy, to provide a consistent target object over time, and to ensure compliance with regulatory requirements. A picture of the human model as it was tested is shown in figure 4. Figure 6 is a computer drawing of the structure of the model, since clothing obscures much of the structure in figure 4. The human model consisted of a human form made of polyvinyl chloride (PVC) and a metal stand to support the model. The stand was attached to a wheeled metal cart to allow the model to be moved easily.

The torso was made of PVC sheets, and the rest of the body was made with PVC tubing. Silicone caulk was used to seal the corners of the torso. The arms, legs, and neck were PVC tubing with an outside diameter of 89 mm and an inside diameter of 78 mm (nominally 3 in., schedule 40 PVC tubing). The joints for the shoulders and feet were 90° PVC elbows. Flanges connected all the tubing to the torso, and the arms and feet were capped at the ends. The head was constructed of PVC tubing with an outside diameter of 170 mm and an inside diameter of 154 mm (nominally 6 in., schedule 40 PVC tubing). Two reducers were required to connect the head to the torso. The short piece of tubing connecting the reducers to the torso had an outside diameter of 118.4 mm and an inside diameter of 102 mm (nominally 4 in., schedule 40 PVC tubing). The top of the head was machined so that a drain waste vent (DWV) cap with an outside diameter of 170 mm and an inside diameter of 160 mm slipped freely over the top of the head.

The human model was filled with water during testing. Although the water was not expected to have an impact on the ultrasonic sensor, this model was also used for testing other sensors that relied more heavily on the water content for detection. Fittings were attached to the caps on the feet so that warm water could be pumped through internal piping within the model to maintain its temperature close to body temperature. This temperature control was not expected to play a significant role in the ability of the ultrasonic sensor to detect the human model; however, as the human model was also used to test other sensors, this capability was built into the model. Finally, the human model was clothed in a t-shirt and jeans by cutting the backs of the clothes and fastening the clothes around the human model with safety pins. During testing, the human model was oriented so that it was facing the sensor. This provided the largest surface area to the sensor and represented the best expected detection scenario.

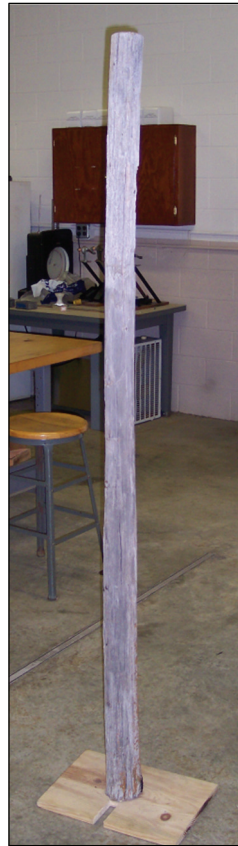
Figure 5. Wooden fence post target object.

The wooden fence post (fig. 5) was a round wooden post sold for use in constructing agricultural fences. It was 7.6 cm in diameter and 170 cm tall. Like the metal fence post, the wooden fence post was selected because it was similar to the wooden posts that are commonly used in outdoor environments for fence construction and to support other objects. The sensor tests included two types of fence posts (wooden and metal) because both types are commonly used, they were made of different materials with different properties, and they represented two different target geometries.

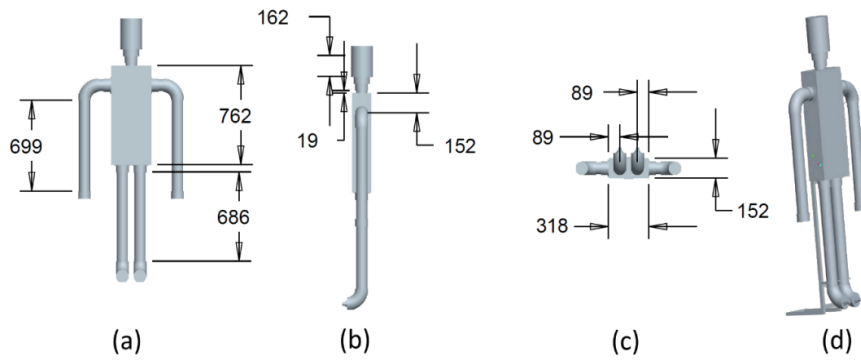
Figure 6. Computer drawing of human model target object: (a) front view, (b) side view, (c) bottom view, and (d) angled view (all dimensions are mm).

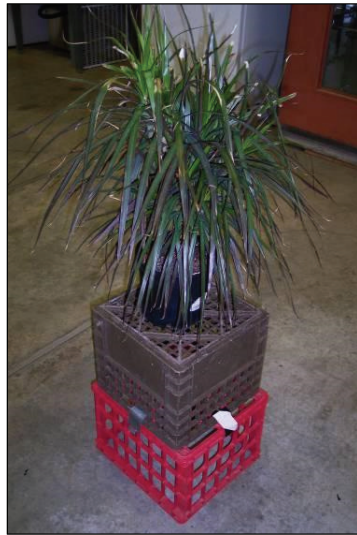
Figure 7. *Dracaena* plant target object.

The plant target object (fig. 7) was of the genus *Dracaena*. The exact species was not available when it was purchased; however, it had characteristics matching the *marginata* species, which is also listed as *Dracaena reflexa* var. *angustifolia*. It had long flexible strap-like leaves. The plant was rooted in potting soil in a container 20 cm high with a volume of 6.3 L. Excluding the container, the plant was 60 cm tall and 60 cm in diameter. Although plants of the genus *Dracaena* are most often found in outdoor environments in Africa, southern Asia, and Central America, the long flexible leaves resemble the structure of many other plants, such as grasses or crop plants that are found worldwide. Unlike many grasses or crop plants, the *Dracaena* plant target object had been developed as a houseplant. Thus, it was easy to maintain during testing and was not rapidly developing or growing, which would have prevented its use as a consistent test object. The *Dracaena* plant was placed on crates during testing to align the center of the leafy part of the plant with the sensor.

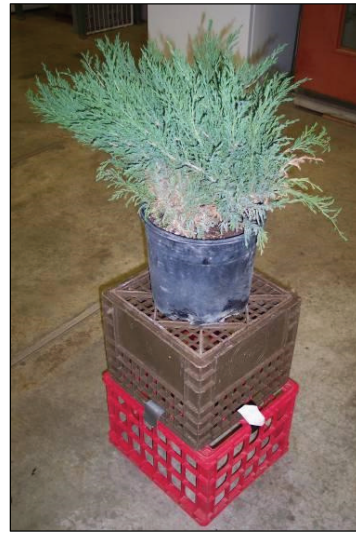
Figure 8. Juniper plant target object.

The juniper (fig. 8) was a Youngstown Andorra juniper (*Juniperus horizontalis* ‘Andorra Youngstown’) in a 9.7 L container filled with potting soil. Excluding the container, the juniper was 40 cm tall and 60 cm in diameter. It was also placed on plastic crates during testing so that the leafy part of the plant was at the same height as the sensor. This target object with its smaller, denser leaf structure was selected to represent evergreens and other similar plants that are found in many agricultural and construction environments.

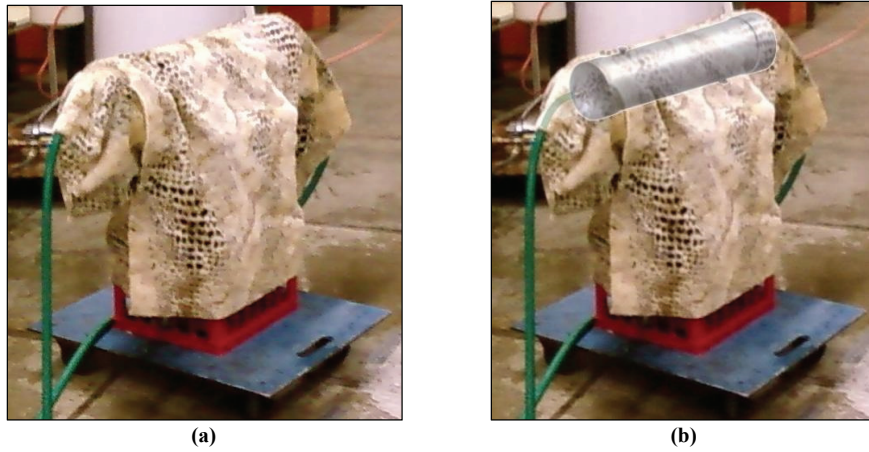
Figure 9. Dog model target object (a) as tested and (b) with external surface rendered transparent to reveal placement of the internal body.

The final target object was a model of a dog. As with the human model, a model was used for this testing to ensure consistent results, allow adequate control of the object position, and alleviate concerns over animal welfare in testing. A picture of the dog model as tested is shown in figure 9. The body of the dog model was a length of PVC tube with an internal diameter of 154 mm and an outside diameter of 170 mm. This tube was capped on both ends, and fittings were added to allow filling with water and circulation of warm water through the model during testing. A computer drawing of these PVC components is shown in figure 10. The PVC tube was placed on plastic crates, and the PVC tube and

plastic crates were wrapped in faux fur with a nap depth of 10 mm. As with the plants, the height and orientation of the dog model during testing was such that the largest part of the model was the same height as the sensor and faced toward the sensor. The overall size and height of the dog model approximated that of a large dog.

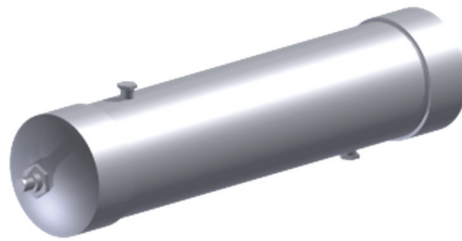
Figure 10. Computer drawing of the internal body of the dog model target.
