Peer-Reviewed Original Research

Outcomes of external repair of HeartMate II™ LVAD percutaneous leads

The VAD Journal, 2. doi:
<http://dx.doi.org/10.13023/VAD.2016.14>

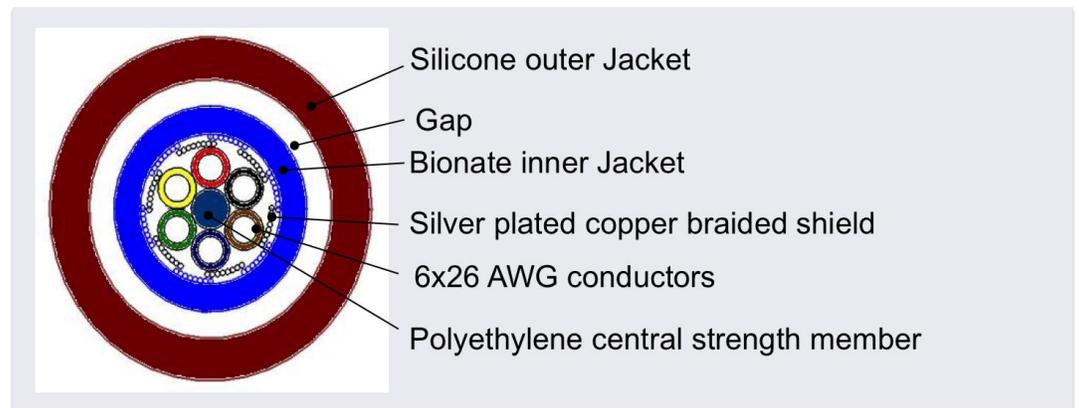
Figure 1: Schematic of HeartMate II percutaneous lead

The HeartMate II percutaneous lead consists of three pairs of redundant wires that are electrically shielded and protected by two water-resistant jackets (Figure 1). The internal wiring schematic is shown in Figure 2. Damage to the external lead by repeated flexion can be manifested by retraction of the silver-coated copper

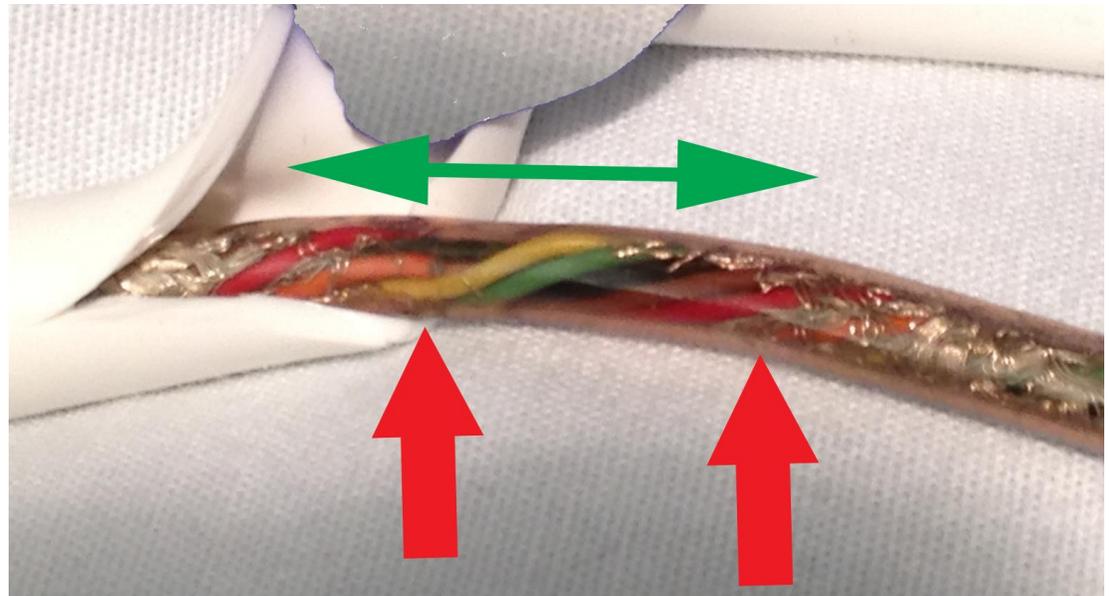
braided shield and fracture of an individual wire (Figure 3). Damage to the braided shield without internal wire fracture, can lead to a phenomenon known as short-to-shield, which can result in pump dysfunction when connected to a grounded power source⁵. There is also the possibility of a short between two different motor leads by the shield wires which cause pump stoppage even if a non-grounded shield cable is used.

Figure 3: Damage to the external lead by repeated flexion can be manifested by retraction of the silver-coated copper braided shield and fracture of an individual wire (orange).

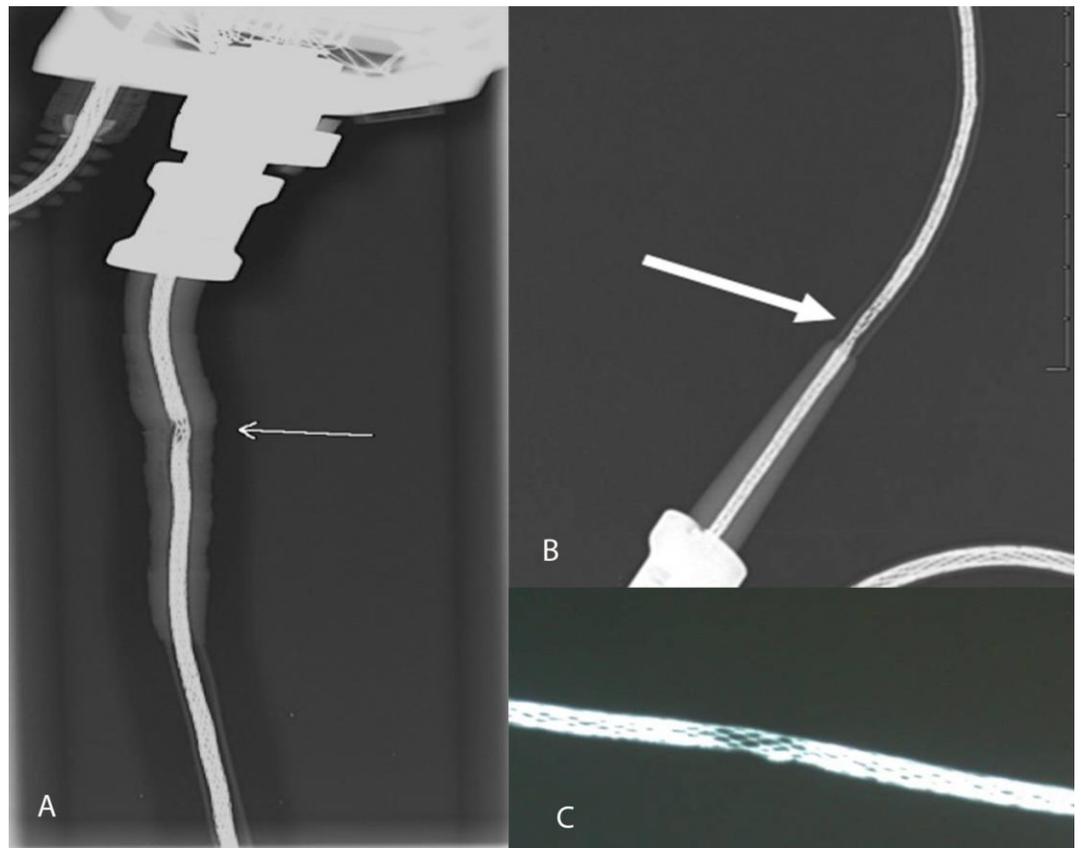
Figure 4: Radiographs of lead damage

A retrospective review was undertaken of all percutaneous lead repairs performed by the St Jude Medical Technical Services Team. The HeartMate II log file for each patient was reviewed for alarms, unexplained pump stoppages, pump speed and/or power fluctuations. Each patient initially underwent a controller exchange and close examination of visible connectors to ensure adequate contact. A radiograph of the externalized portion of the percutaneous lead was obtained, and examined for evidence of broken wires or abnormal shielding. If external damage was identified (Figure 4), preparation for repair by St. Jude Medical personnel was undertaken.

A cohort of patients experienced ongoing pump dysfunction after lead repair, necessitating LVAD exchange. This could be due to concomitant intracorporeal lead fracture, or other electrical damage not grossly visible on examination of the driveline. Therefore, we recommend comprehensive and careful radiographic evaluation to ensure that the intracorporeal portion of the percutaneous lead is intact, and that areas not easily visible on radiographs are directly examined prior to proceeding with external percutaneous lead repair.

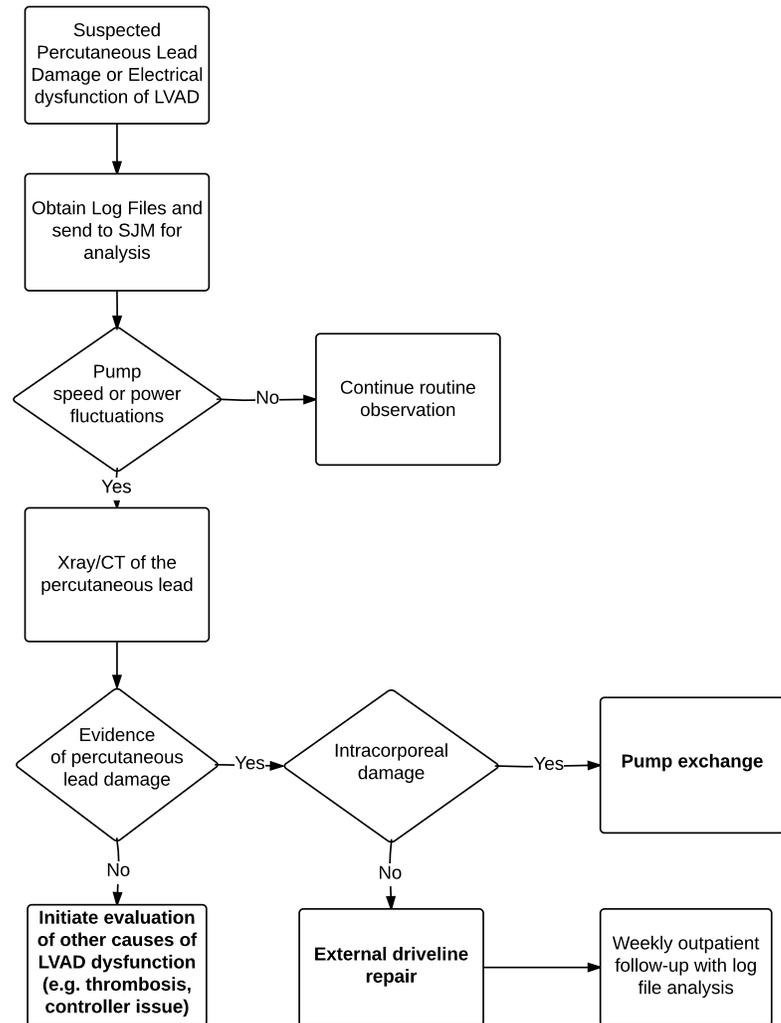
Figure 7: Algorithm

Our algorithm to evaluate suspected percutaneous lead damage is to analyze the pump log files for evidence of pump speed or power fluctuations, unexplained pump stoppage, or alarms (Figure 7). If concern exists for an electrical malfunction of the left ventricular assist system, comprehensive radiographs are obtained of the external component of the driveline. Computed tomography may be required for evaluation of the internal portion of the percutaneous lead. If a lead fracture if the external part is identified, the St Jude Medical Technical Services Team is called to perform an external lead repair. Internal lead damage must be excluded prior to external repair to avoid the possibility of abrupt pump stoppage during repair or persistent pump malfunction. We perform the repair procedure in patient's room in an intermediate care telemetry unit or intensive care unit. Given the low likelihood of pump stoppage, we do not routinely take precautions, such as surgical stand-by for emergent pump exchange.
