**EXAMINATION OF ECONOMICAL METHODS
FOR REPAIRING HIGHWAY LANDSLIDES**

Research Report KTC-05-04/SPR-180-98-1F
KYSPR-180-98-1F

April 2005

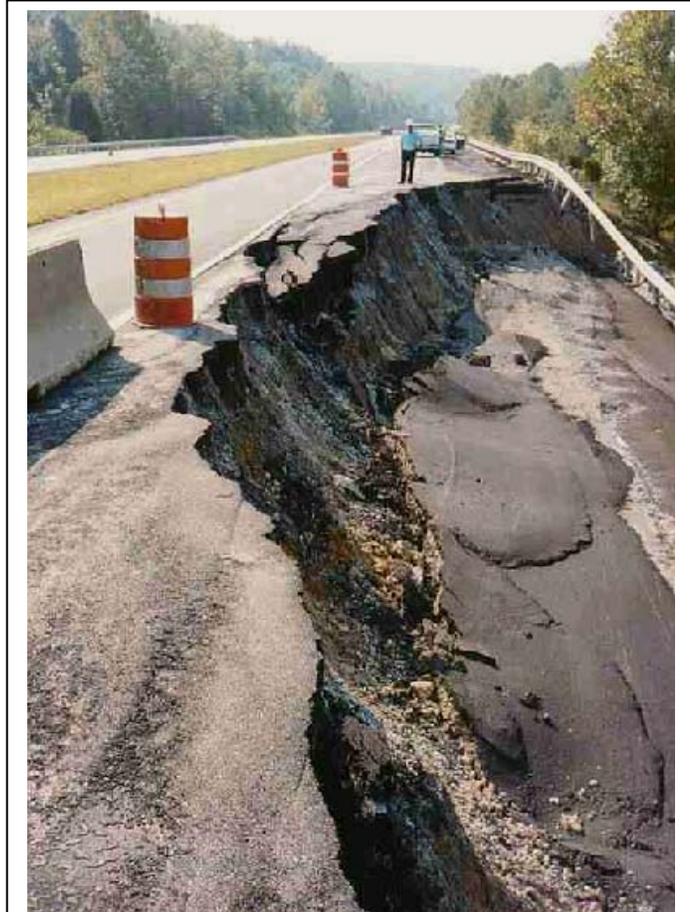
Figure 1. Massive highway embankment failure on a parkway route in Butler County—repair cost was 1.4 million dollars

Most highways in Kentucky are generally more than four decades old. As Kentucky's roadways increase in age, highway embankments and cut slopes deteriorate and frequently collapse, as illustrated in Figure 1. Each year, the Kentucky Transportation Cabinet spends millions of dollars repairing highway landslides. The maintenance of highway slopes and the restoration and correction of landslides has been identified by the engineers of the Kentucky Transportation Cabinet as a major engineering problem in Kentucky that involves considerable expenditures of funds each year. Unfortunately, the landslide problem has not received the attention that it deserves and often, remedial action is only taken when a catastrophic failure occurs – a reactive stance.

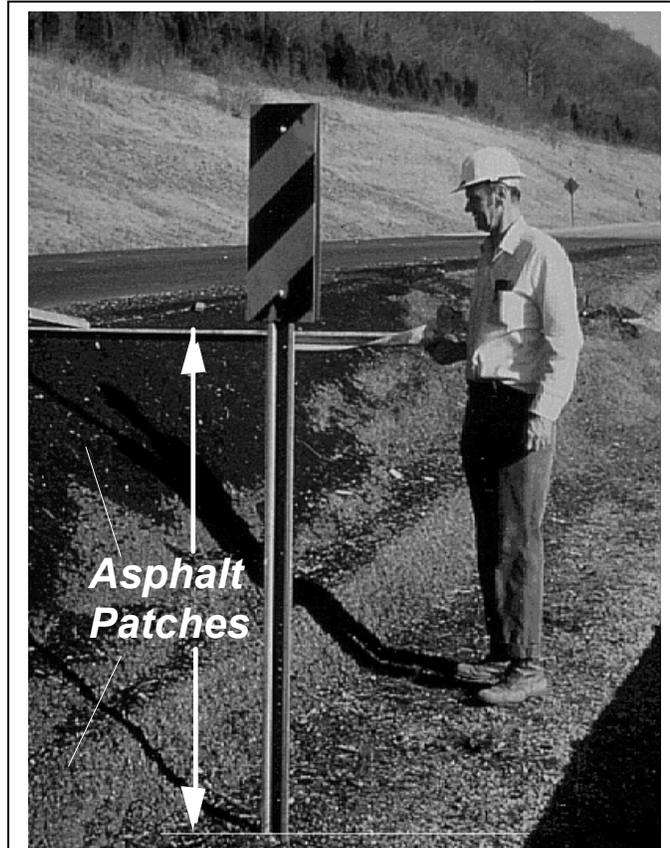
Figure 2. Use of asphaltic patching overlays to maintain grade elevation at a landslide (total thickness of patching is about 5 feet)

To insure the safe movement of traffic through areas of active movements, maintenance crews patch the settled roadway frequently to maintain grade elevation -- a very common practice. As illustrated in an example in Figure 2, the pavement has been patched so often that the accumulated thickness is some 4 or 5 feet (1.5 meters). In one instance, asphalt patching of the pavement resting on an unstable landslide embankment in an advanced stage was observed to be some 13 feet (4 meters) thick. The addition of heavy asphaltic patching only adds weight to the top of the landslide and hastens the failure of the embankment. Unfortunately, this very costly technique does not repair the landslide and often accelerates movement with the added weight. Usually, whenever the pavement resting on an embankment has settled to such a degree that more than about three patches have been required to maintain grade elevation, the Cabinet's Geotechnical engineering staff should be notified to review the conditions at the site. The potential for a landslide exists.

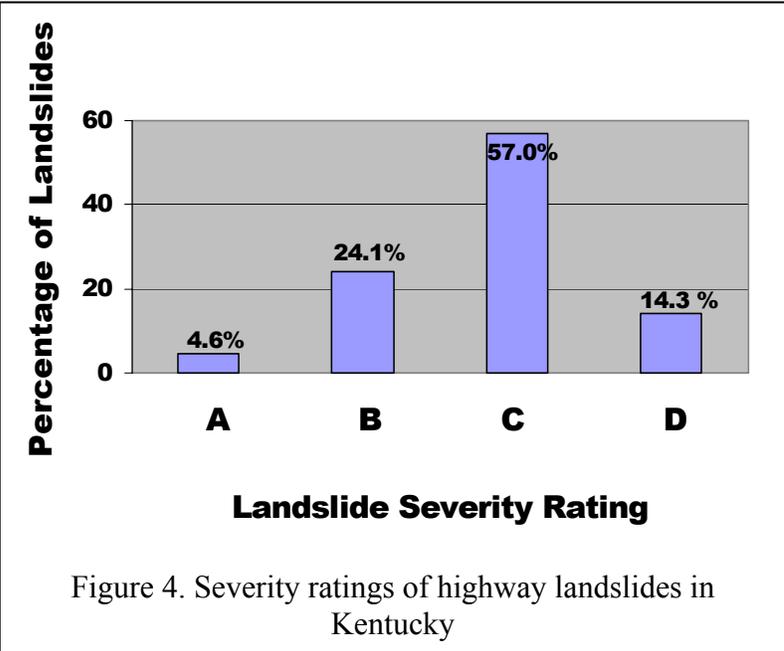
Severity ratings of about 86 percent of the failures ranged from moderate to very serious, as shown in Figure 4. The majority (57 percent) of the highway landslides were assigned to the “C” category, which was described as “moderate movements, breaks in the pavement (occurrence over several years).” Generally, many highway embankments and foundations in Kentucky consist of clayey materials that tend to strain very slowly and prolong the time to the complete collapse of the embankment. About 24 percent of the landslides were rated “B,” that is “(the landslide) is moving rapidly and requires constant maintenance (daily, weekly, monthly, etc.).” Approximately, 14 percent of the landslides were identified as “D,” or minor slope failures affecting slope only. Highway landslides identified as “A,” and described as “road is closed, one lane

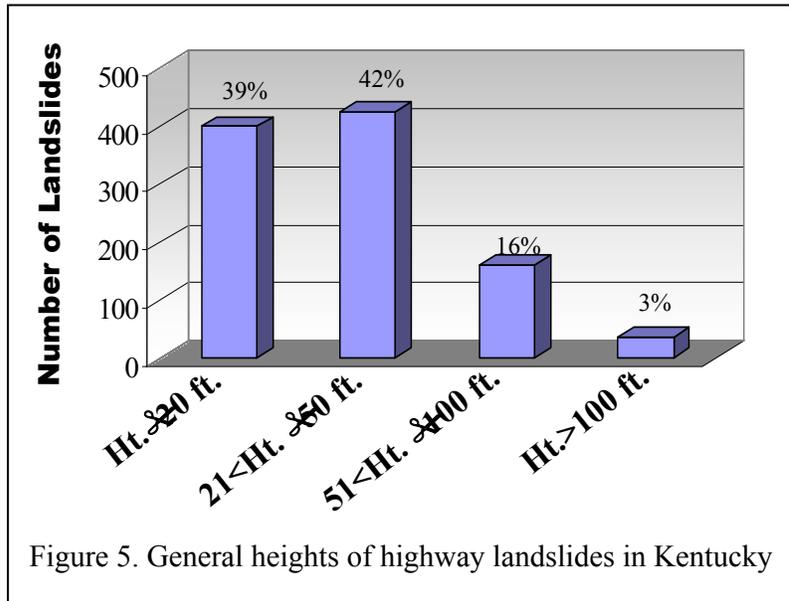
Figure 5. General heights of highway landslides in Kentucky

Different categories of heights of highway landslides compiled by UKTC are shown in Figure 5. The height of about 39 percent of the highway landslides is equal to or less than 20 feet while the height of about 42 percent of the landslides was greater than 21 feet or less than or equal to 50 feet. The height of about 81 percent of the landslides was less than or equal to 50 feet. The height of about 16 percent of the landslides ranged from 51 to 100 feet while the height of about 3 percent were greater than 100 feet.

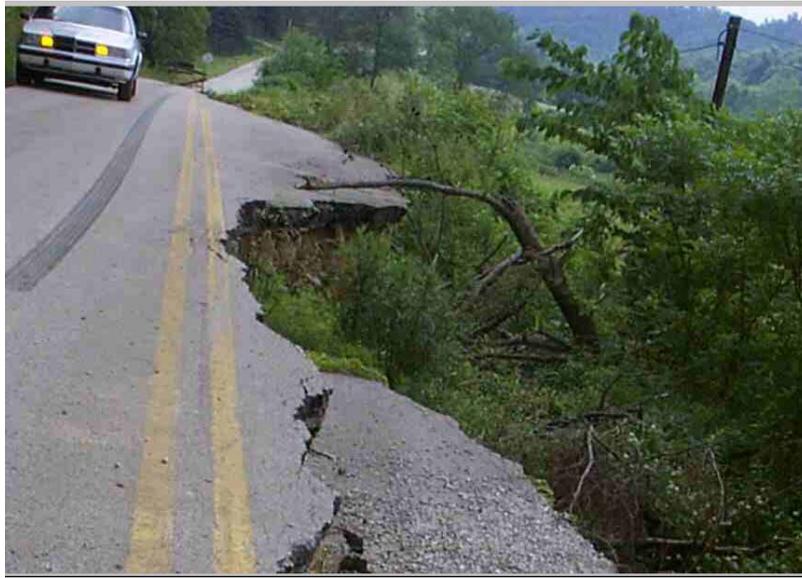
Figure 6. Highway embankment failure on KY 847 in Owsley County

Frequently, emergency measures are required to repair highway landslides when the roadway completely collapses, as shown in Figure 6. Costs may exceed one million dollars when the embankment height is over 50 feet. Generally, when the height of the highway failure is less than about 15 to 20 feet, the attempted repair using railroad rails to construct a restraining structure had some success. However, when the height was greater than 20 feet this measure was largely unsuccessful as illustrated in Figure 7.

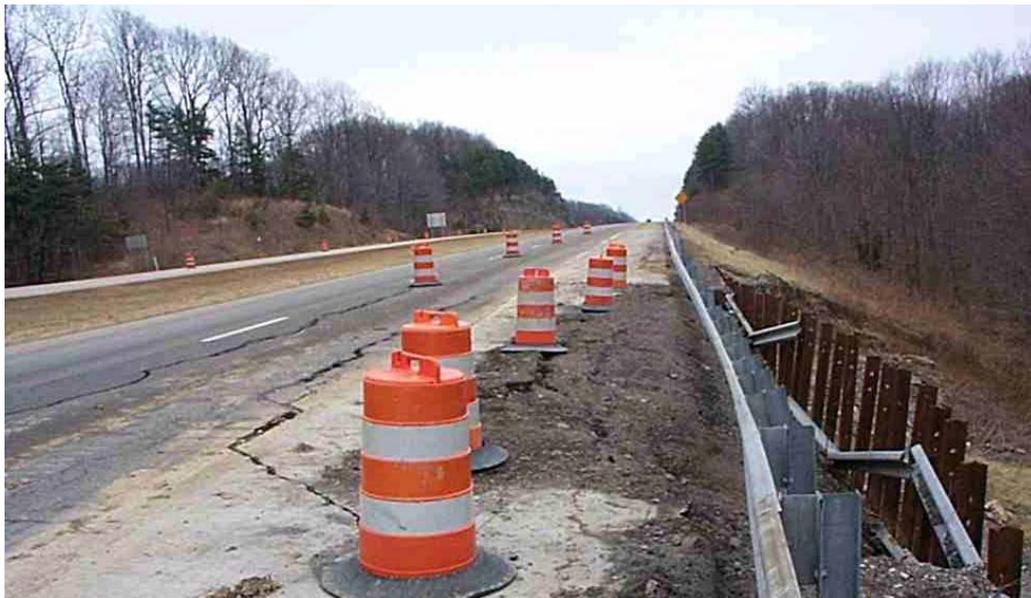
Figure 7. Attempts to halt highway failure using railroad steel rails

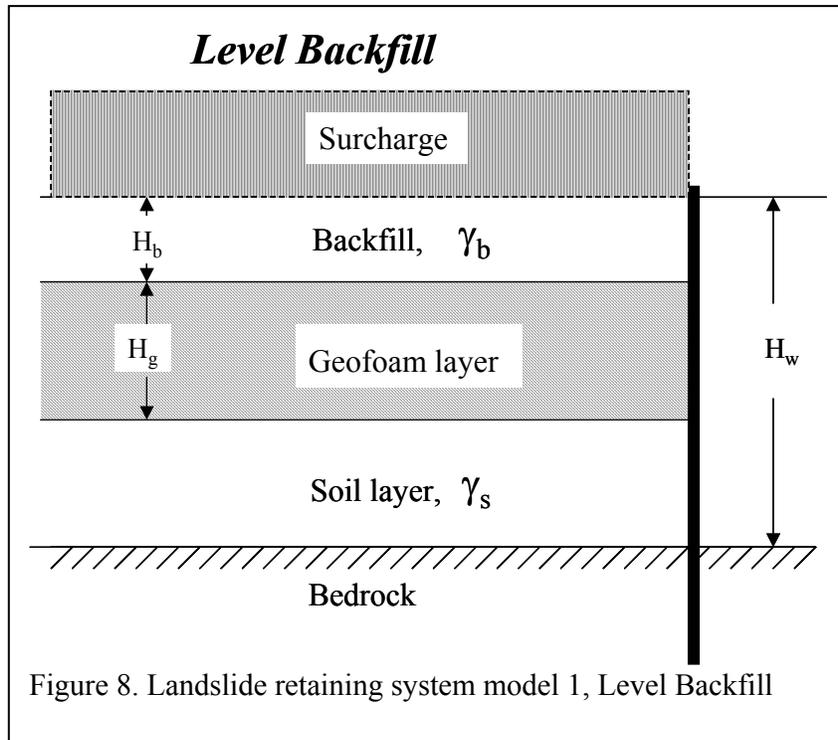
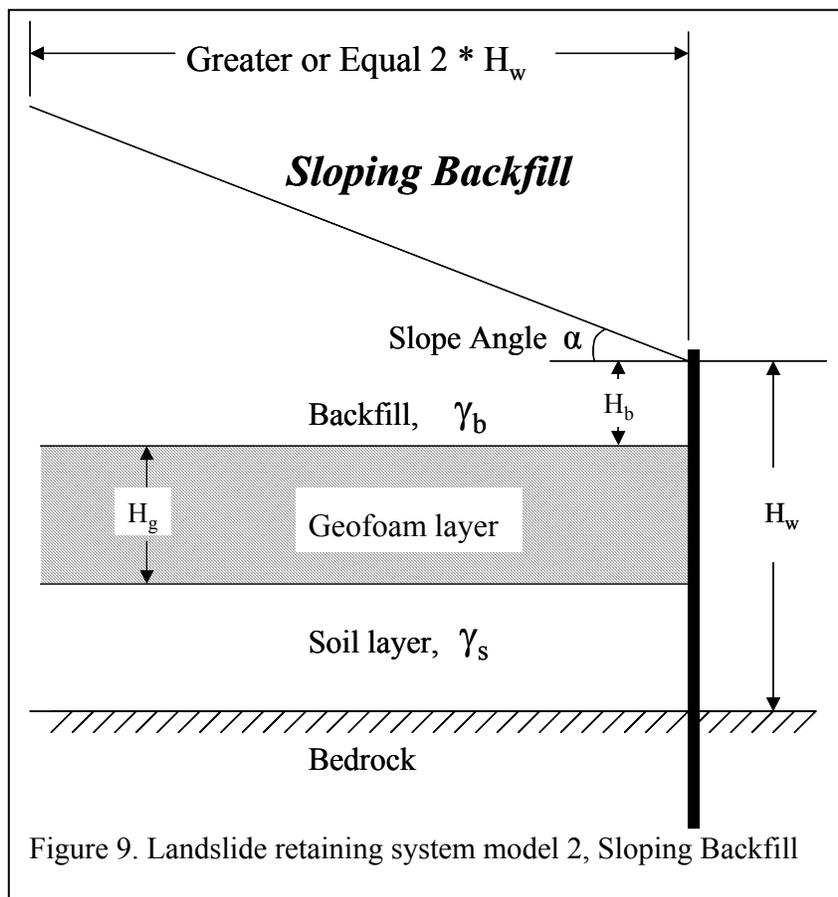
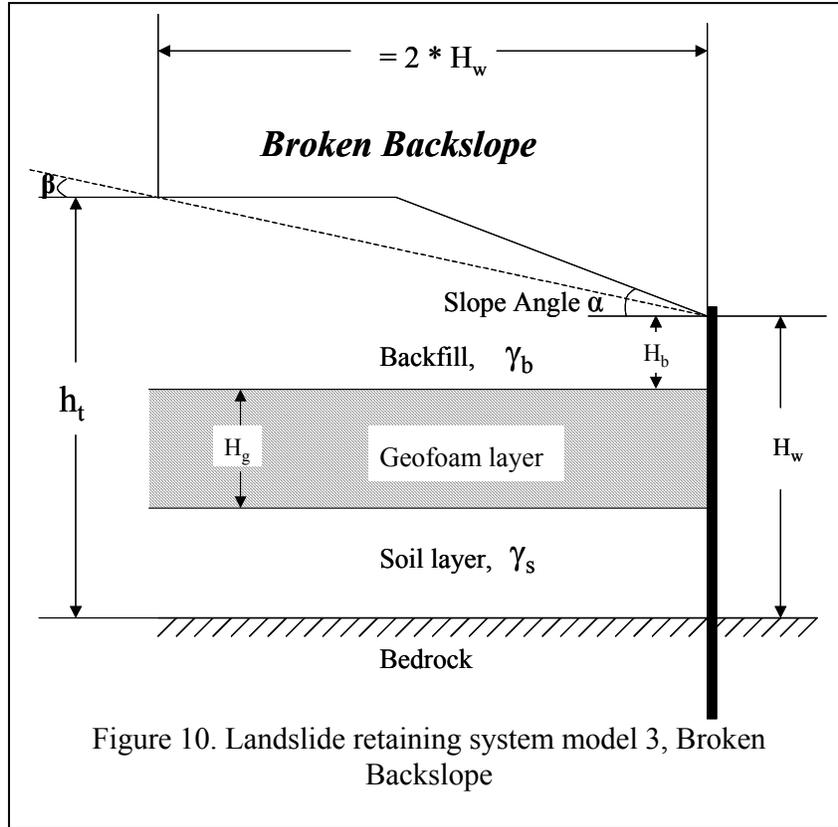
It is assumed that bedrock exists (or the tip of the bottom of the piles are located a sufficient distance below the shear plane) under the soil layer of the slope with a height H_w , so that a rail pile could be driven and socketed into the bedrock (or below the shear plane in soil). In this case, the rail piles are assumed to form a cantilever wall. For highway retaining wall construction, three different models are considered: Level Backfill, Sloping Backfill, and Broken Backfill, as shown in Figure 8 to 10. The layer of geofoam with thickness of H_g is situated between backfill and soil layer.

The sliding movement of a slope will transfer the horizontal driving force to the rail pile. If this force is controlled at a certain level at which the rail pile will not fail, further sliding movement of the slope is prevented and the slope will be safe. Therefore, the key point of this repair method is to keep the rail pile from failing. As shown later, the lightweight material can play a significant role for this purpose. The stress distribution along the boundary between the rail and slope body is complicated. A conventional method is to assume a linear distribution for both vertical and horizontal stresses by using Rankine's and Coulomb's active pressure theories. For the soil layer and lightweight material layer, the vertical and horizontal stresses are expressed as follows:

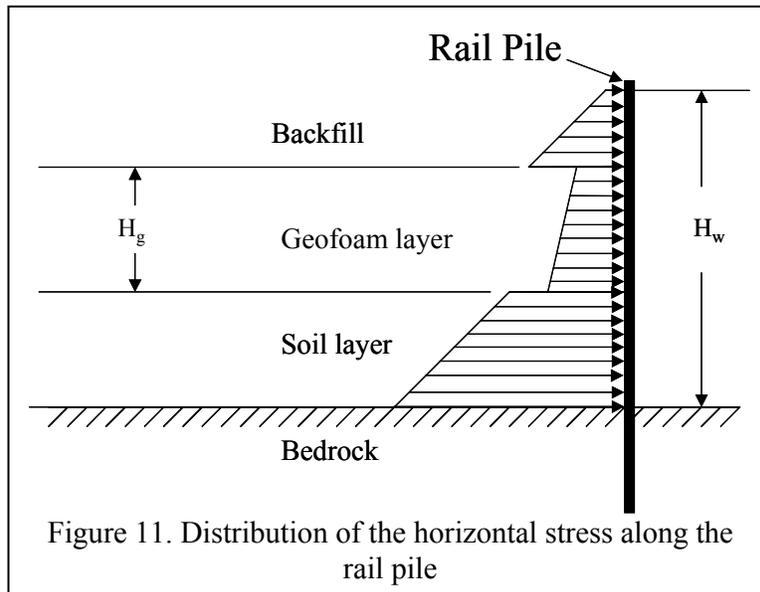
The bending moment of the rail mainly comes from the horizontal stress because vertical stress is parallel to the axis of the rail pile. The distribution of horizontal stresses along rail pile is shown on Figure 11.

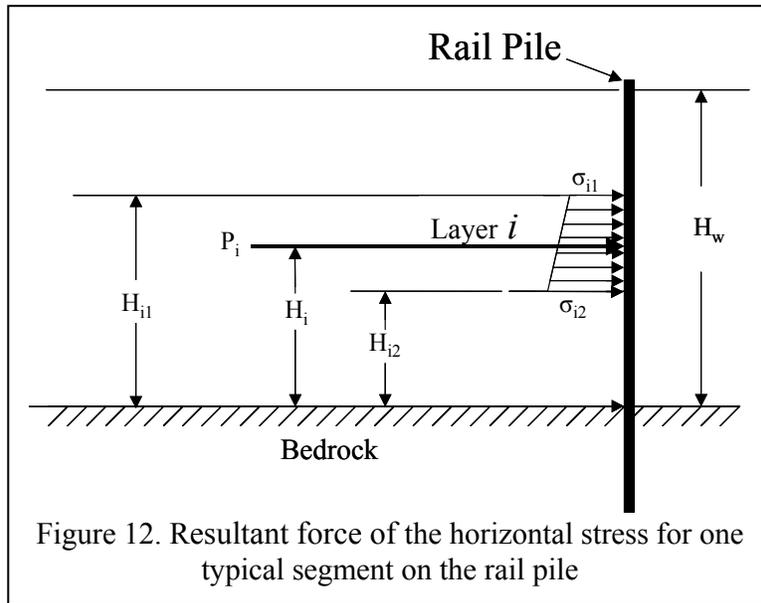
respectively. S_r in Equation 11 is the spacing of the rail pile. The total moment M_m is obtained by

$$M_m = \sum_{i=1}^N M_i \quad (13)$$

where N is the number of the segment of horizontal stress distribution along the rail. N is not necessary equal to the number of layers of material in the slope.

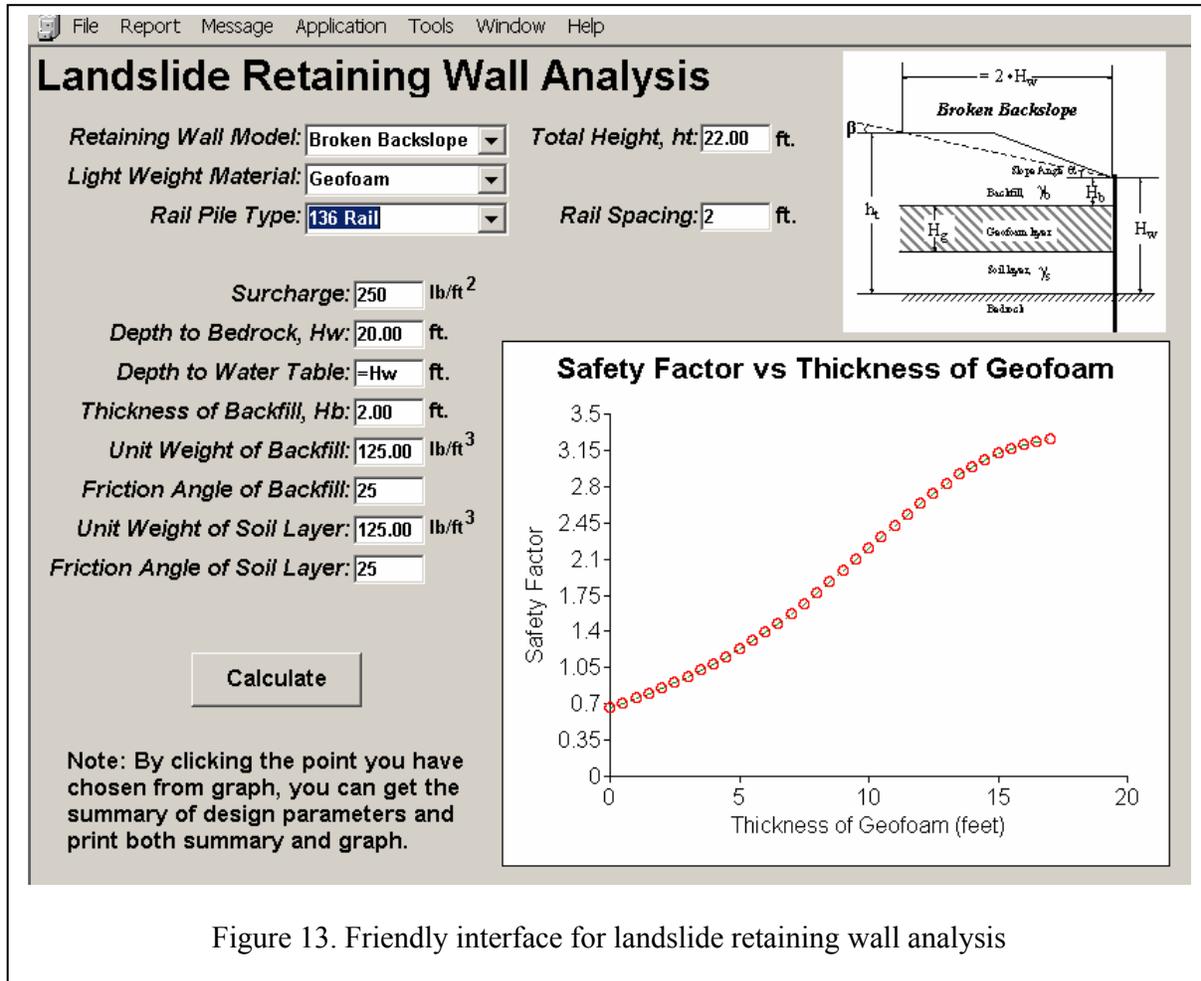
Figure 13. Friendly interface for landslide retaining wall analysis

As a tool, the friendly Graphical User Interface (GUI) constructed for a program is one of the most important targets. Using PowerBuilder over Windows platform, the theory presented above is built into an event-driven program. When this program is started, the first interface shown on the computer screen is a data entry sheet with default design data, geometry of the landslide retaining wall system, and an analyzing curve of safety factor versus geofoam thickness, as shown in Figure 13. If any datum is changed, a new analyzing curve is drawn on the screen.

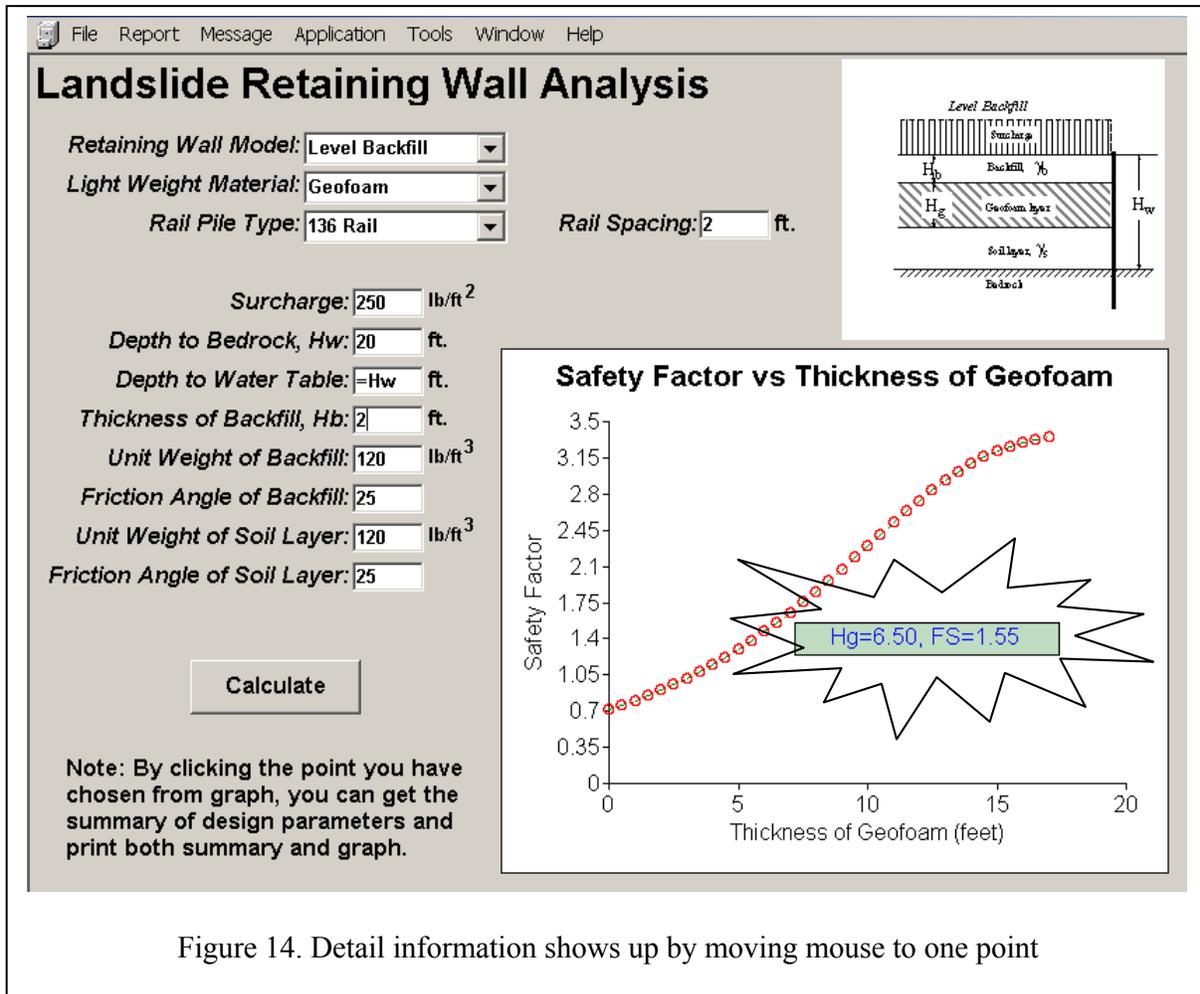
Moving the mouse to a point on the analyzing curve, the user can see a value of safety factor and a corresponding thickness of lightweight material, as shown in Figure 14. By clicking a point on the analyzing curve, a detail design sheet, connected with data on the clicked point, will appear as illustrated in Figure 15. On this design sheet, all data entry parameters used in analyzing a problem are automatically listed. A drawing with the landslide retaining wall system selected by the user is displayed. As shown in Figure 15, the Organization, Designer's name, Design Date, and project Location are entered. After that information is added, the sheet is ready to print for a user's report.

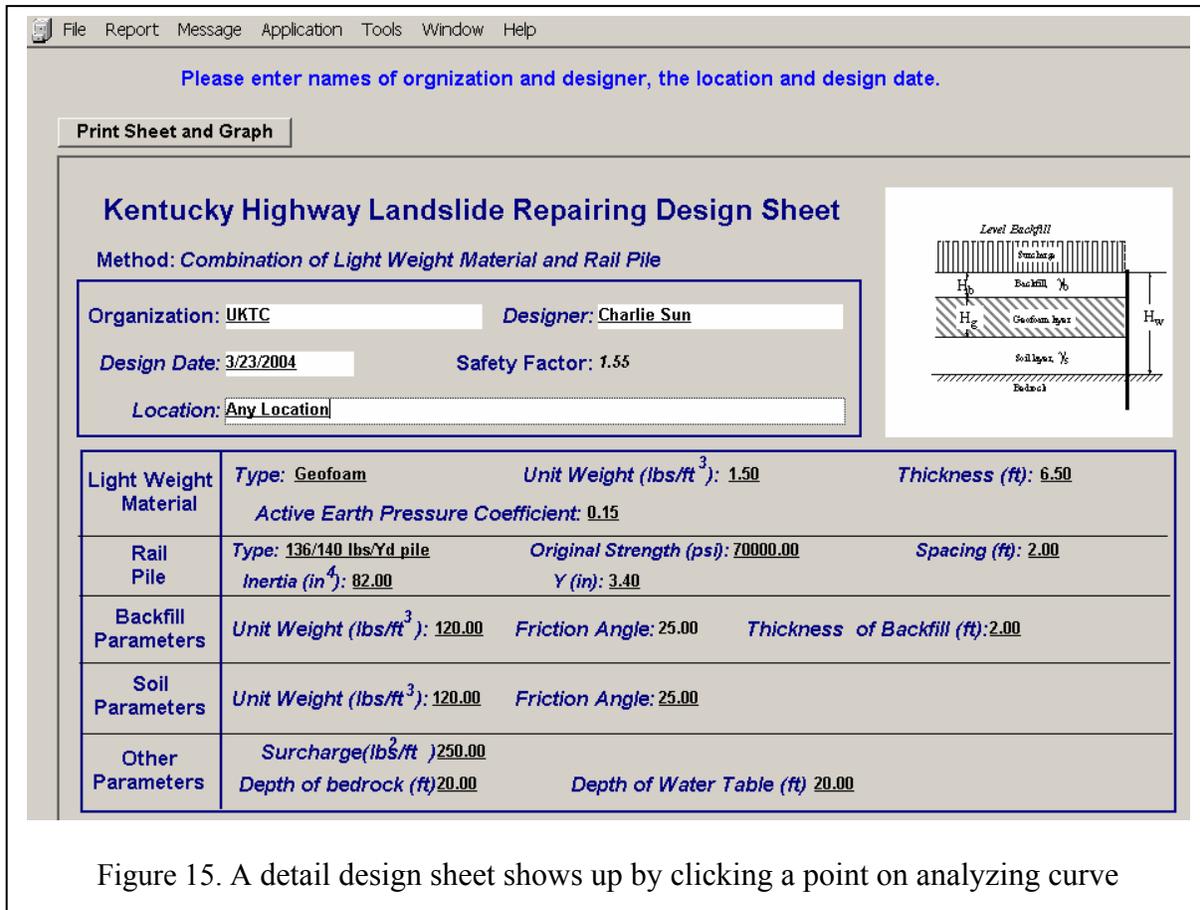
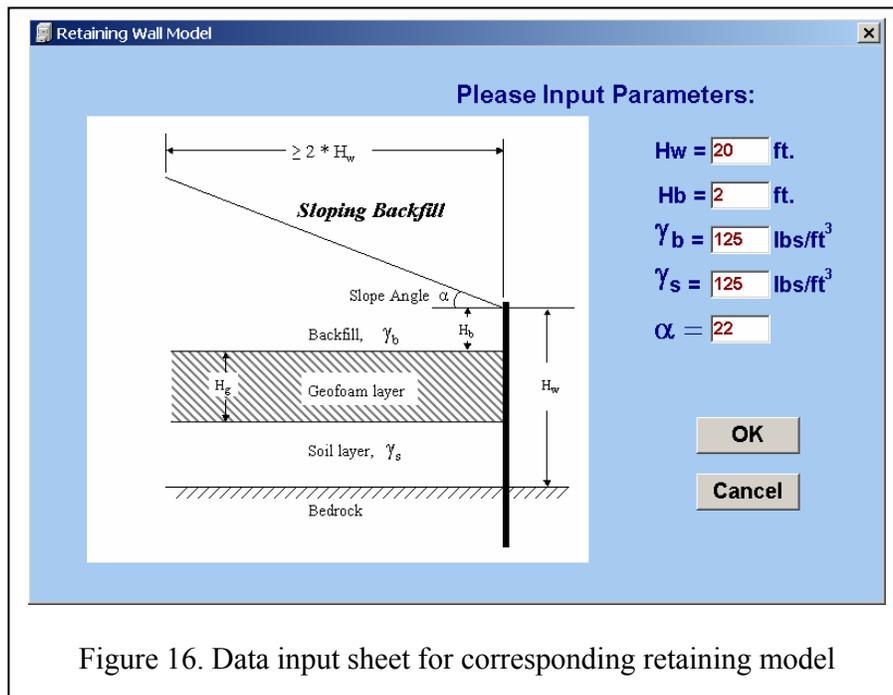
If the retaining wall model is changed, a new screen with the new model appears, as shown in Figure 16. On the page layout, the drawing with landslide retaining wall system illustrates every parameter describing the system. A set of default parameters is ready for general use. Parameters can be modified based on the user’s requirement. After clicking the OK button, the relationship of safety factor as a function of thickness of geofoam (or other lightweight material) involving new parameters is displayed.

When the user changes to different lightweight material, a new screen with some default data, as shown in Figure 17, will appear. The default data can be changed to suit any practical project. After clicking on OK, new analyzing curve will be related to new lightweight material.

Two types of rail piles, 136/140 lbs/Yd and 130/133 lbs/Yd, are built in as default rail piles. If the user has a different pile to analyze, “Other Rail” in the Rail Pile Type dropdown list is an option. When this option is used a new rail property screen with some default data, as shown in Figure 18, will appear for the user to enter new parameters. The user can modify data on screen to match a real problem. After clicking on OK, a new analyzing curve will be associated with the new pile.
