**Research Report
KTC-99-58**

**An Analysis of Wastewater Generated
During Water Jetting Tests on the
I - 65 John F. Kennedy Bridge at Louisville**

September 1999

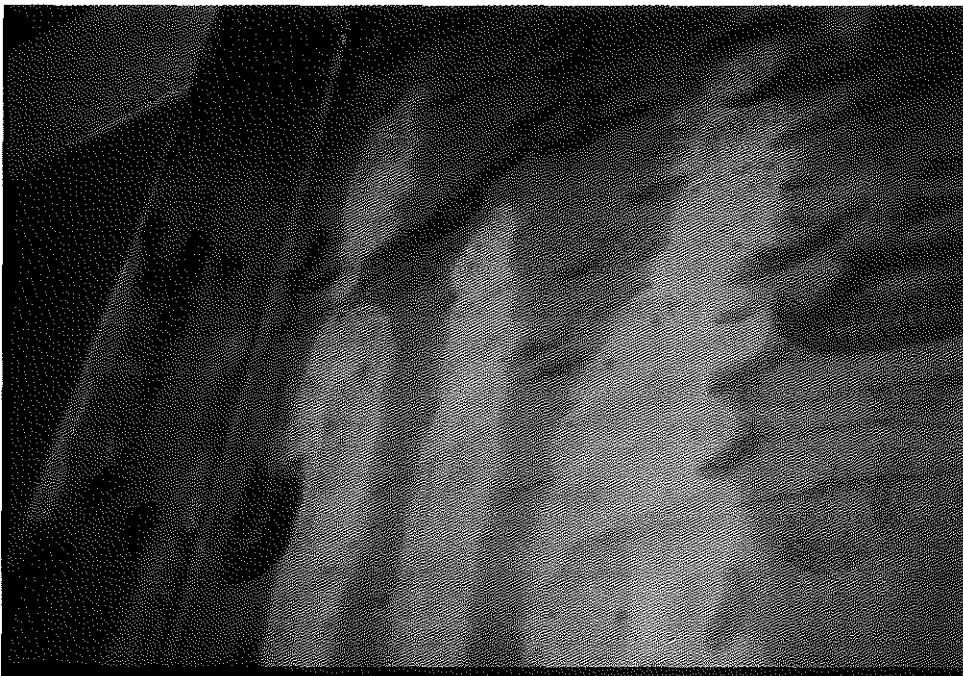
Figure 2. Water jetting removed the topcoat and much of the red lead primer.

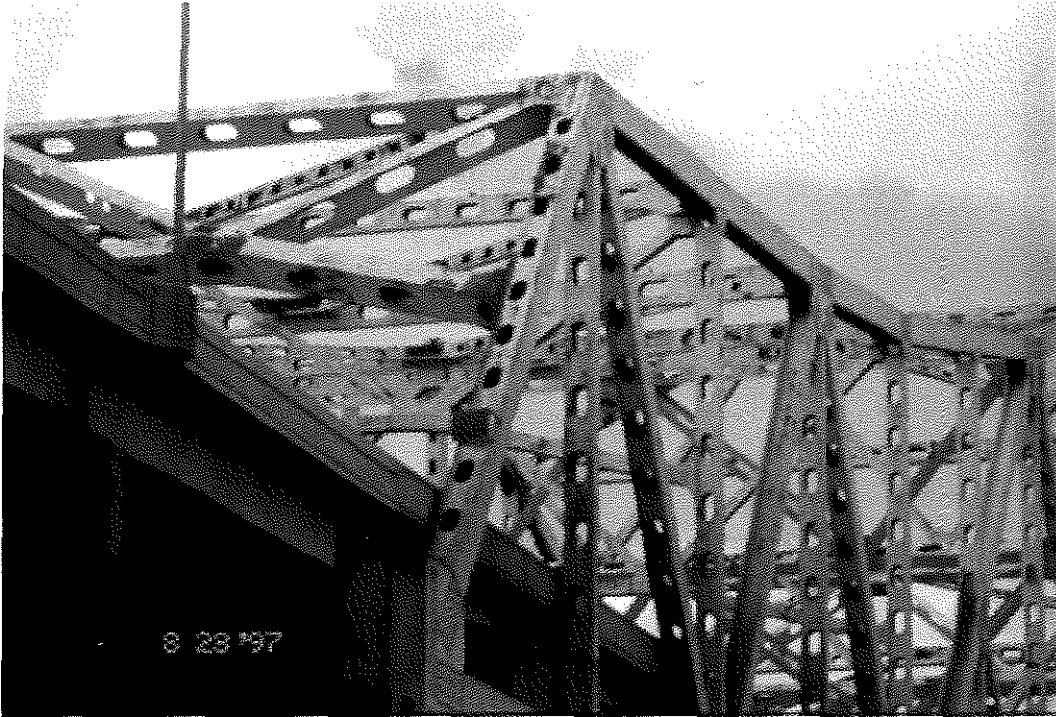
Figure 5. Close-up of Kennedy Bridge (note extensive rust in splash zone).

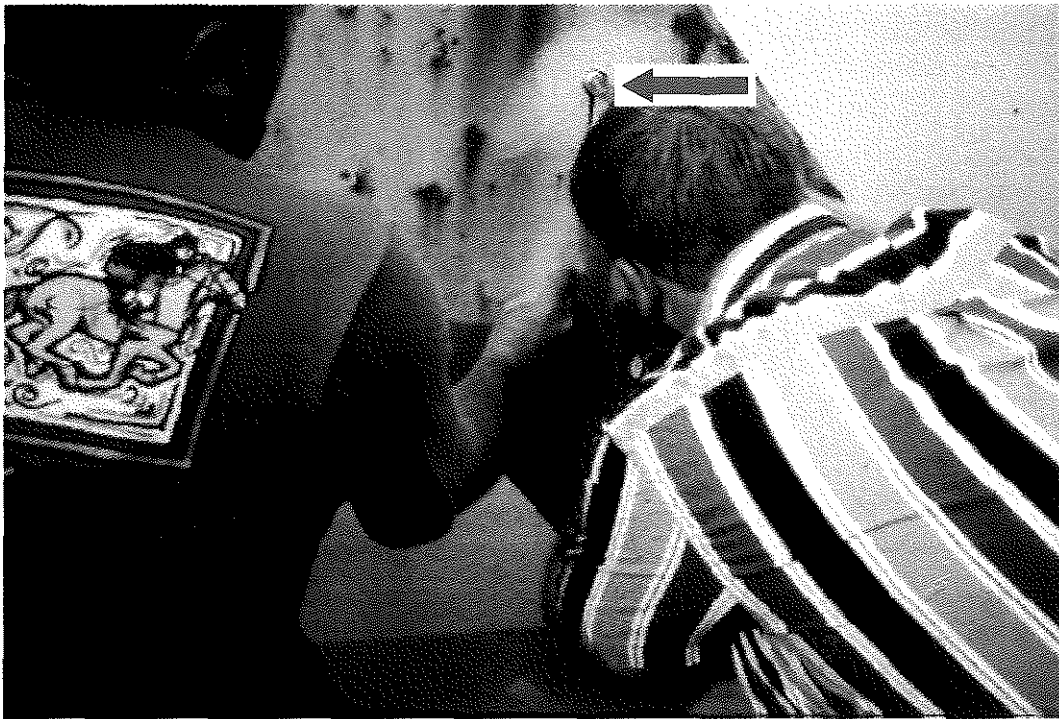
Figure 6. Pre-wash surface analysis (note pull-off dolly).

Traffic control was arranged for October 7 and 8, 1997. Paint team members surveyed the truss and identified test areas to be washed on the 7th and the demonstration was conducted on the 8th. The test areas were approximately 10 ft² and were located on both vertical and diagonal members, primarily in areas where much of the coating was still intact (identified as Paint #3 etc.). Two test areas were located where most of the existing coating was completely deteriorated (identified as Rust #1 and #2). In the areas where the coating was intact, there were numerous rust spots (Figure 5). The coating on the Kennedy Bridge is seriously degraded over the entire structure with the splash zone above the deck and at joints below the deck being in the worst condition. Prior to washing, the test areas were assessed for adhesion (pull-off test per ASTM D-4541 (Figure 6) and tape test per ASTM D-3359 (Figure 7), surface chloride content, and existing coating Dry Film Thickness (DFT) per ASTM D-4138 (Figure 8). Chloride content was assessed using a commercially available titration kit (Figure 9). At some test areas, it was not possible to distinguish all the individual coating layers, but generally there was an alkyd topcoat over 615D lead primer which covered the original aluminum topcoat and red lead primer. Total coating DFT ranged from 8 to 18 mils (1 mil = 0.001 inch). Pull-off tests results ranged from 0 to 590 psi with five of ten tests at or below 100 psi. Tape adhesion test results ranged from 1A to 3A. Most pull-off failures occurred in the 615D lead primer. Chloride content tests results ranged from 125 to 200 $\mu\text{g}/\text{cm}^2$.

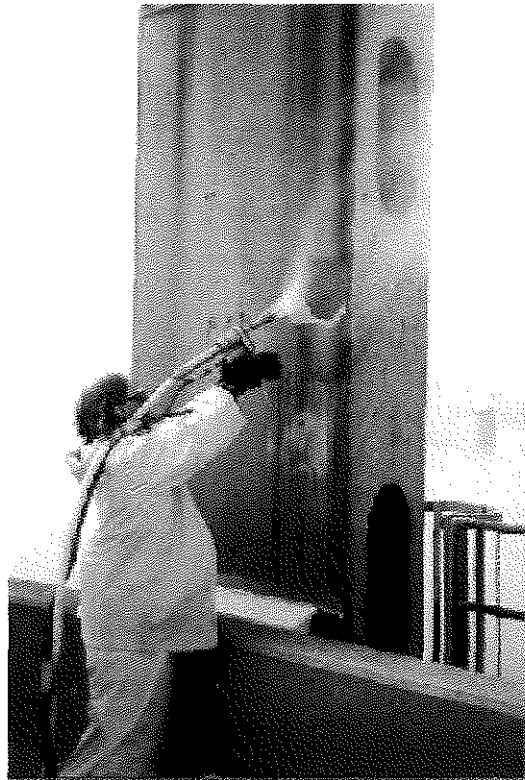
Figure 12. Washing at 6 inches from surface.

The first test area (Rust #1 @ 20,000 psi) was washed with considerable effort, with the wash nozzle within six inches of the surface, cleaning at a rate of approximately eight ft²/min. (Figure 12). This "level of work" resulted in the removal of all the topcoat and much of the 615D primer. Wastewater from Rust #1 contained mostly pulverized paint. Subsequent washing tests were conducted at lower "levels of work". After the washing was completed and all test areas were surface dry, pull-off, chloride content, and profile tests were performed. Post-wash pull-off adhesion test values were higher than pre-wash tests in all test areas and ranged from 50 to 900 psi.

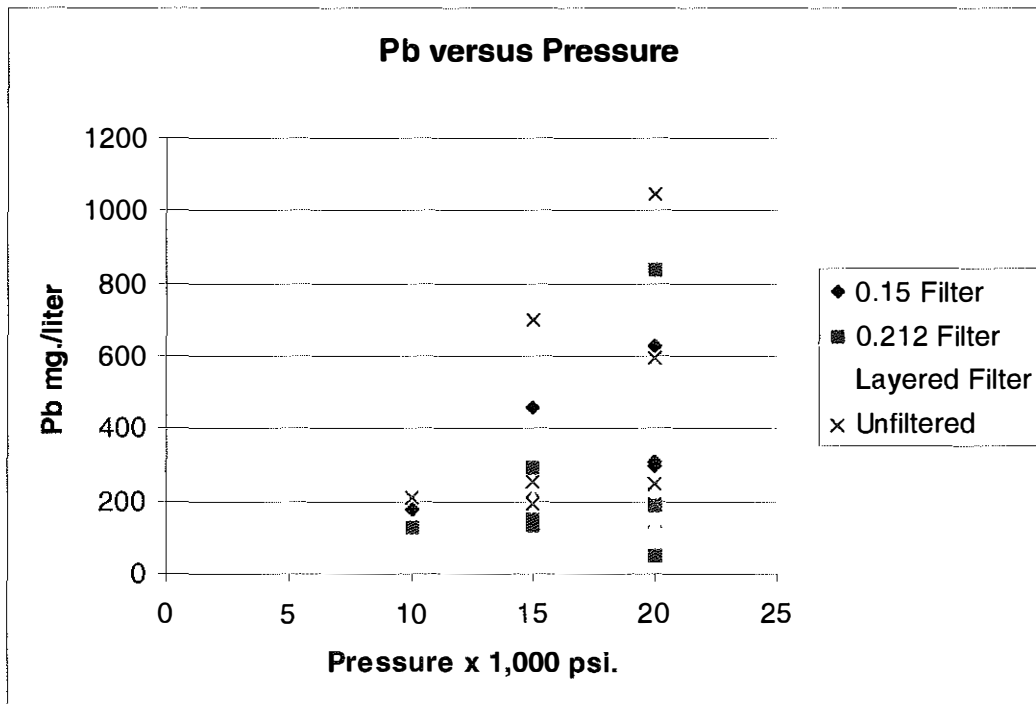
Figure 14. Wastewater lead levels at various wash pressures.

The "level of work" appears to have had a greater impact on wastewater lead levels than the filtering variables. Rust #1 (20,000 psi. and higher level of work) had total lead levels ranging from 1,048 ppm for the unfiltered sample to 625 ppm for the filtered (AOS of 0.15 mm) samples. Paint #10 had a lower "level of work" and a corresponding lower total lead level of 595 ppm for the unfiltered sample and 310 ppm for the filtered sample. Paint #4 and #5 had the lowest "level of work" (approximately 16 ft²/min) and had wastewater total lead levels ranging from 298 to 49 ppm. Rust #2, Paint #6, and Paint #7 were washed at 15,000 psi and had lead levels ranging from 710 to 132 ppm. Paint # 8 was washed at 10,000 psi and total lead levels ranged from 209 ppm for the unfiltered sample to 125 ppm for a filtered sample. Filtering the wastewater reduced the lead level but the filter AOS did not have a consistent effect on the lead level (Figure 13). The relationship of wash pressure and "level of work" to wastewater lead levels is shown in Figure 14. The wastewater lead levels and test area variables are shown in Table 2.
