Research Report
KTC-99-61

**EVALUATION OF THE ADAPTIR SYSTEM
FOR WORK ZONE TRAFFIC CONTROL**

November 1999

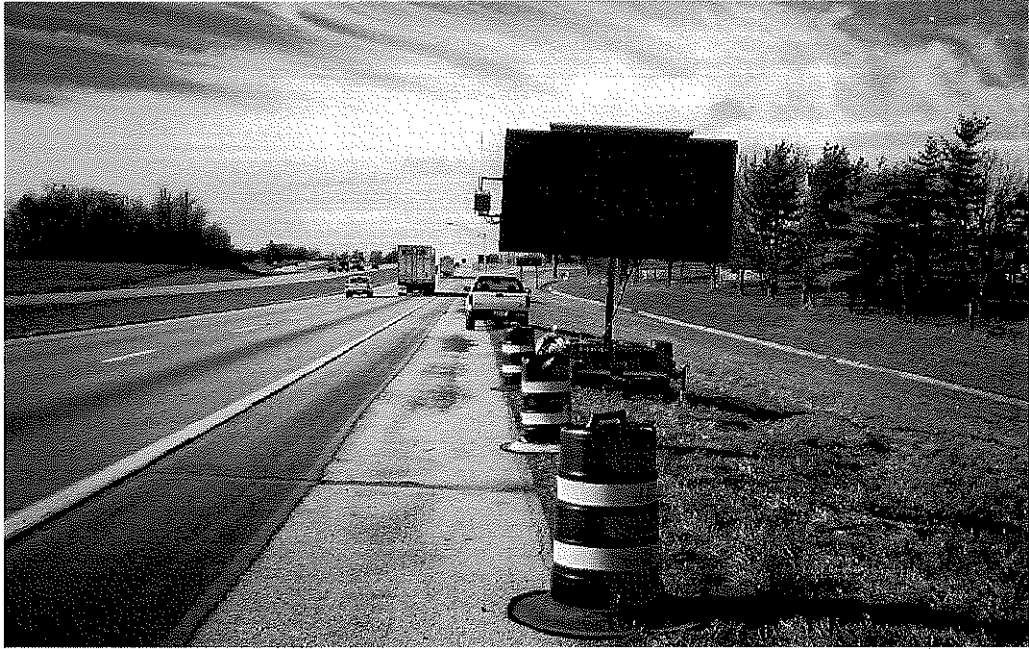
Figure 1. Variable Message Sign Equipped with Radar Unit.

The ADAPTIR system uses variable message signs (VMS) equipped with radar units (Figure 1), along with a software program to interpret the data, to display appropriate warning and advisory messages to motorists approaching a work zone when certain speed and delay thresholds are met. The messages warn drivers when average speeds are reduced ahead, when delays become excessive, and advise the motorist of long delays when use of an alternate route should be considered.

Both the ADAPTIR and contractor's systems used radar units to collect speeds at a series of four VMS leading to the work zone along with another radar unit on the arrow display at the lane closure. While the distances varied slightly, the first VMS was typically located about 4 to 5 miles from the lane closure with the lane closed about 2.5 miles. The ADAPTIR and contractor's systems were used in addition to the typical traffic control measures used for a lane closure on a multi-lane highway. Three types of messages were displayed. The messages dealt with a reduction in speed, a level of delay, and the display of an alternate route. Certain criteria were used in the development of the messages. Each warning consisted of two messages. Each message had three lines with a limit of eight characters for each line.

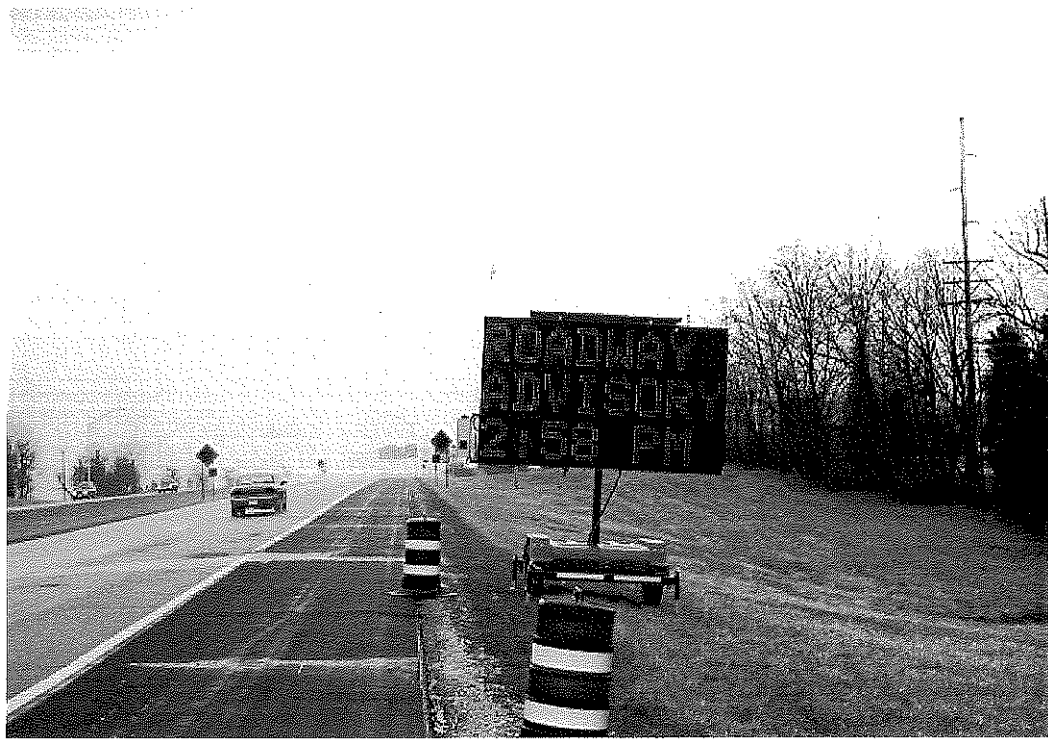
Figure 2. Message Showing Current Time.

Average speeds were calculated at each VMS and the arrow display at set intervals (every two minutes westbound and every three minutes eastbound). When the average speed between two adjacent radar locations was reduced by 10 mph or more, a message was displayed on the VMS upstream from the location at which the radar found the reduced speed. The speed warning consisted of a sequence of the following two messages.

ROADWAY		REDUCE
ADVISORY		SPEED TO
XX AM OR PM	followed by	XX MPH

Photographs showing these messages are shown in Figures 2 and 3. The message was updated every two minutes for the ADAPTIR system used in the westbound direction and every three minutes for the contractor’s system in the eastbound direction. The “time stamp” gave a new time so motorists would realize the information was current. The speed was given in five mph increments with the speed rounded to the next lowest five mph interval from the average. If traffic was stopped at one location giving a zero speed, the upstream VMS gave a speed of five mph.

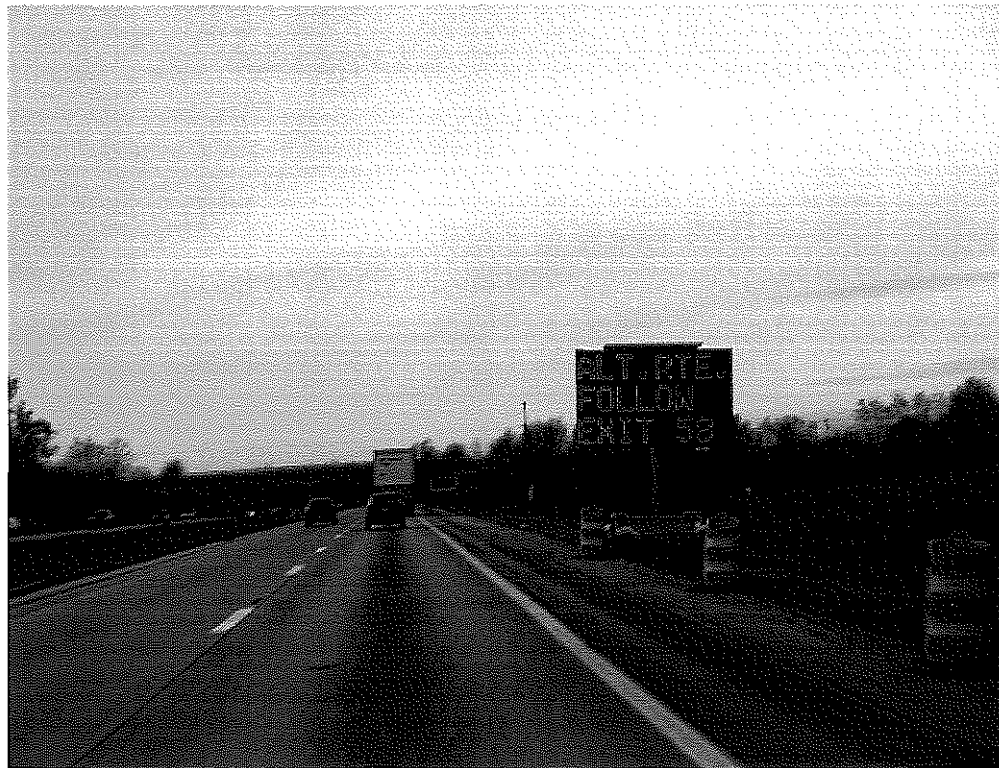
Figure 6. Alternate Route Message.

The final message related to an alternate route. It was displayed when the delay reached 15 minutes and this delay was maintained for a minimum time of 10 minutes for the ADAPTIR system and 9 minutes for the contractor’s system. The diversion message consisted of a sequence of the following two messages (Figures 5 and 6).

LONG		ALT RTE
DELAYS		FOLLOW
AHEAD	followed by	EXIT XX

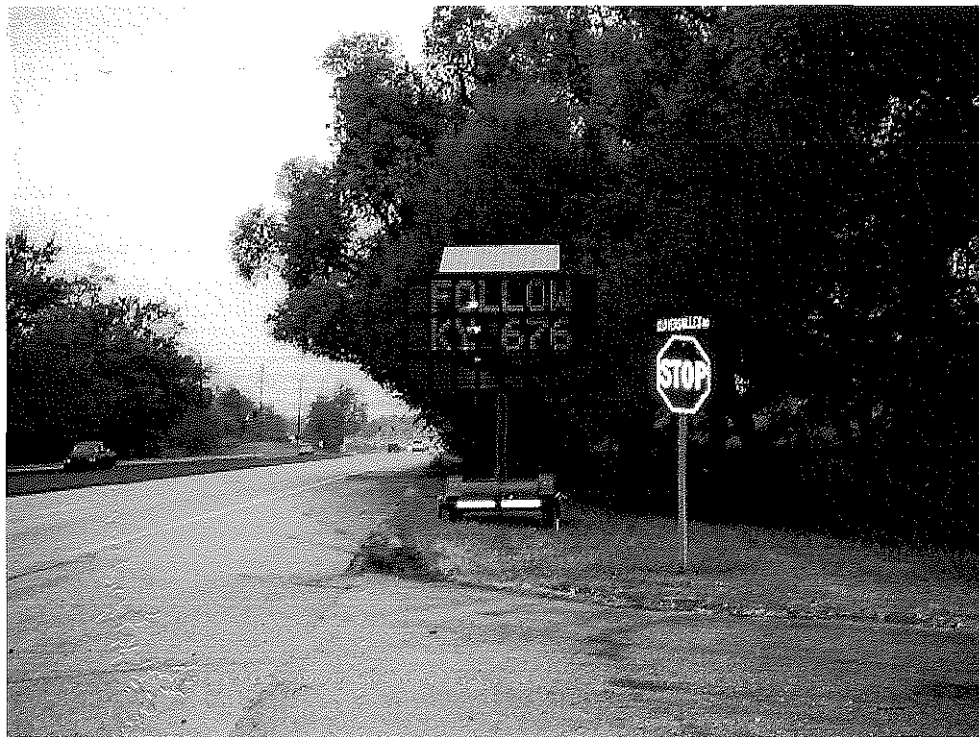
Figure 8. Message on Intersecting Route Advising Use of Alternate Route.

This system provided information to motorists on the interstate. Additional VMS were placed on the diversion route to provide information when excessive delays occurred (Figures 7 and 8). The messages on these signs were input manually.
