Truck Route Access Evaluation: Safety  
Kleen, Henry County, Site #2145

# TRUCK ROUTE ACCESS EVALUATION

Safety Kleen  
Henry County  
Site #2145

Report No. KTC-99-7

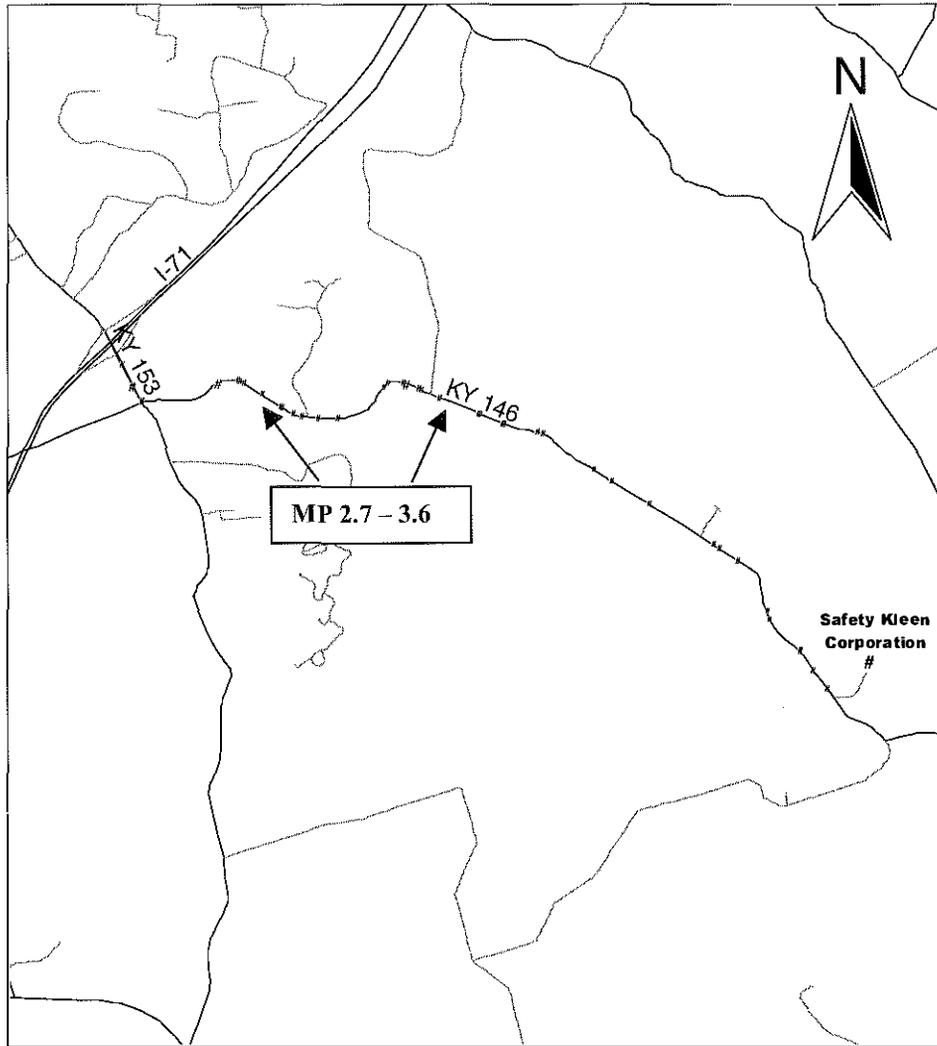
Figure 2: Accident Locations (1995-1997)

Figure 3 shows the locations of accidents during the years 1995, 1996, and 1997. A summary of the accidents along both truck routes (for all roads, not just state-maintained roads) is shown in Table 2 for the same three-year period. The percentage of trucks involved in accidents along this route (13.5%) is more than the percentage of trucks found on the KY 146 portion of the route from 1998 traffic counts. Traffic on KY 146 was composed of 8.8% trucks while KY 153 had 16.3% trucks. This suggests that there is a possible problem with truck accidents on KY 146 from a recent accident history point of view.

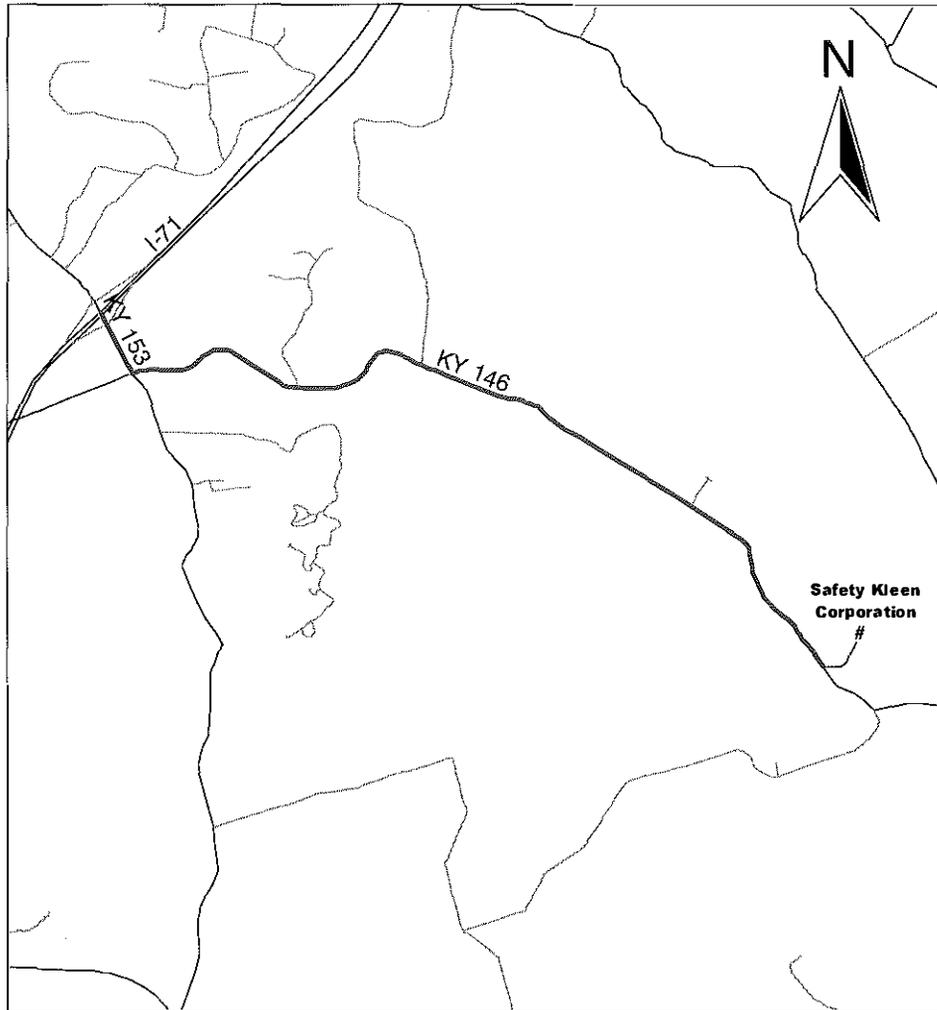
**Figure 3: Lane Widths**

Figures 3 and 4 illustrate the sections of the route with different lane widths and shoulder types, respectively. KY 153 and KY 146 both have 10-foot lanes which are considered “less than adequate”. Pavement along both roads is in good condition.

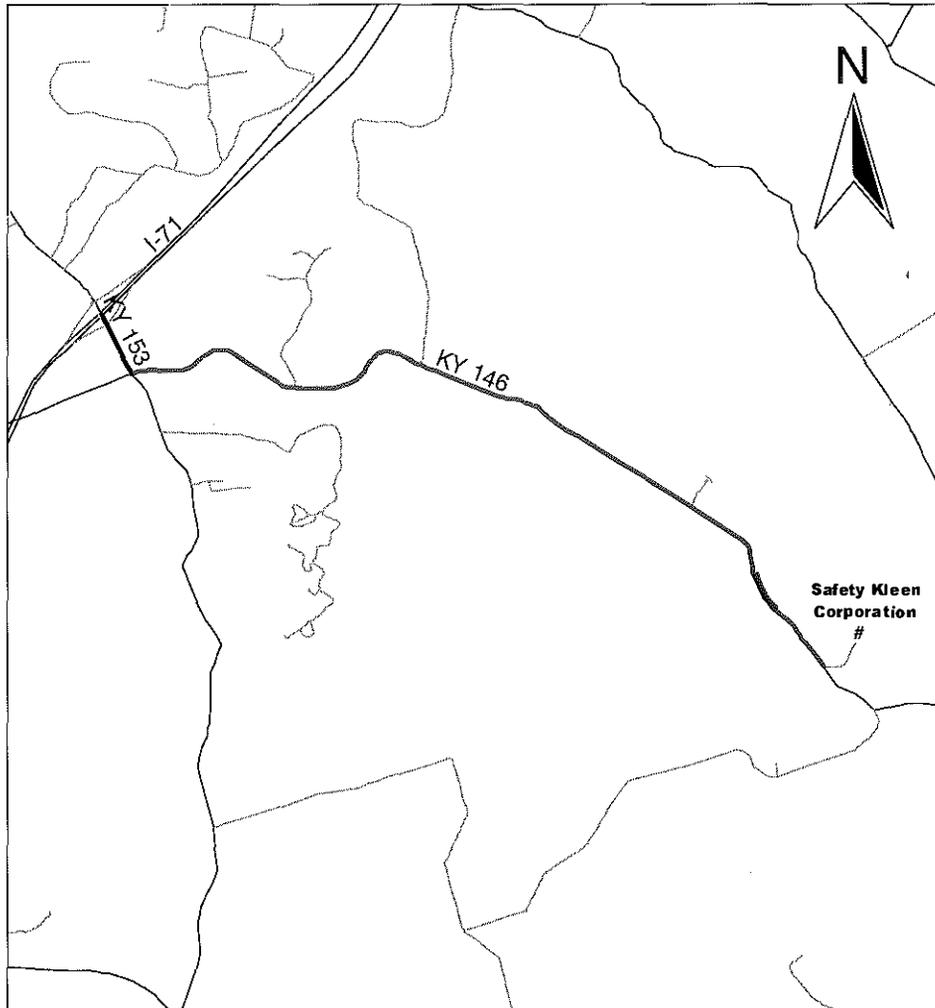
**Figure 4: Shoulder Widths**

KY 146 has only a “less than adequate” 2- to 4-foot of turf shoulder along its length. The only exception to the turf shoulders is shown in Figure 5. This figure shows a short portion of KY 146 between milepoints 5.5 and 5.6 with no shoulder. All of the route portion of KY 153, except the area in the immediate vicinity of the intersection with KY 146, has 10-foot “preferred” paved shoulders, as shown in Figures 6 and 7.

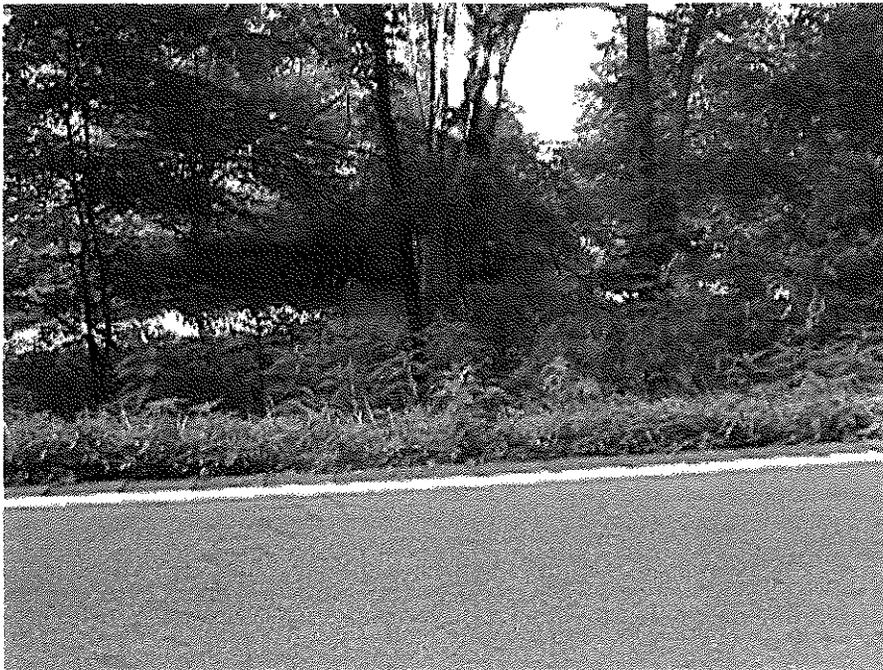
**Figure 8: Section of KY 146 with No Clear Zone or Shoulder**

The only problem associated with clear zone is between milepoint 5.5 and 5.6 on KY 146. Figure 8 shows the section along the northern side of the road where there is no clear zone (or shoulder) available. With Bartlett Creek just below the roadside, the inclusion of guardrail along this section might be considered.

The section of KY 146 with no shoulder or clear zone could be improved by installing guardrails, which has already been done on portions of the route in the vicinity. The remaining problems could only be remedied through reconstruction of the route, which is deemed unnecessary at the current time. If further development increases the truck volumes in the area, such reconstruction might be reconsidered.

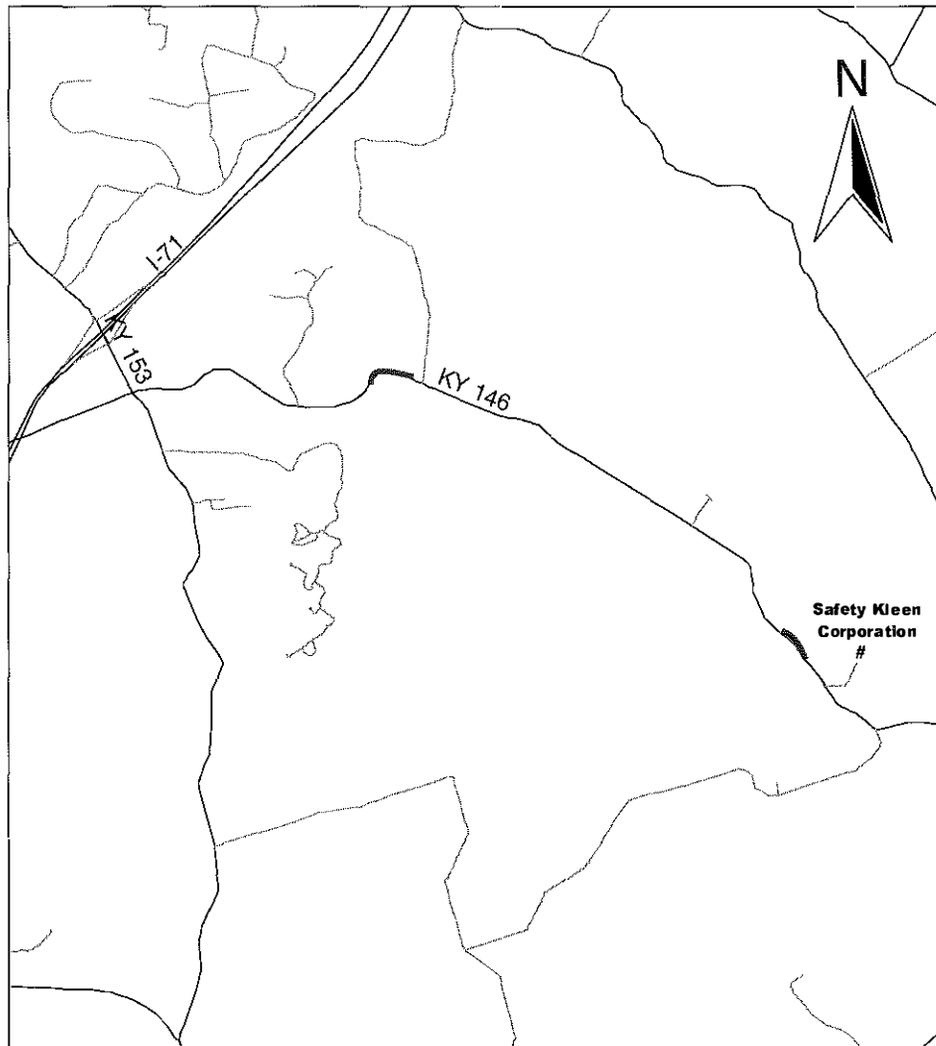
Figure 9: Curve Safe Speeds

The route was tested for curves with safe speed problems by the use of the ball-bank indicator. By maintaining the posted speed limits and/or advisory speeds through curves, the ball-bank indicator allows for the determination of whether or not the curve should be safely driven at indicated speeds. There are two curves along the route with less than “preferred” ball-bank readings, as shown in Figure 9. Both curves had 45 mile-per-hour advisory speeds. The first can be found at approximately milepoint 3.5 on KY 146. This curve had a ball-bank reading greater than 10° which is “less than adequate”. The second curve is located at approximately milepoint 6.0 on KY 146. Figure 10 shows the beginning of this section of curvature. This curve also had a ball-bank reading of greater than 10° which is “less than adequate”.

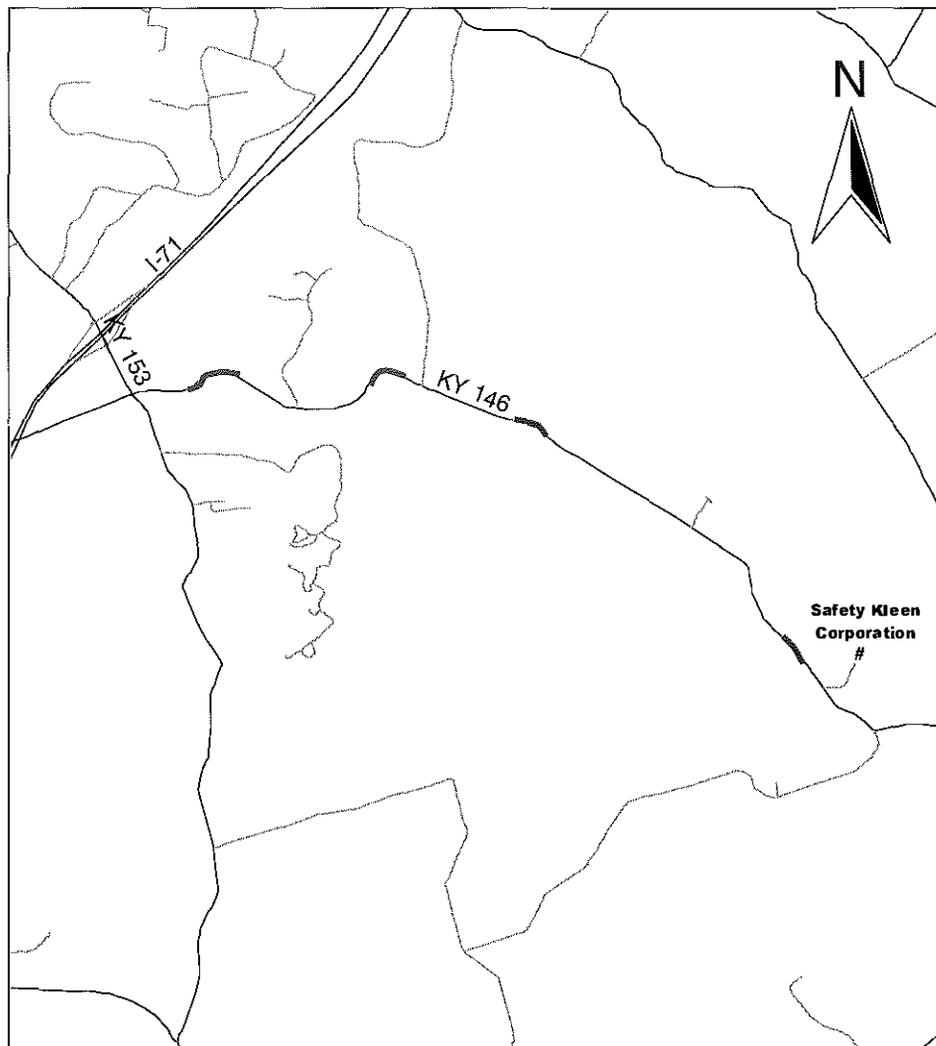
Figure 11: Offtracking Locations

Offtracking is considered a problem where a truck cannot stay in its lane through a curve. With only 10-foot lanes on KY 146, some curves were investigated for offtracking. Figure 11 shows the four curves that were evaluated due to suspected offtracking. The first two, beginning at milepoints 2.95 and 3.2, are approximately 6 degrees and are

both considered “adequate” for the 48-foot semi-trailers and 10-foot lanes. Two other curves, beginning (approximately) at milepoints 4 and 5.35, are approximately 10 and 8 degrees (respectively) and are considered “less than adequate”.

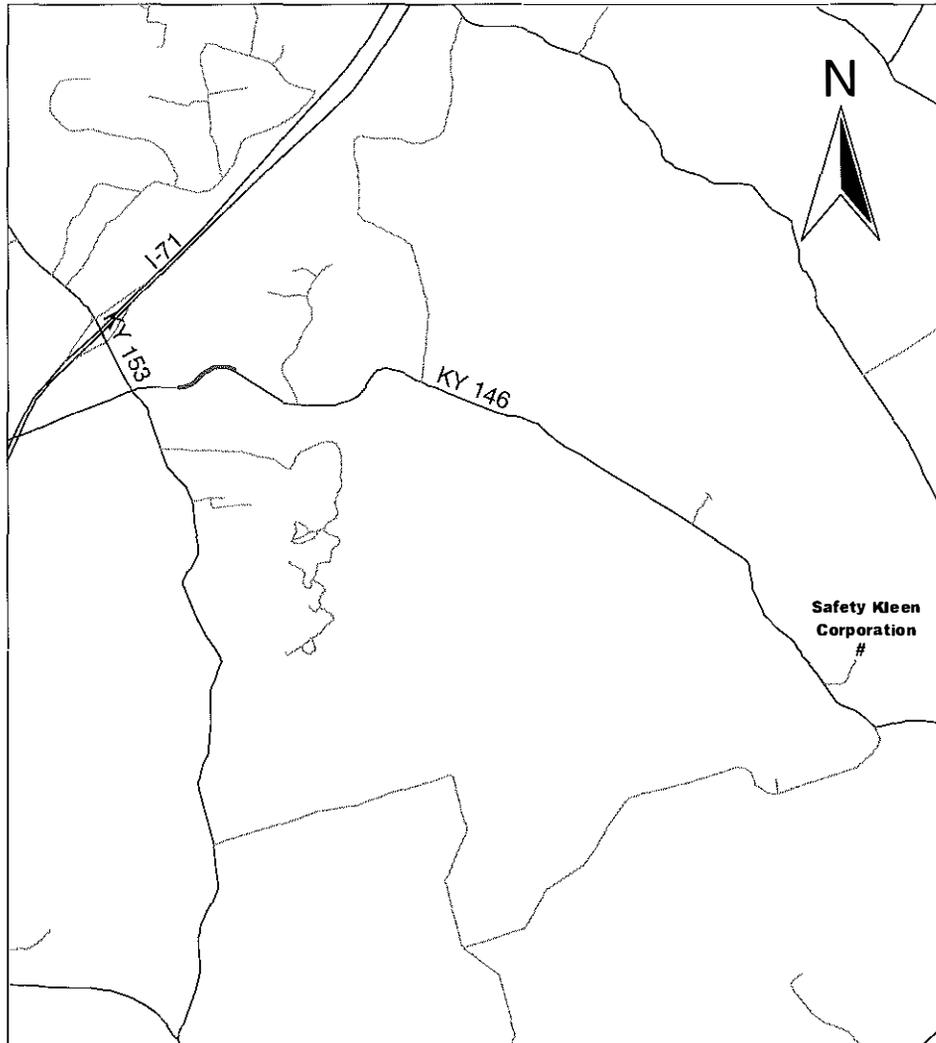
**Figure 12: Problematic Grade Location**

Grades are considered problematic if they cause trucks to slow excessively. One grade on KY 146 near the intersection of KY 153 (from milepoints 2.5 to 2.7, shown in Figure 12) was investigated. The vertical curvature along this section is approximately 6%, which is “less than adequate” given the length of the grade.

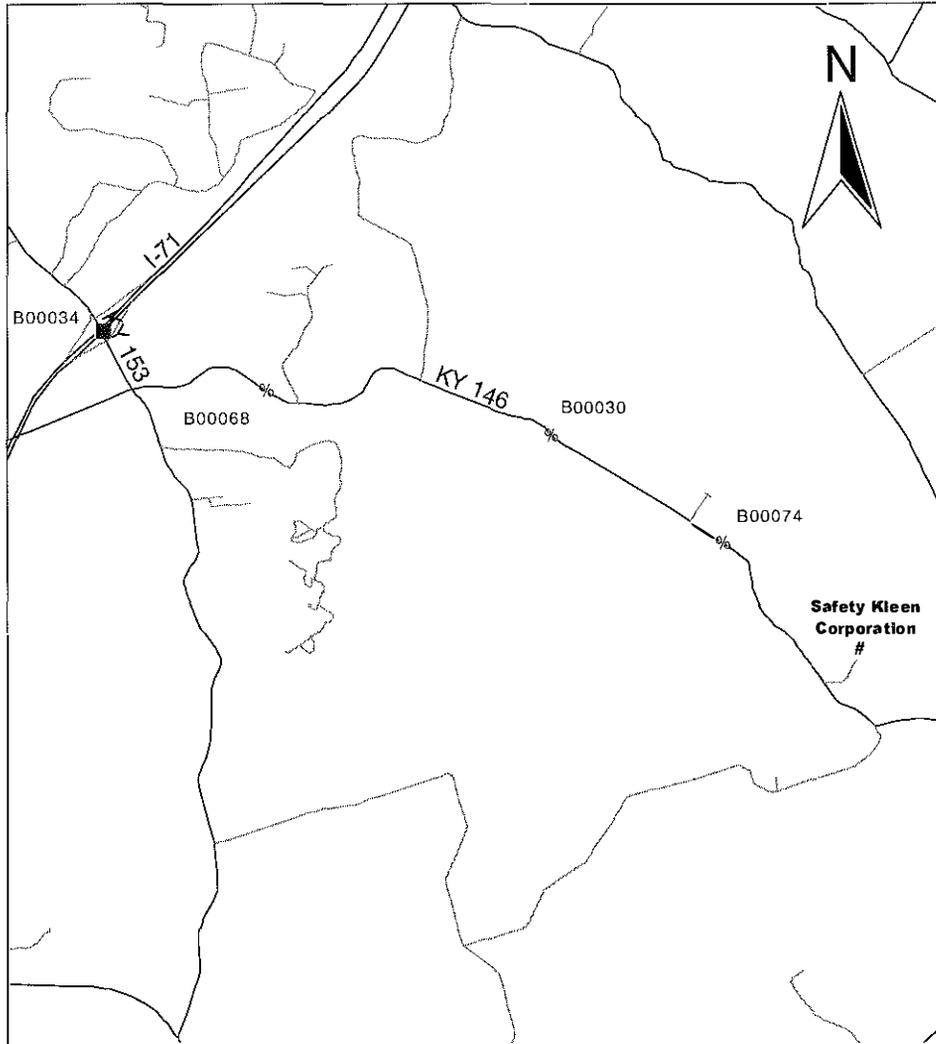
**Figure 13: Bridge Locations**

There are four bridges along this route, as shown in Figure 13. The Kentucky Transportation Cabinet’s Division of Operations maintains a database of bridge sufficiency ratings that are based on the serviceability (as well as other features) of the structure. KY 153 has only one bridge, which crosses over I-71 at milepoint 5.81. It has a sufficiency rating of 90.8, which is considered “preferred”. KY 146 has three bridges at mileposts 2.88, 4.41 and 5.37. The sufficiency ratings for these bridges are 79.8, 79.7 and 89, respectively. The first two bridges are both “adequate” and the last one is “preferred”.
