# TRUCK ROUTE ACCESS EVALUATION

Campground Road Cluster  
Louisville  
Site # 8

Report No. KTC-98-30

“Freight Movement and Intermodal Access in Kentucky”  
Project No. SPR 98-189

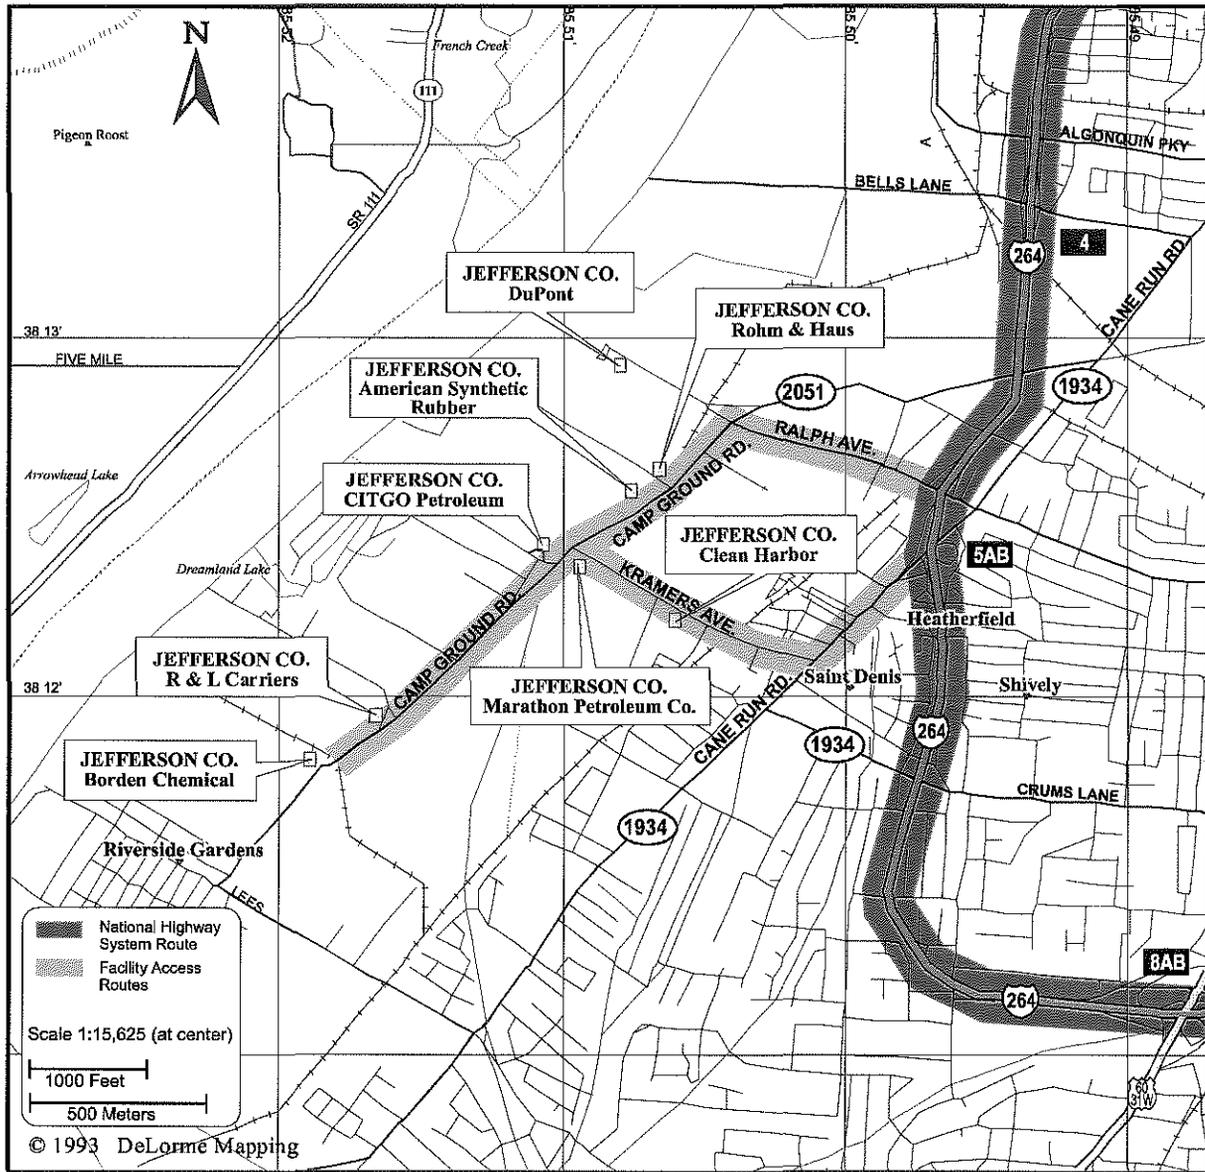
**Figure 1: Location of Truck Generating Sites**

\*Although KY 1934 (Cane Run Road) is part of the National Highway System, the route to I-264 was evaluated for these facilities. As shown in Figure 1, trucks from these facilities access I-264 exit 5a (Ralph Avenue) and exit 5b (Cane Run Road). Exit 5a is a partial interchange with an on ramp to eastbound I-264 and a westbound off ramp. Exit 5b is a full interchange. The layout of these interchanges is shown in Figure 2. Cane Run Road is a four lane signalized arterial. Ralph Avenue and Kramers Lane are two lane paved roads with no shoulders. They are slightly less than a mile in length and connect Cane Run Road and Campground Road (KY 2051). Campground Road is a two lane road with narrow shoulders. Cane Run Road and Campground Road are the only state maintained roads on this route.

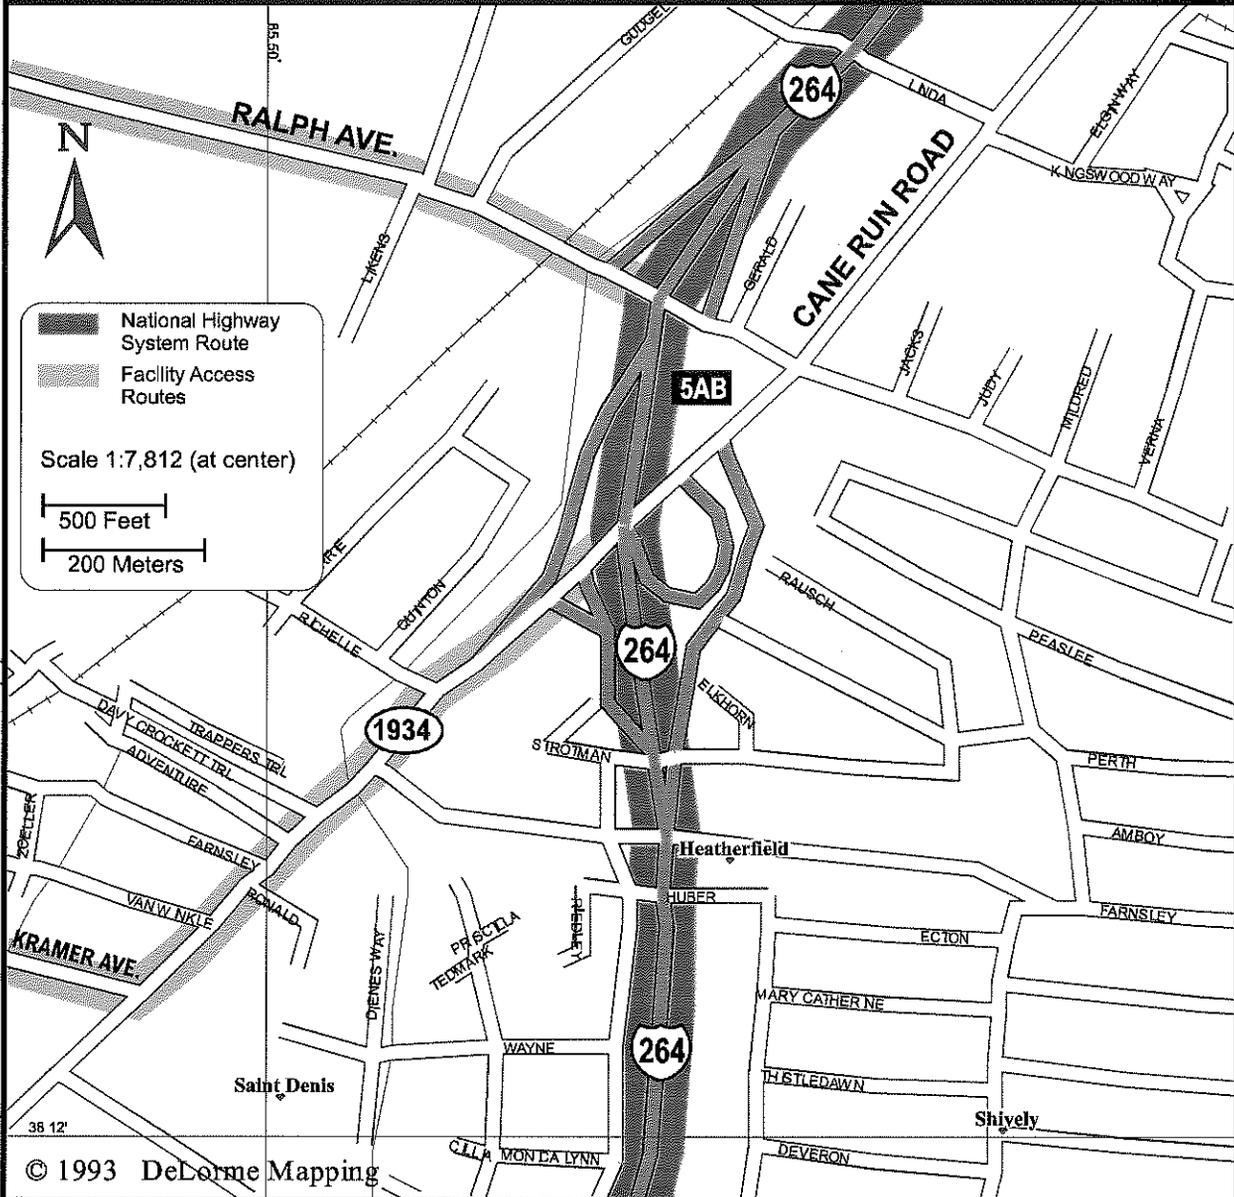
Figure 2: Layout of I-264 Interchange

Ralph Avenue is in a residential area with houses along both sides of the road. The crosswalk on Campground Road near Rohm & Hass is extremely faded. The interchange layout is unique because exit 5 is divided between two intersecting roads (see Figure 2).

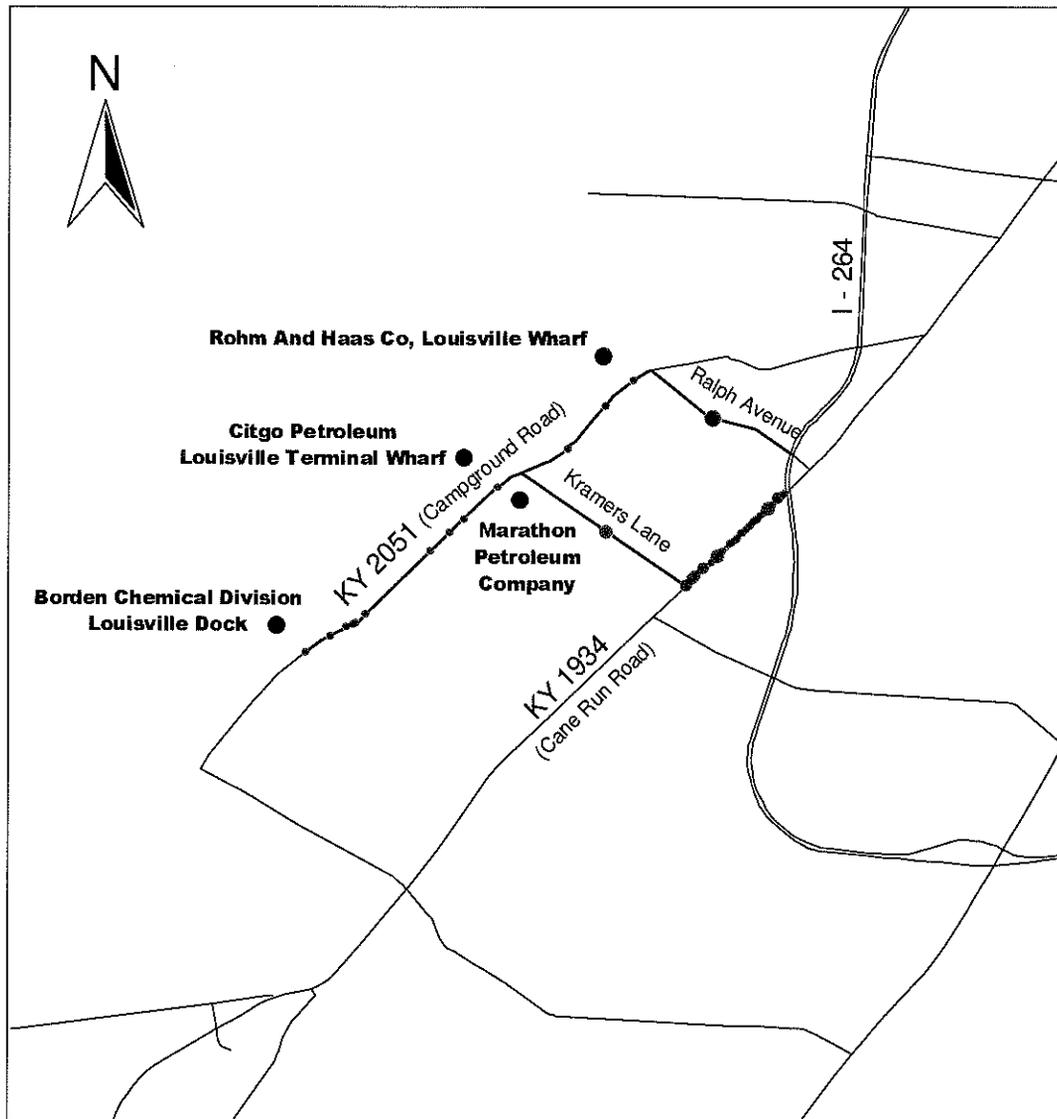
**Figure 3: Accident Locations (1994 - 1996)**

Figure 3 shows the locations of all accidents during the years 1994, 1995 and 1996. The section of Cane Run Road with critical accident rate is shown in the figure. The accidents on Ralph Avenue and Kramers Lane are grouped together because specific locations were not available. The figure clearly shows that accidents along Cane Run Road are an issue and that a large number of accidents also occurred along Ralph Avenue.

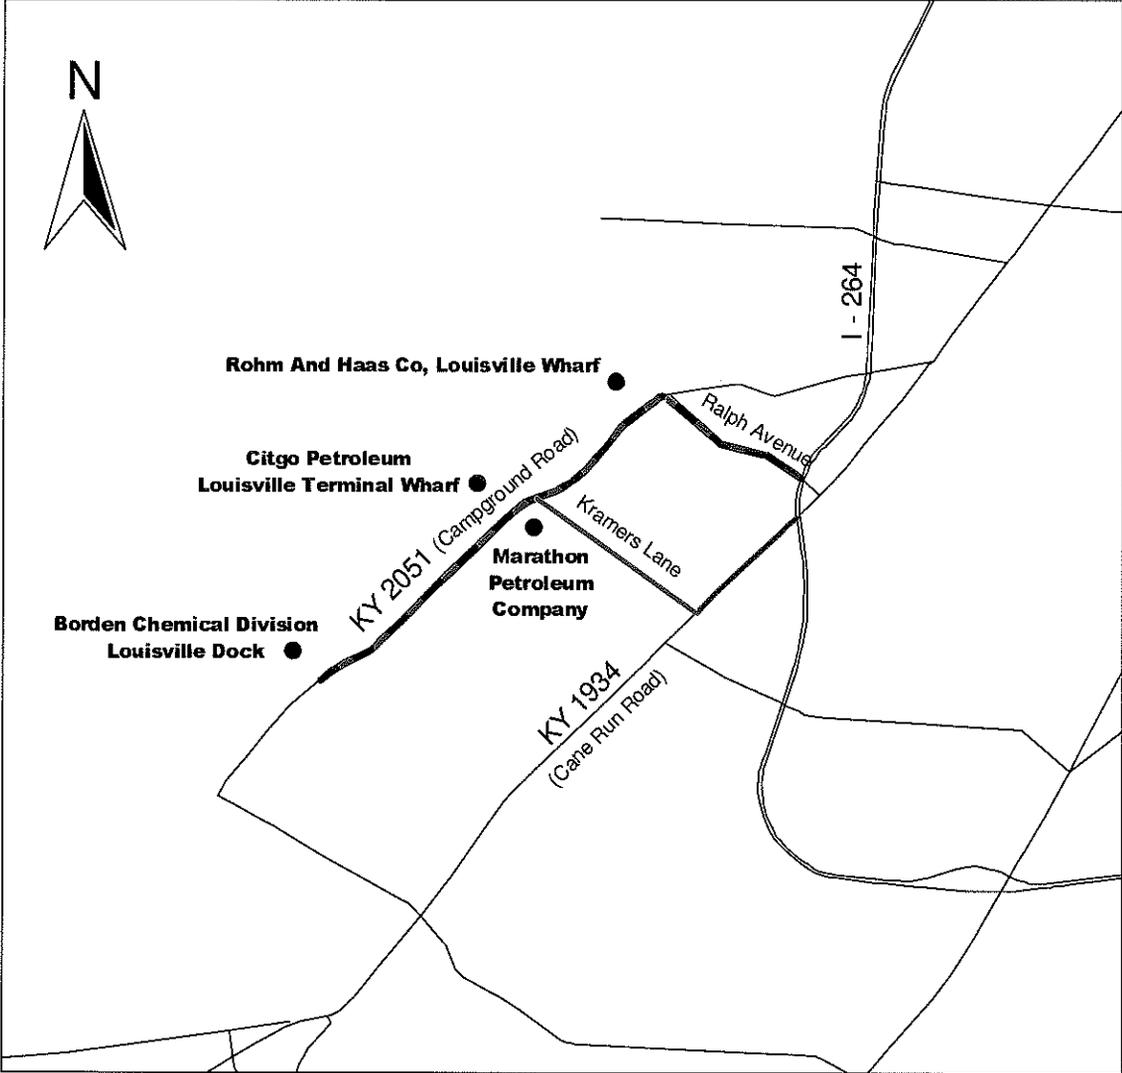
**Figure 4: Lane Widths**

Figures 4 and 5 illustrate the sections of the route having different widths of lanes and shoulders. Cane Run Road has “preferred” 12 foot lanes with curbs in place of shoulders. Ralph Avenue has “preferred” 13 foot lanes and a curb east of the railroad crossing, with “adequate” 11 foot lanes and no shoulders west of the crossing. Kramers Lane has “less than adequate” 10 foot lanes and no shoulders. Campground Road has “adequate” 11 foot lanes and “less than adequate” shoulders that vary from 2 to 8 feet in width.

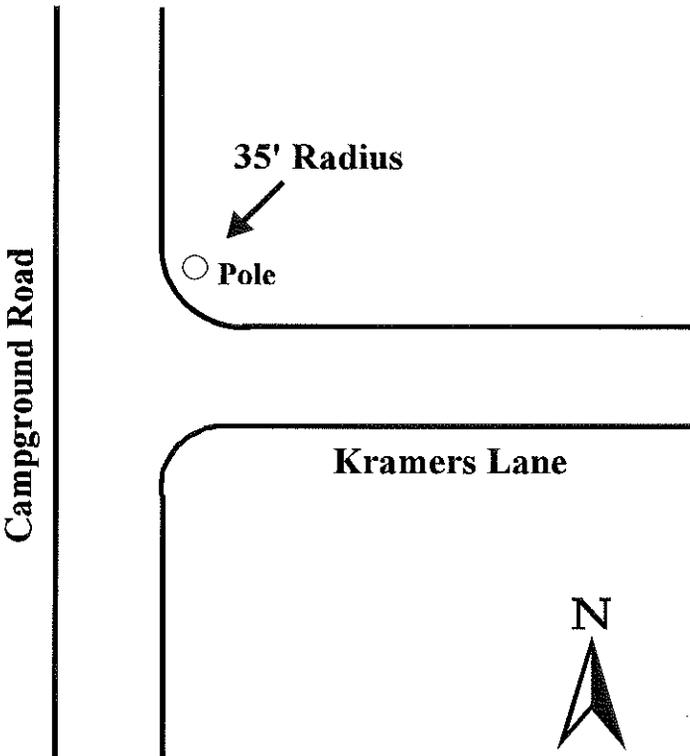
The turning radius from Kramers Lane onto Campground Road was approximated in the field. The layout of this location is shown in Figure 6. The turn (35 foot radius) was rated “less than adequate” because trucks must turn into the opposing traffic lane. A pole adjacent to the intersection (shown in Figure 7) has been repeatedly hit by trucks attempting to make the turn. The turning radius from Cane Run Road onto Kramers Lane was also “less than adequate” due to trucks turning into opposing lanes. The curb was broken as a result of being hit by trucks.

**Figure 6: Approximate Turning Radius at Kramers Lane and Campground Road**

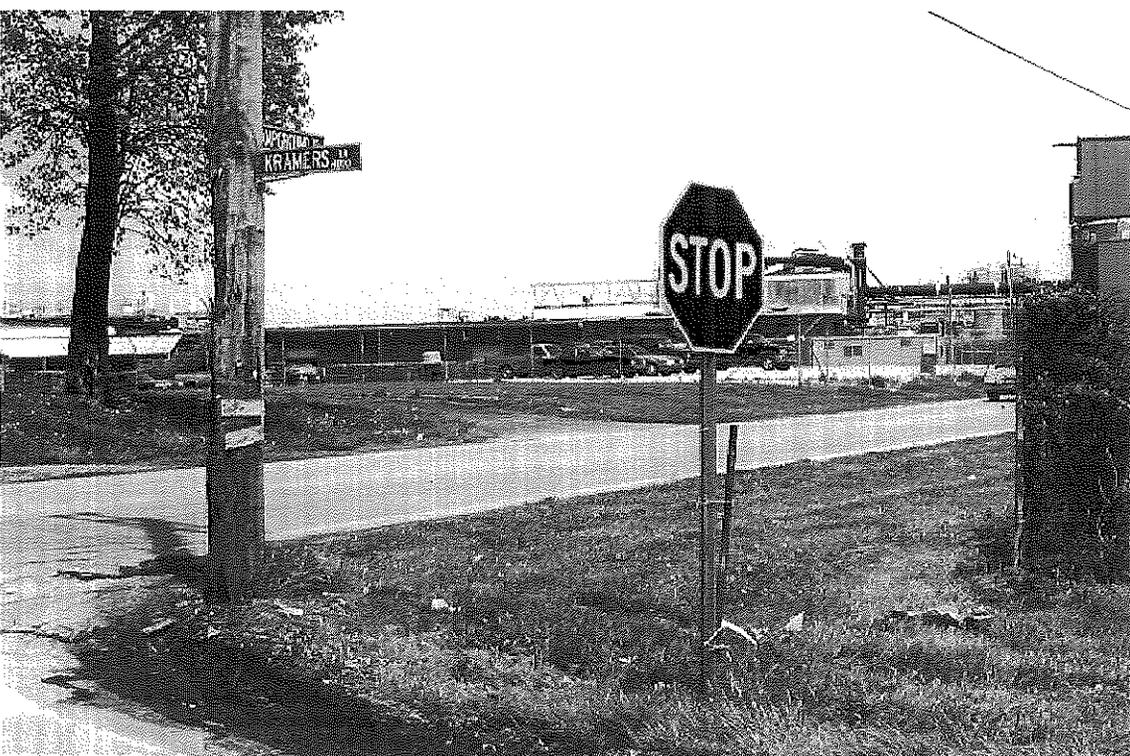
**Figure 7: Pole at Intersection of Kramers Lane and Campground Road**

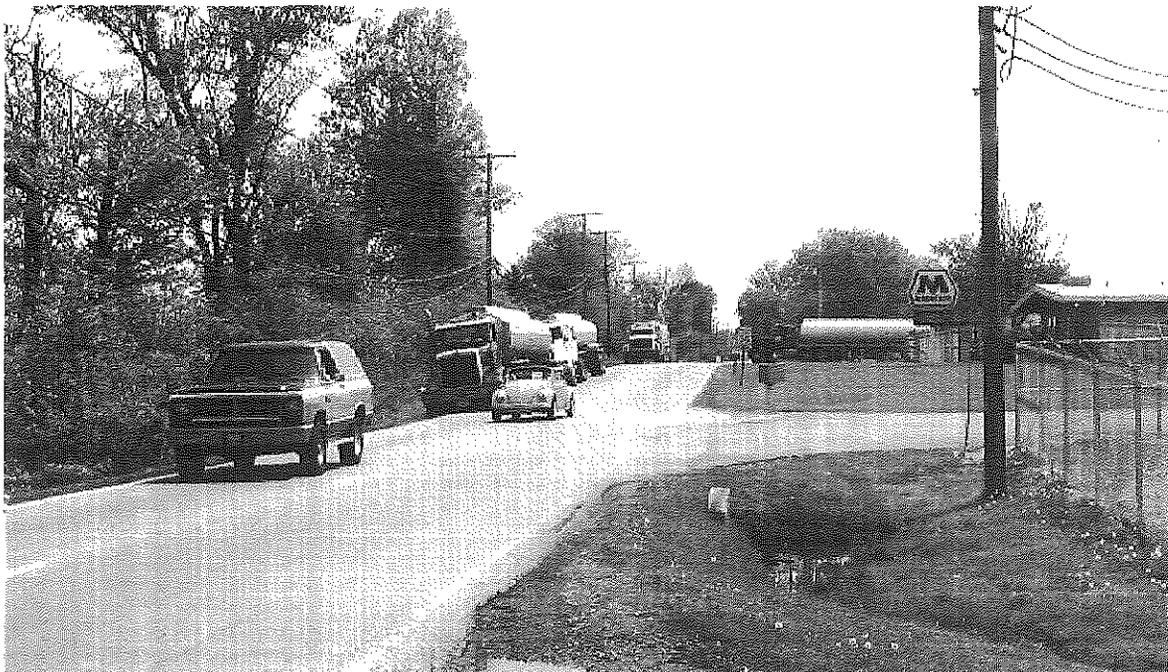
The entrance of the Marathon facility (see Figure 1) occasionally becomes congested forcing trucks to wait on the side of the road. As shown in Figure 8, this partially blocks the eastbound lane of Kramers Lane.

**Figure 8: Trucks Waiting to Enter the Marathon Facility**
