TRUCK ROUTE ACCESS EVALUATION

Paradise Power Plant
Muhlenberg County
Site # 1113

Report No. KTC-98-25

“Freight Movement and Intermodal Access in Kentucky”
Project No. SPR 98-189

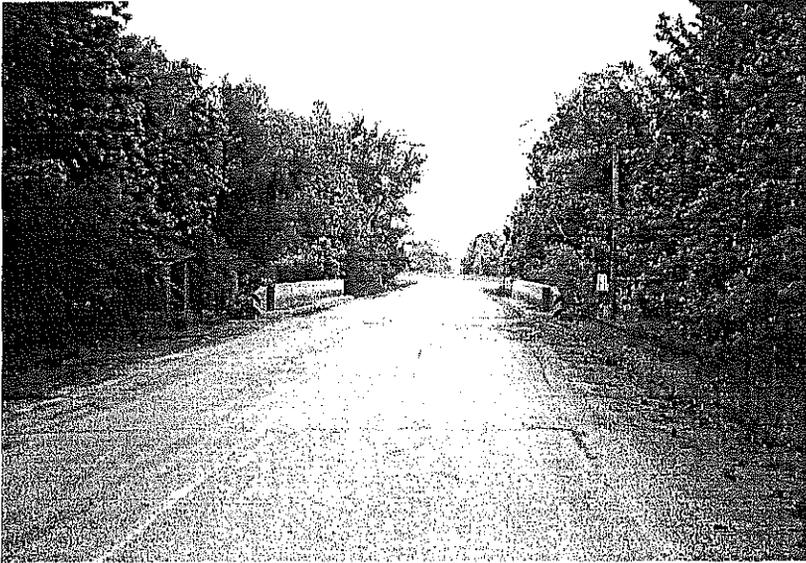
Figure 2: KY 176

There is currently only one primary route for trucks to reach the National Highway System. The Paradise Power Plant is located at the west end of KY 176 on the Green River. The trucks travel from an access road to the power plant west on KY 176 (about 3 miles) to US 431 and then travel north to the Western Kentucky Parkway (about 6 miles) which is a total distance of about 9 miles (as shown in Figure 1). There is a distance of about 2 miles from the access road to the end of KY 176 at the power plant. Both KY 176 (Figure 2) and US 431 (Figure 3) are two lane roadways through a rural area except where they intersect in Drakesboro.

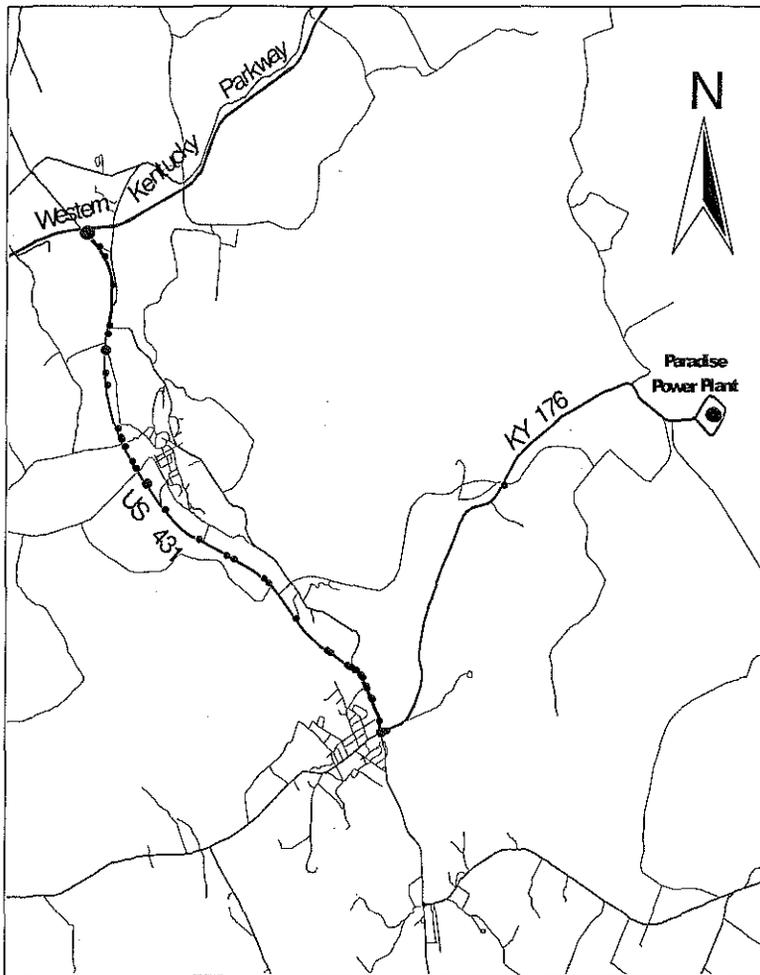
Figure 4: Accident Locations (1994-1996)

Figure 4 shows the locations of all accidents during the years 1994, 1995 and 1996. The two sections with a critical accident rate are identified. A summary of the accidents along the entire truck route (for all roads not just state-maintained roads) is shown in Table 2 for the same three year period. Truck accidents represent a significant portion of the overall accidents along this route. The 18.7 percent of accidents involving trucks compares to 9.0 percent trucks along US 431. Of the 14 accidents, nine involved a rear end collision while two were a same direction sideswipe and two were an opposite direction sideswipe. The fatal accident was an opposite direction sideswipe.

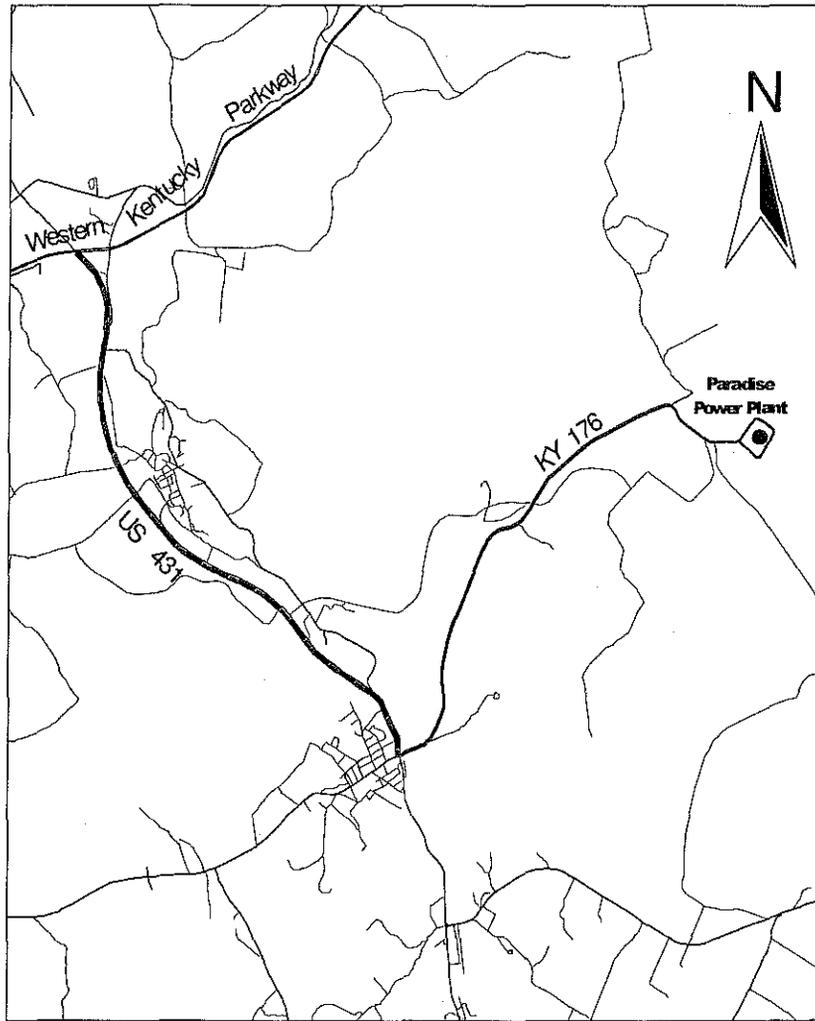
Figure 5: Lane Widths

Figures 5 and 6 illustrate the sections of the route having different widths of lanes and shoulders. While the 12-foot lanes on US 431 are considered “preferred” for trucks, the 11-foot lanes on KY 176 are only rated as “adequate”. A 0.4-mile section of US 431 at the Western Kentucky Parkway has a 10-foot paved shoulder which is considered “preferred”. The 1.5-foot paved shoulders on the remaining portion of US 431 and the 2-foot paved shoulder on KY 176 are considered “less than adequate”.

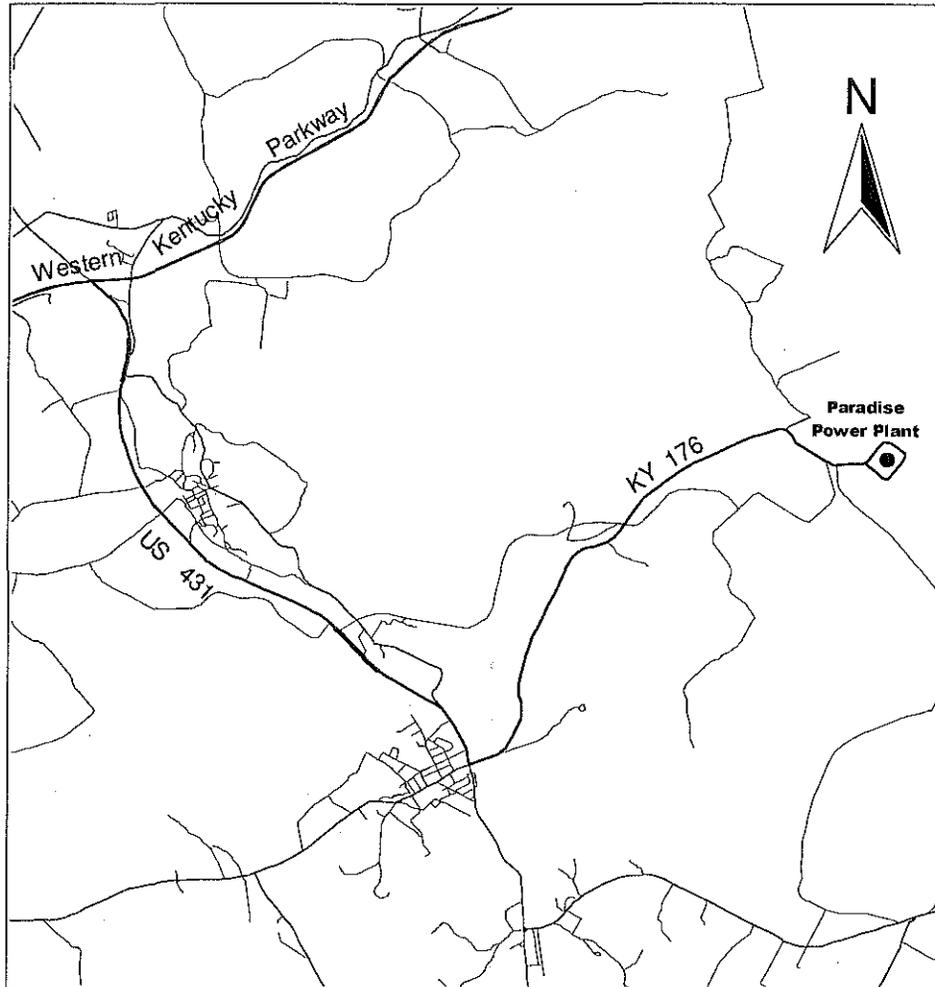
Figure 7: Grade Adequacies

Grades are considered problematic if they cause trucks to slow excessively. Observations showed there were two grades on US 431 which caused trucks to slow (Figure 7). One section between milepoints 16.5 and 16.9 could cause a speed reduction of 6 to 10 mph (“adequate” rating) while the other grade around milepoint 13 would cause a reduction of less than 5 mph (“preferred”). There were no problem grades on KY 176 between US 431 and the plant haul road.

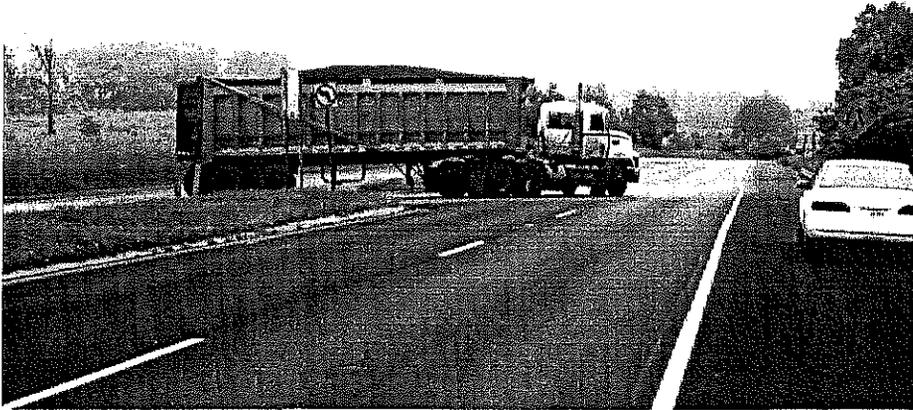
Figure 8: Left turn from Western Kentucky Parkway to US 431

The turning radius from the Western Kentucky Parkway to US 431 was determined as well as the radius at the intersection of US 431 and KY 176. At the parkway, the turn is made onto a four-lane section with trucks turning typically into the right southbound lane (Figure 8). The left turn from southbound on US 431 to eastbound on KY 176 has a radius of about 75 feet and can be made without crossing into the opposing lane although a few trucks were observed crossing into the opposing lane. The radius has been widened for the right turn from KY 176 westbound to US 431 northbound to allow this turn to be made without crossing into the opposing lane.

Trucks were observed exiting and entering the Western Kentucky Parkway from US 431. Numerous brakelight conflicts were noted for vehicles southbound on US 431 from trucks turning left from the exit ramp to proceed southbound on US 431.

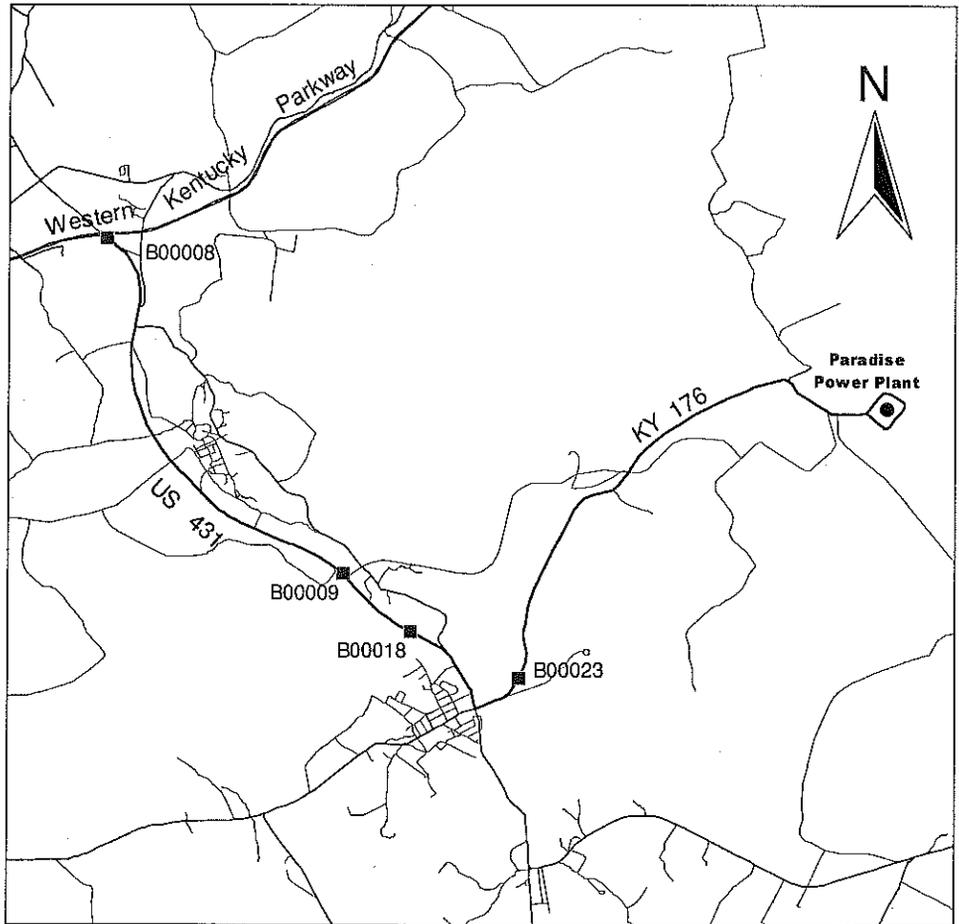
Figure 9: Bridge locations

The locations of the four bridges are shown on Figure 9. The bridge on US 431 near milepoint 17.5, at the Western Kentucky Parkway, has a sufficiency rating (provided by the Division of Operations of the KYTC) of 73.5 (out of a possible 100) which is considered as “adequate”. The bridge on US 431 at milepoint 13.3 has a sufficiency rating of 88.6 which is considered “preferred” while the bridge at milepoint 12.4 has a rating of 64.5 which is considered “adequate”. The bridge on KY 176 at milepoint 8.5 has a sufficiency rating of 89 which is “preferred”.

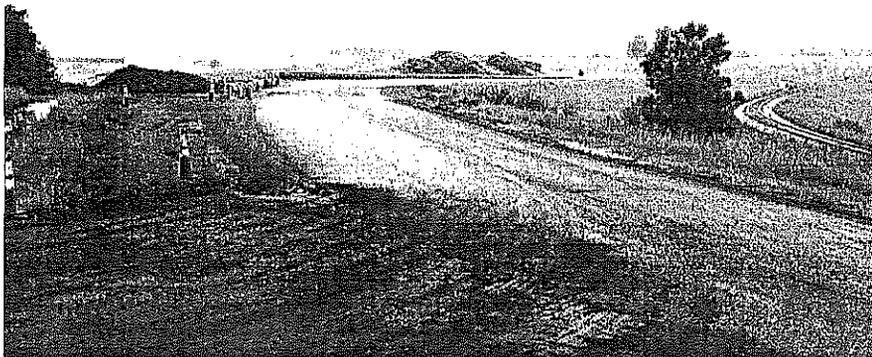
Figure 10: Mud Tracked from Haul Road to KY 176

Site visits were made after a rain had occurred. Tracking of mud from the haul road onto KY 176 was noted.

This type of improvement could be addressed during routine maintenance programs by either the state of county and therefore could improve truck access without requiring major construction or expense. A potential maintenance problem was observed on KY 176 at the haul road. The haul road is not paved and debris is tracked on the road. An observation after a heavy rain found a substantial amount of mud tracked onto KY 176 from the haul road (Figure 10).
