Research Report  
KTC-88-2

**CALCIUM NITRITE AS A CORROSION INHIBITOR  
IN REINFORCED CONCRETE BRIDGE DECKS**

Kentucky Transportation Center  
College of Engineering  
University of Kentucky  
Lexington, Kentucky

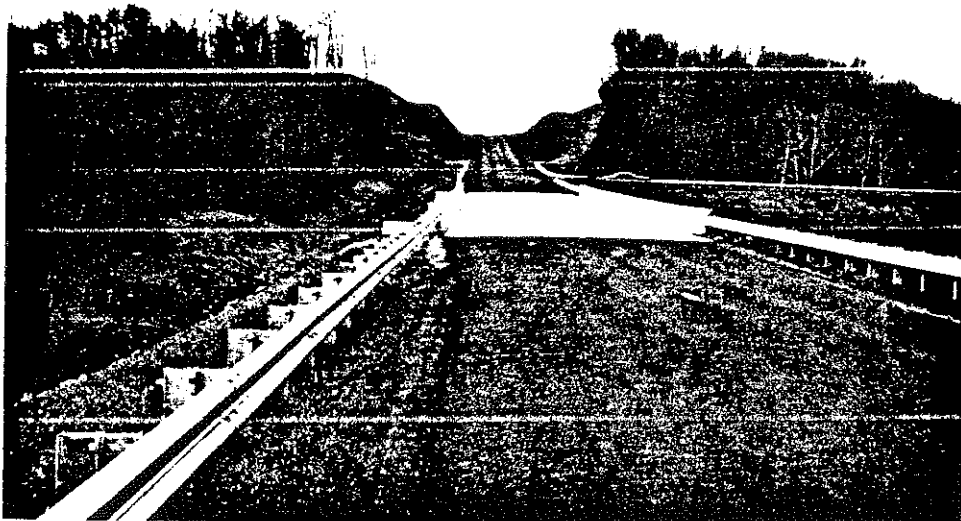
Figure 2. KY 152 Bridge (December 1986).

KTRP personnel inspected the bridge decks in December 1986 (5). The surface finish of both decks was not good. Pull cracks were detected along the north edge of the KY 152 bridge deck (Figure 2). That deck was observed to have irregular tyning varying from almost flush to approximately 1/4-inch deep. In areas where tyning was deep, aggregates were pulled from the concrete giving the deck a "pock-marked" appearance. Several small areas where plastic shrinkage cracking occurred had been sealed with epoxy.

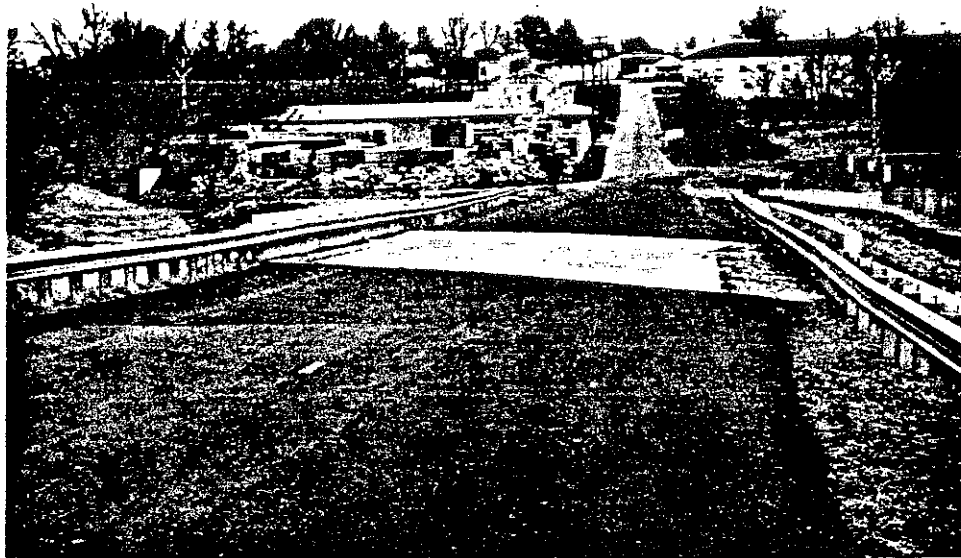
Figure 3. The Gose Road Bridge (December 1986).

The Gose Road deck also exhibited an irregular surface (Figures 3 and 4). Uneven tyning was noticeable, especially on the lower end of the bridge where the tyning depth was shallow. That portion of the deck surface apparently had been finished and tyned after the concrete had stiffened. Deep tyning had pulled loose or exposed aggregate at many points on the deck; however, pull cracking was not detected. Some surface voids were present where the concrete had not been completely consolidated during placement.

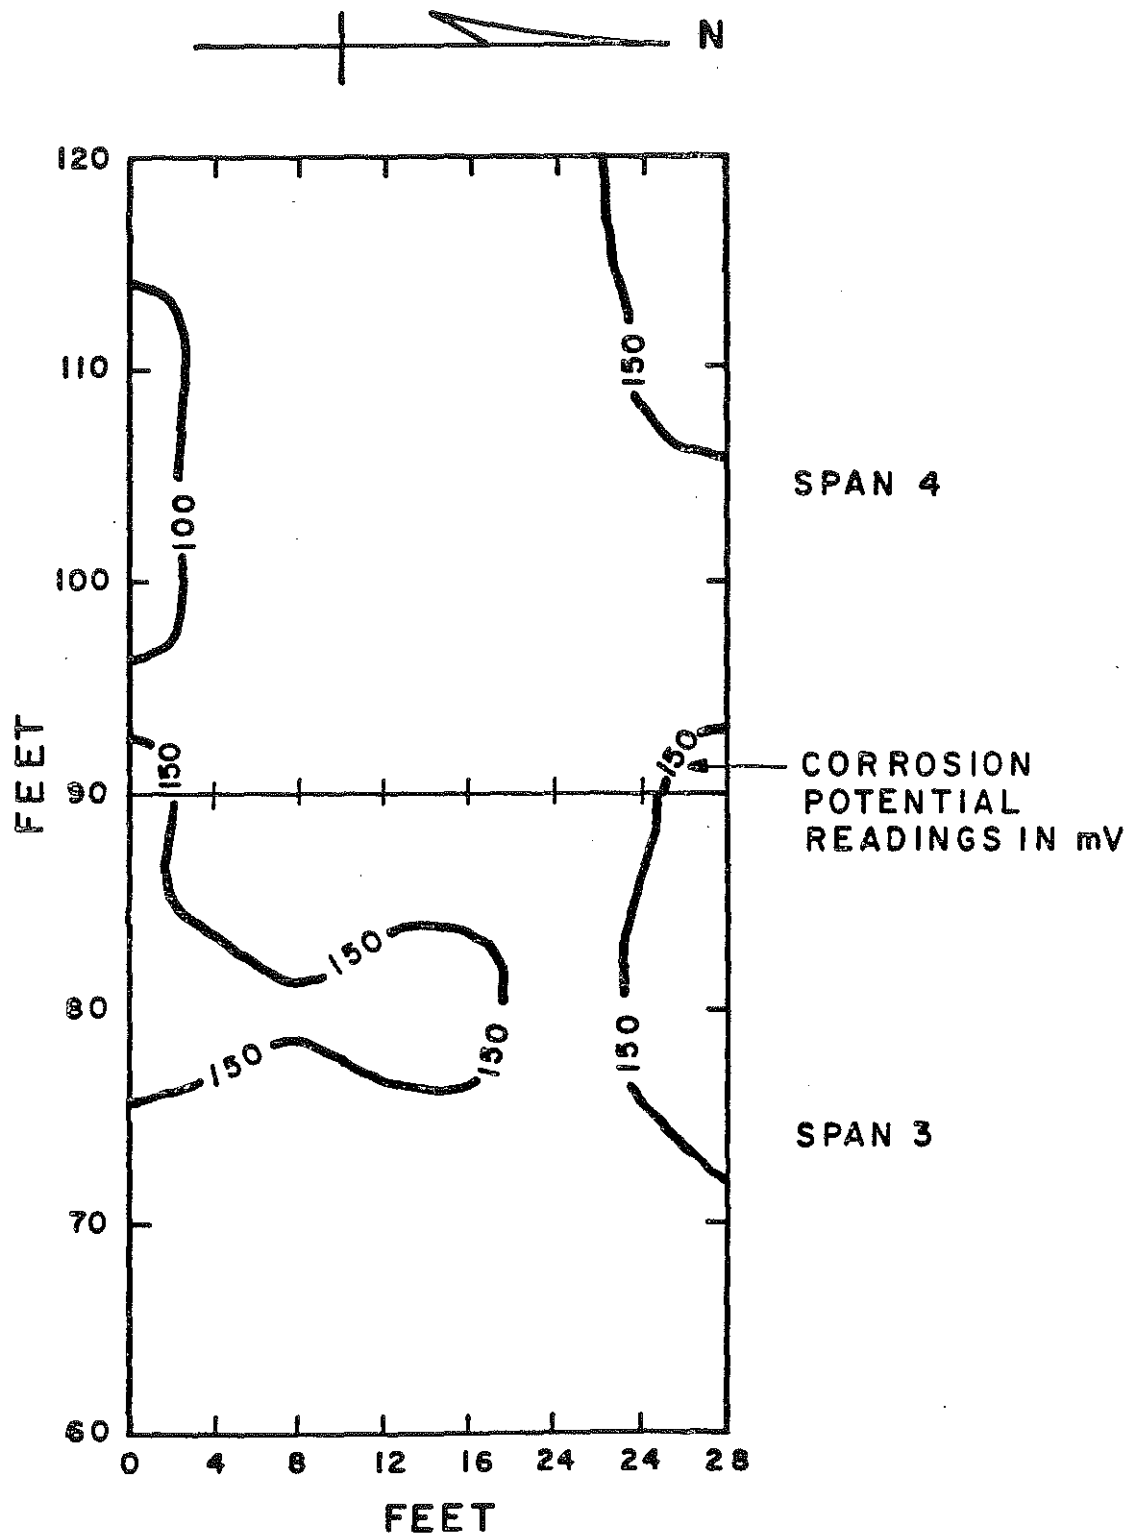
Figure 5b. Corrosion Potential Test of the KY 152 Bridge - Spans 3 and 4 (March 1987).

In December 1986, KTRP personnel performed half-cell (saturated copper-sulfate) corrosion-potential tests on the two decks. For each test, the probe lead wire was grounded to a gutter. Test results are shown on Figures 5 and 6. Active corrosion was not detected (i.e., corrosion potentials measured were less than 337 mV). However, some corrosion potentials were measured in the 300-mV range. Those high readings are typical of new bridges and are expected to decrease with time. A low oxygen concentration may occur in concrete containing calcium nitrite which may cause such high readings. It is too early in the service lives of the bridges to expect any significant corrosion (whether the calcium nitrite is beneficial or not).

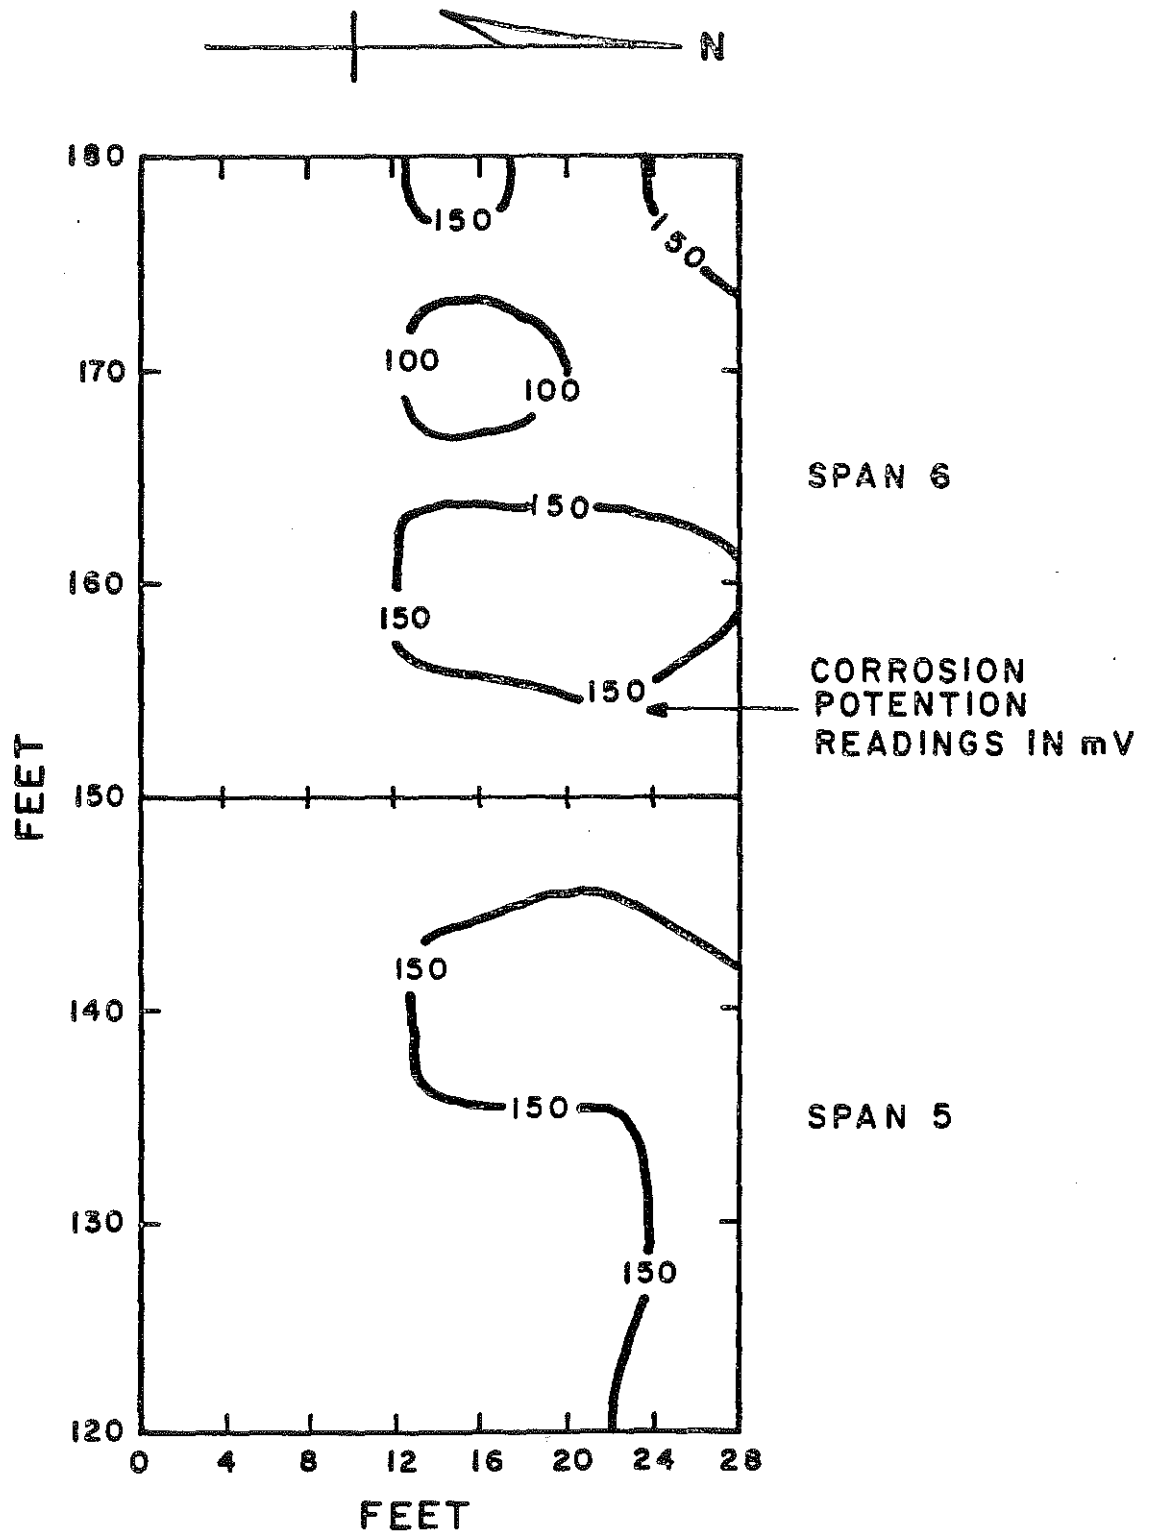
Figure 5c. Corrosion Potential Test of the KY 152 Bridge - Spans 5 and 6 (March 1987).

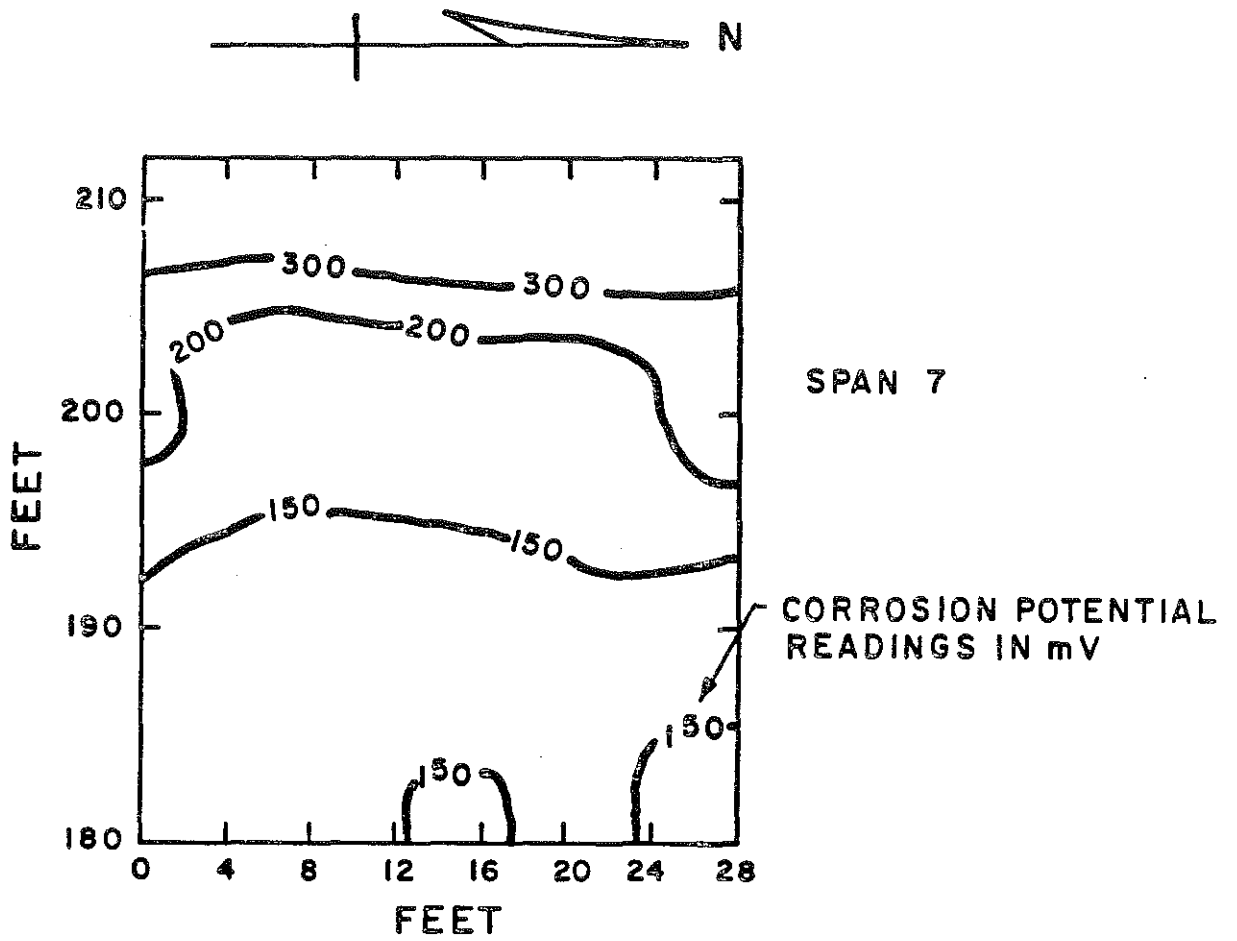
Figure 5d. Corrosion Potential Test of the KY 152 Bridge - Span 7 (March 1987).

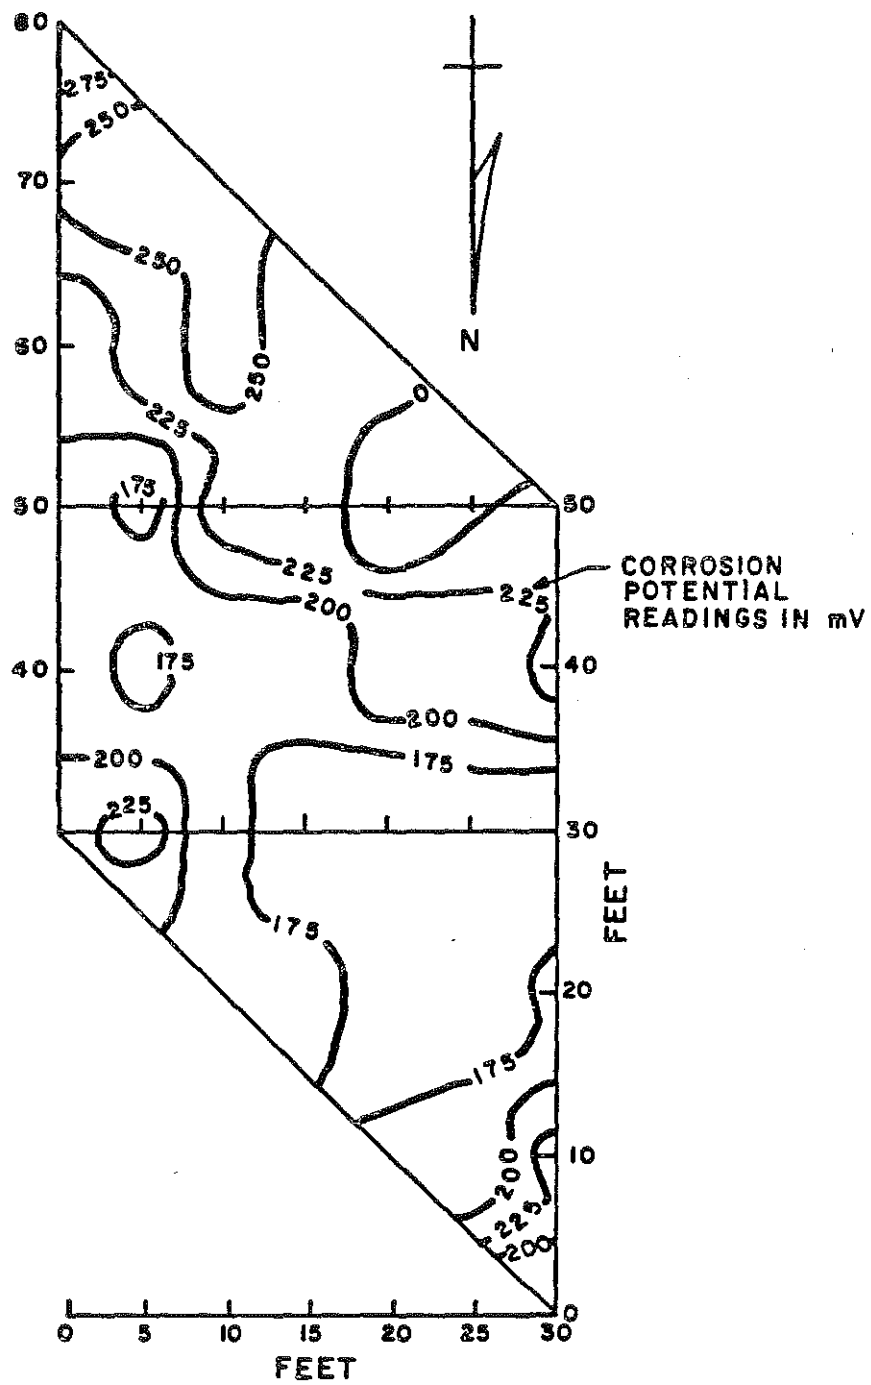
Figure 6. Corrosion Potential Test of the Gose Road Bridge (March 1987).

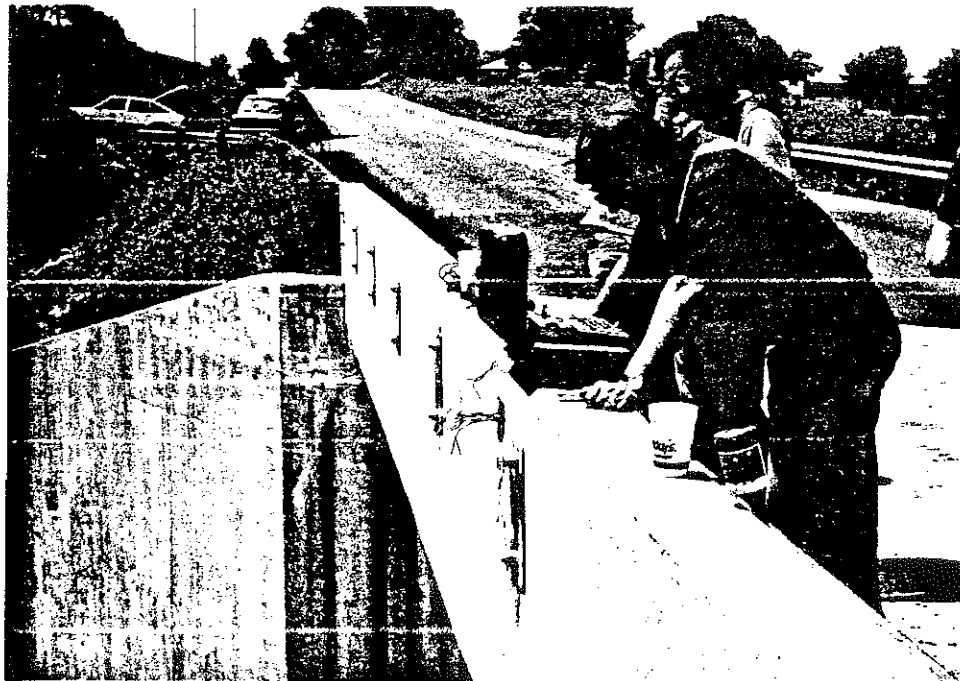
Figure 8. Polarization Resistance Measurements Being Taken of the Reference Electrodes Buried in the Deck of the Gose Road Bridge (July 24, 1987).

Polarization-resistance measurements were made with a computer-controlled potentiostat, the AUTOSTAT, made by Thompson Electrochem LTD (Figure 8). Reference voltages were first measured between each of the buried 316 stainless-steel reference electrodes and the reinforcing steel. The AUTOSTAT then slowly varied the direct-current potential between the reinforcing steel and a reference electrode at a rate of 2 mV per minute from -20 to +20 mV. The computer measured both the instantaneous voltage and current. The polarization resistance,  $R_p$ , was measured as the slope of the instantaneous voltage versus the instantaneous current curve at  $I_p=0$ . That process was repeated for each reference electrode. Half-cell potential measurements were taken with both copper-sulfate and calomel half-cell electrodes (the calomel cell produced lower corrosion-potential values). The test results are shown in Table 3.
