RESEARCH REPORT
UKTRP-87-7

ACOUSTIC EMISSION MONITORING OF
BASCULE BRIDGE COMPONENTS

March 1987

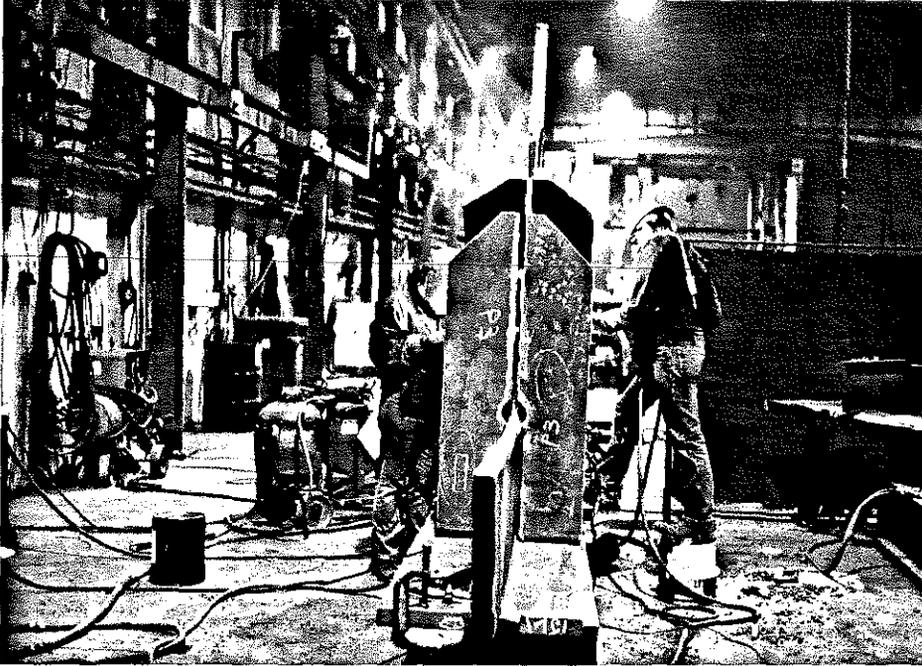
Figure 4. Depositing Full-Penetration Stiffener-to-Flange Welds Using Manual SAW (Welder on Right).

the webs. Flange-to-web full-penetration welds consisted of three straight welds deposited using automatic submerged-arc welding (SAW) and two corner welds deposited by manual SAW (Figures 2 and 3). Stiffener-to-web welds were made using manual shielded metal-arc welding (SMAW). Stiffener-to-flange welds were made using both manual SAW and SMAW (Figures 4 and 5).

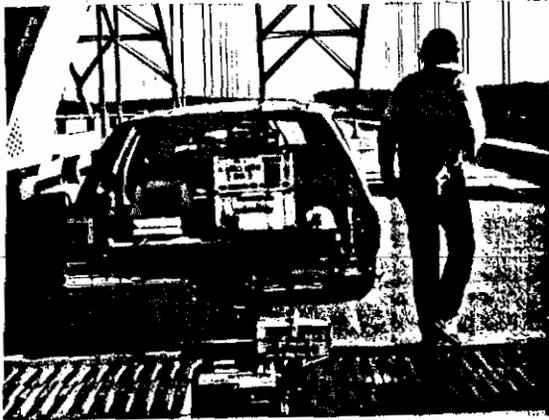
Figure 2. AEWM in Rear of Station Wagon, I-24 Bridge over the Tennessee River.

GARD and Kentucky Transportation Research Program personnel first tested the AE System on the I-24 bridge over the Tennessee River near Paducah, Kentucky, in December 1982 (Figure 2) (3). The bridge possessed out-of-plane bending cracks in the deck beams. Of five sites monitored, only one produced AE flaw indications. At that test site, several 2-3 inch-long cracks were present in the web between the deck beam upper flange and a bolted angle splice plate which connected the deck beam to tie-chords.

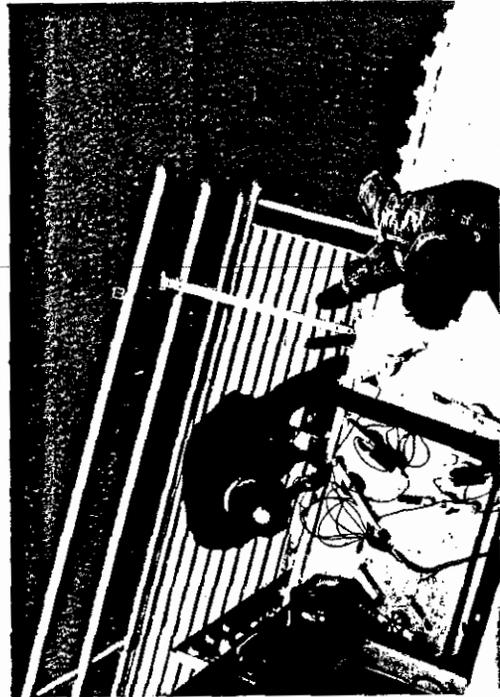
Figure 4. Setting Up Transducer Array on a Tie-Chord Upper Flange on the I-24 Ohio River Bridge.

Also, in November 1984, GARD and Kentucky Transportation Research Program personnel performed an inspection on the I-24 bridge over the Ohio River. The tests were performed to confirm expected growth of ultrasonically detected subsurface defects in the butt welds on a tie-girder which had been reinforced with splice plates (Figure 4). The AEWM detected AE flaw-related activity at one location coinciding with an ultrasonic flaw indication. The tie chords produced relatively low AE rates of 50-100 events per hour. Additionally, a six-inch long out-of-plane bending crack in a deck beam was monitored. The crack, which had jumped two check holes, was very active and produced AE flaw indications every 15 minutes. That was
