Research Report
UKTRP-87-20

EVALUATION OF EPOXY THERMOPLASTIC
PAVEMENT MARKING MATERIAL

August 1987

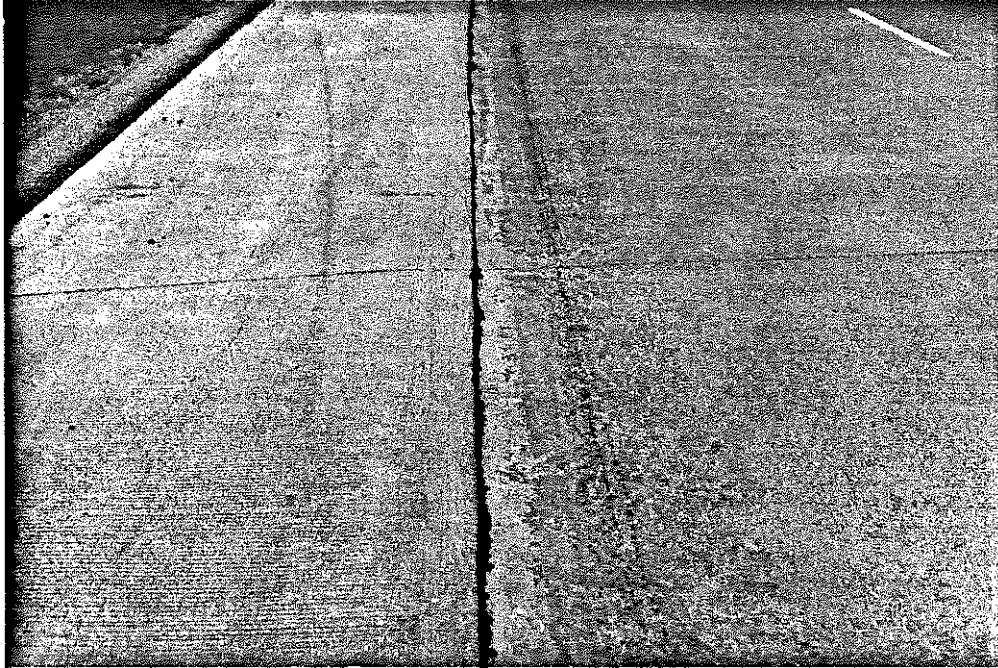
Figure 4. ETP Durability Problem.

Durability ratings are presented in Table 2. As described in Figure 3, durability rating corresponds to the percentage of material intact, with a rating of 10 representing 100 percent intact and a rating of 0 representing all the material missing. The ratings show that the regular traffic paint had no durability problem. However, the ETP started to show signs of a durability problem after 3 months, with a significant problem existing after 12 months.

The durability problem with the ETP material, as illustrated in Figure 4, appeared to be related to a loss of bond between the material and the pavement. The durability problem was not consistent. There would be sections of surface with almost 100 percent of the material missing followed by a section having no problem. The durability problem resulted in the decision to restripe the ETP with regular traffic paint after 18 months in service, before the planned 24-month evaluation period was completed.

The field performance of the ETP revealed the material does not have the necessary durability to provide reliable lane delineation. Approximate costs figures also indicate that ETP would be considerably more expensive than alkyd traffic paint. No future use of epoxy thermoplastic (ETP) is recommended.
