Report No. 1  
on  
AN EXPERIMENT WITH EXPANDED-METAL INTEGRATING MATS  
IN  
BITUMINOUS CONCRETE PAVEMENT

Highway Materials Research Laboratory  
Lexington

September 30, 1947.

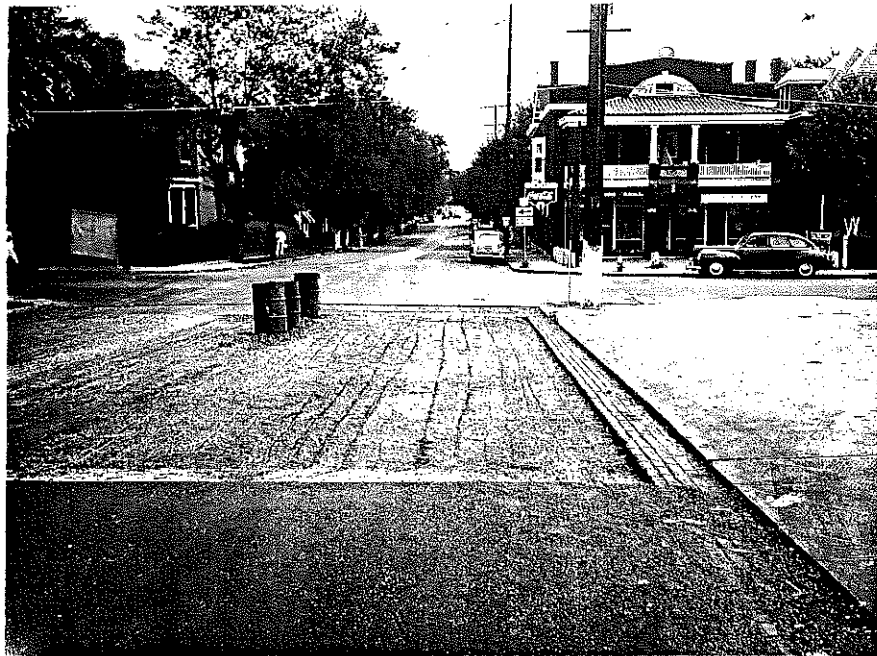
Fig. 1. Looking north on Jefferson Street into the intersection with Third Street. Here the old sheet asphalt pavement has been removed down to the original brick in preparation for the new pavement and the metal mats.

The location selected was a down-hill approach (about 4 per cent grade) to a traffic light on Jefferson Street at the intersection with Third Street in Lexington. (See Fig. 1) Through traffic on U.S. 25, as well as heavy urban traffic, is involved in the experiment since U.S. 25 traffic is carried on Jefferson Street as far as this intersection then west on Third.

The Class I mix, described in Table III, was laid in two courses over the original brick base which in many places on Third Street had been patched by concrete (apparently over sewer openings) that usually protruded above the brick. However, as shown in Fig. 1 nothing of that type existed in the location where mats were placed on Jefferson Street. Design for the new pavement

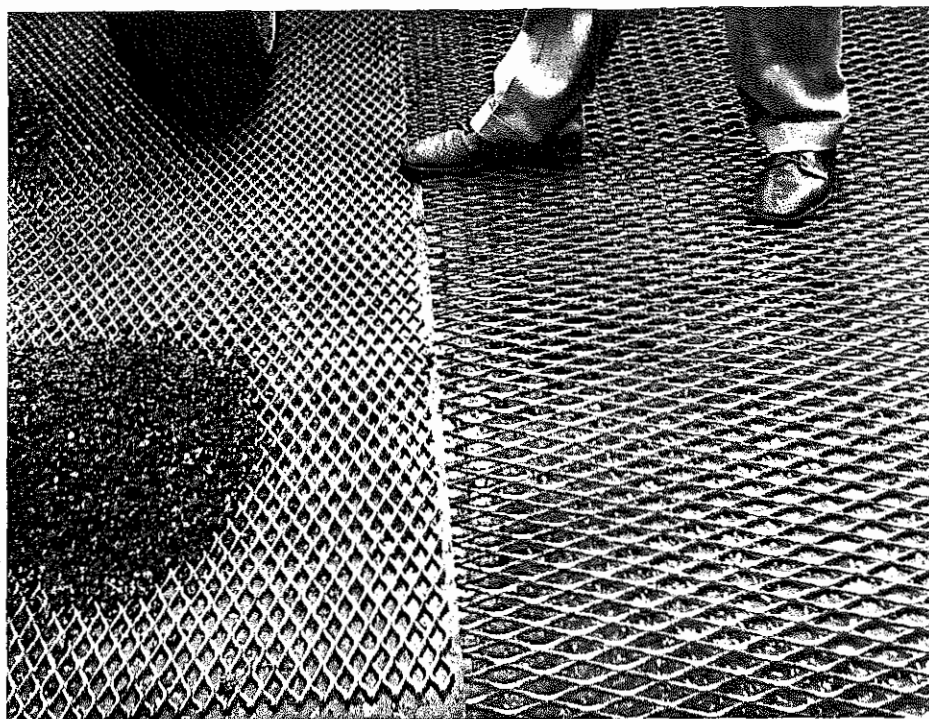
Fig. 3. Near view of abutting mats showing the 6 x 8 foot size on the right with mesh running transversely, and the 4 x 8 foot size on the left with mesh running longitudinally. Some of the smaller sheets were placed with the mesh running transversely (see Fig. 2). This view is toward the paver and away from the intersection.

Eight separate mats of two different designs were used in forming an area essentially 26 feet in length and 12 feet in width, the longer dimension being in the direction of traffic. Both were 9 gauge metal, but the larger sheets (referred to as Type 2 mats in Fig. 2) 8 x 6 feet in size weighed 1.19 pounds per square foot and had diamond mesh  $1\frac{3}{8}$  x 3 inches, whereas the smaller 8 x 4 foot sheets weighed 1.8 pounds per square foot and had diamond mesh  $\frac{7}{8}$  x 2 inches. In addition, all the larger sheets were placed so that the mesh ran in the transverse direction, but the greater part of the small sheets had mesh running in the longitudinal direction. As shown in the layout of Fig. 2, combined large and small mats formed an inner row with mesh running transversely, and three sheets of the small mats formed an outer row with mesh running longitudinally. Arrangement of mesh in abutting sheets of the two rows is illustrated in Fig. 3.

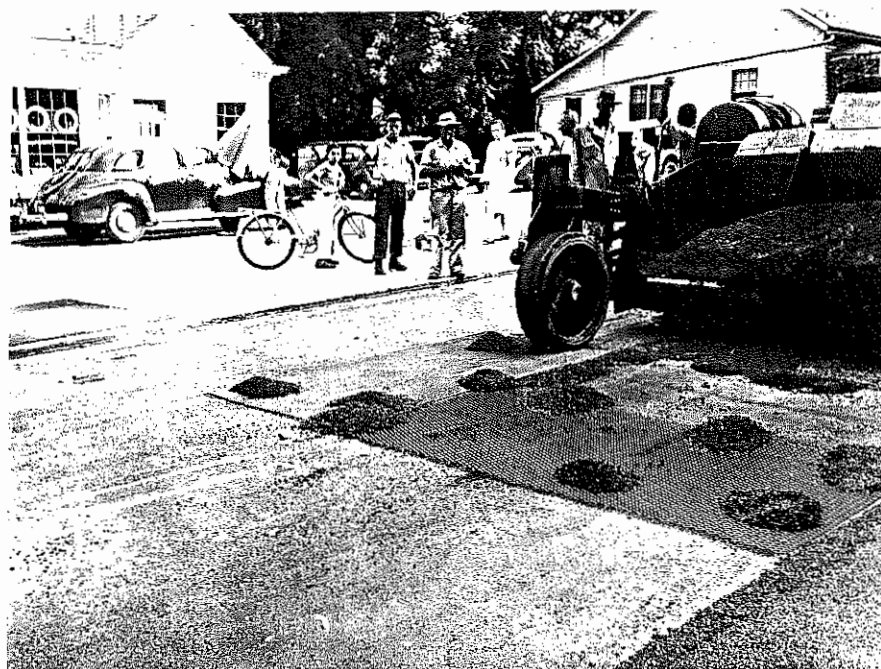
Fig. 4. Mats were placed in position and weighted down with some of the mix in order to prevent curling and consequent interference with the paver. The three mats shown were of the first group, and all were 4 x 8 feet in size.

In the construction where the mats were placed, the designated location beginning 15 feet from the edge of the cement concrete in the intersection and extending 26 feet southward was marked off. The initial set of mats for the entire 12 foot width was placed and loaded down with some of the mix at certain points, (See Fig. 4) then the paver was moved up onto the mats from which point it proceeded as usual. Thereafter, additional mats were placed as needed just prior to the time that the wheels of the paver passed off those mats that were in place. No longitudinal movement of the mats under the paver was noticed. As paving progressed, mix was placed by hand methods on those portions of the mats which extended beyond the width of the paver. A measurement

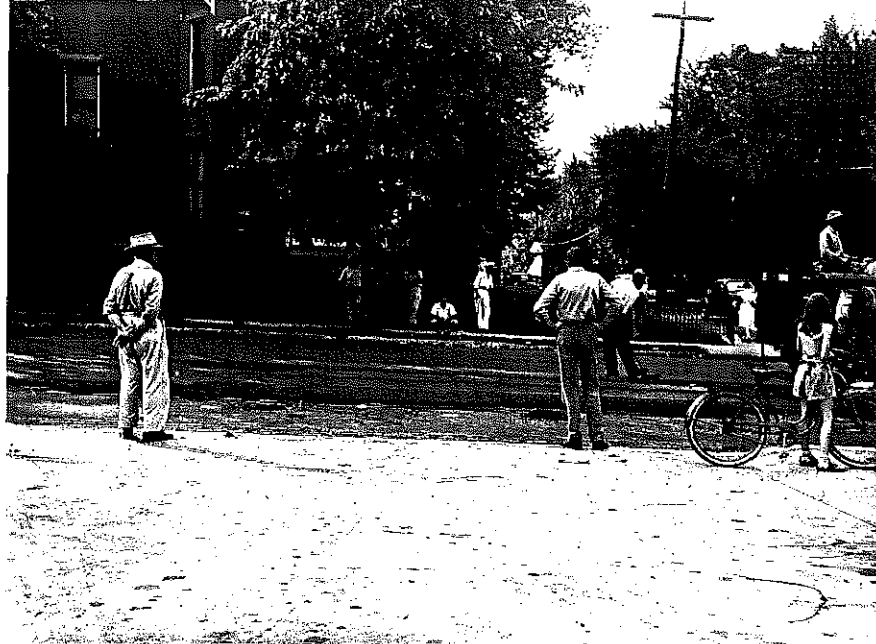
Fig. 5. The extent of the mats longitudinally is illustrated by this view, in which the 26 foot length extends from the rear wheel of the bicycle almost to the left edge of the picture.

made after the pavement had initial rolling showed that the depth of overlying surface material was 2 inches. The longitudinal extent of the mats is shown in Fig. 5 by the portion of paving material extending toward the observer.

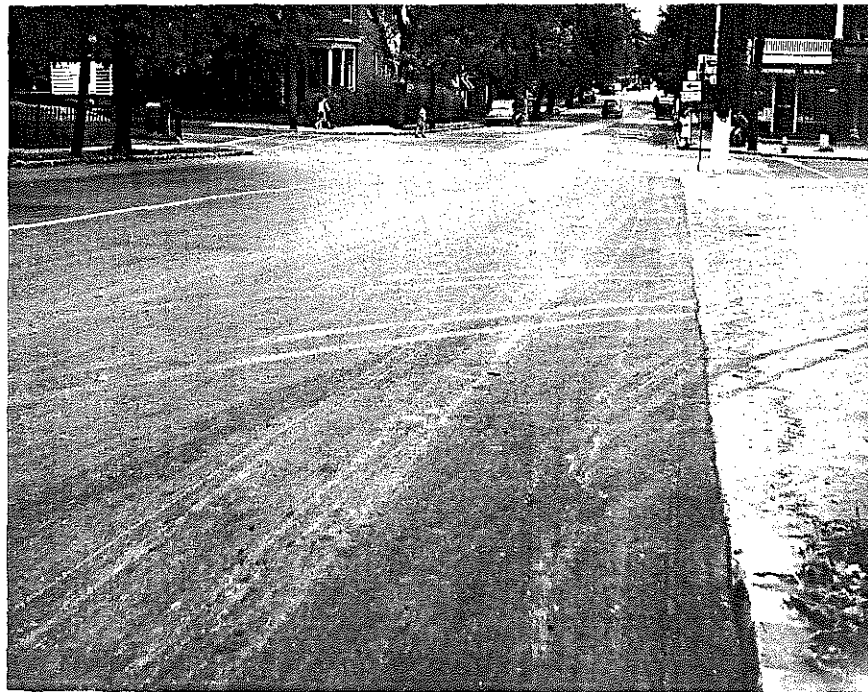
Fig. 6. Appearance of the finished pavement after about a month of use. This photograph was taken from approximately the same location as that in Fig. 1.
