1. Report No.		2. Government Accession No.		3. Recipient's Catalog No.	
4. Title and Subtitle Concrete Barrier Geometrics (US-41 Bridge in Henderson, Kentucky)				5. Report Date October 1983

Research Report
UKTRP-83-26

CONCRETE BARRIER GEOMETRICS
(US-41 BRIDGE IN HENDERSON, KENTUCKY)

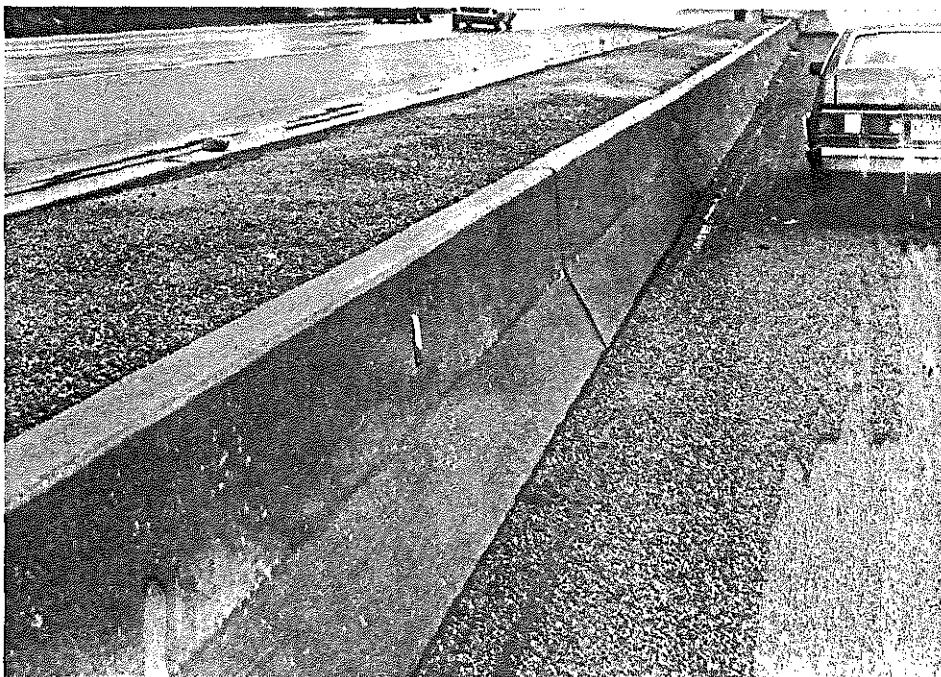
Figure 7. Photographs of Concrete Barriers on I 64 - I 75 in Fayette County.

-MP 116

MP 117

Photographs were also taken at other locations included in the accident analysis. The barrier at the combined section of I64-I75 in Fayette County is shown in Figure 7. There was considerable variance from one point to another along the barrier. In the first photograph at Milepoint 116, the A dimension was 2 1/2 inches and the B dimension was 12 1/2 inches. Measurements were also taken at Milepoint 117, where the A dimension was 1 3/4 inches and the B dimension was 14 inches.
