SURVEY AND VISUAL INSPECTION OF KEYSTONE BLOCK WALL  
AND EMBANKMENT SLIDE AT MIST LAKE PLAZA  
IN LEXINGTON, KENTUCKY

**Research Report KTC-98-6**

**March 1998**

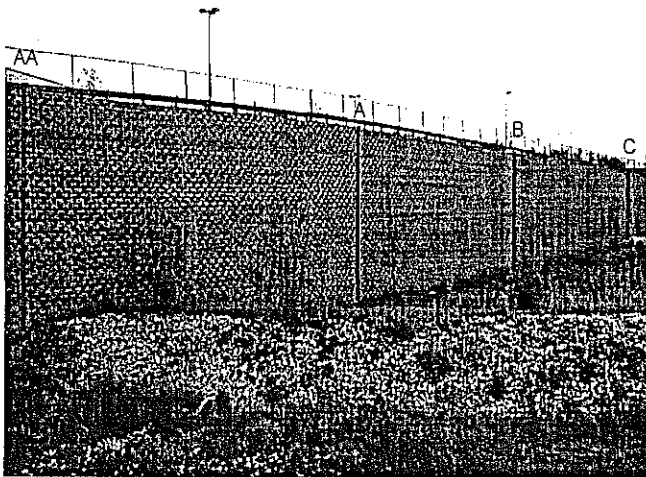
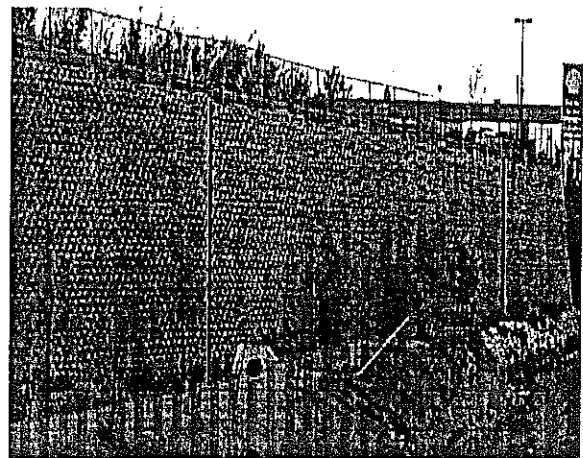
Figure 1

Vertical lines of monitoring points had been installed in five locations. The approximate locations are shown in Figures 1 and 2.
