TRUCK ROUTE ACCESS EVALUATION

Centennial Resources, Inc./B. Four, Inc.

On US 62 in Hopkins County

Report No. KTC-99-11

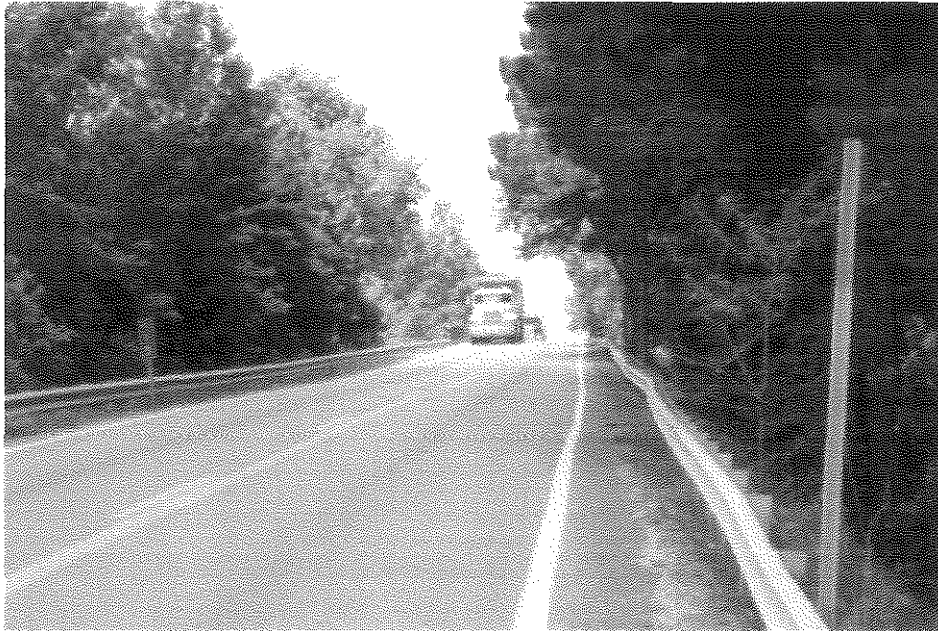
**Figure 9: Bridge at Milepoint 14.9 (B0163)**

Grades are considered problematic if they cause trucks to slow down excessively. There were three grades which could potentially cause a truck to slow (Figure 6). Trucks exiting the facility enter US 62 on a steep upgrade for about 1,000 feet (Figure 7). There is an upgrade for trucks approaching the facility starting at KY 1687 and extending for about 0.3 mile. There is also an upgrade westbound approaching the bridge at milepoint 14.9.

There were five bridges on this route (Figure 8). The bridge at the Pennyriple Parkway (milepoint 15.7) has a sufficiency rating (provided by the Division of Operations of the KYTC) of 81.4 (out of a possible 100 points) which is considered “preferred”. The other major bridge, which is over a railroad and stream (at milepoint 14.9), had a rating of 75.3 which is considered “adequate” (Figure 9). The other ratings were 80.3 (“preferred”) for the bridge at milepoint 12.3, 73.7 (“adequate”) for the bridge at milepoint 12.9, and 76.7 (“adequate”) for the bridge at milepoint 14.0.

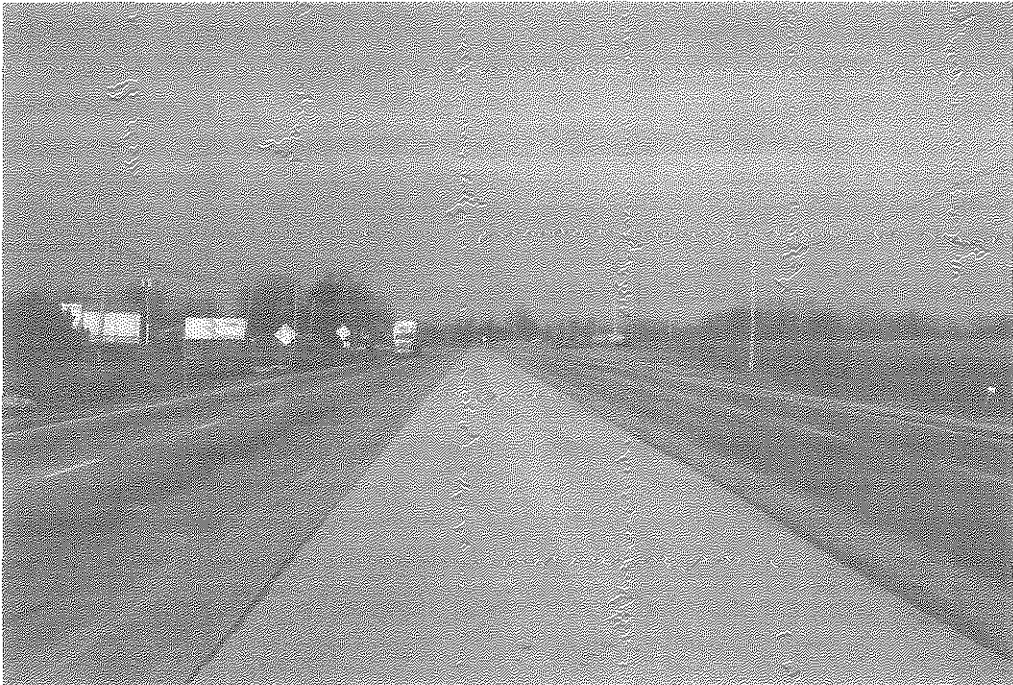
**Figure 2: US 41**

There is currently only one primary route for trucks to reach the National Highway System. The trucks accessing the industrial areas on US 41 are traveling to and from the Pennyrile Parkway, a distance of about 1.7 miles from the main entrance to the industrial park at Bill Bryan Boulevard (Figure 1). The trucks travel north on US 41 to the Pennyrile Parkway. US 41 is a four lane divided (20-foot mountable median) highway with 12-foot lanes and a 10-foot gravel shoulder between the industrial park and the Pennyrile Parkway (Figure 2). US 41 changes to a two lane

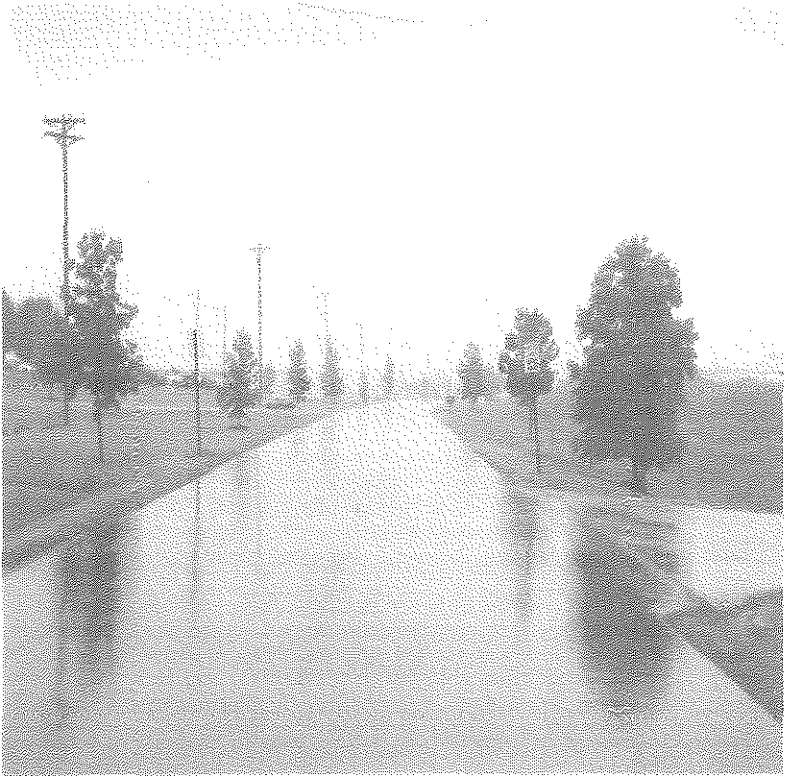
**Figure 3: Bill Bryan Boulevard**

road just south of the industrial park. Trucks in the industrial park travel on a two lane roadway within the park to access US 41. A portion of this road is divided. Bill Bryan Boulevard is about one mile in length with about one third of the road divided (Figure 3). Commerce Drive is about 0.8 mile in length and is a two lane road. The general character of the area is urban. Right of way at the driveways from the industrial park to US 41 is controlled by a stop sign on the driveways. Right of way at the Pennyrile Parkway is controlled by stop signs on the exit ramps.
