**VISUAL INSPECTION OF KEYSTONE BLOCK WALL
AND EMBANKMENT SLIDE AT MIST LAKE PLAZA
IN LEXINGTON, KENTUCKY**

Research Report KTC-97-11

June 5, 1997

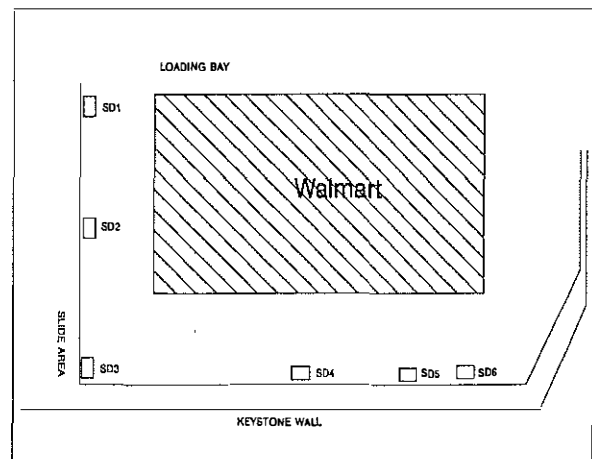
The storm drain system, including the drop box inlets and the storm drain pipes were inspected on May 9, 1997. The pipes were remotely inspected with a robotically controlled pipeline inspection camera. Confined space equipment was used to access and inspect the vertical drop box inlets. A schematic diagram in Figure 8 shows the location of the storm drains and inlets that were inspected.
