THE BUMP AT THE END OF THE BRIDGE

KYHPR-64-17; HPR-1-(4), Part II

Division of Research
DEPARTMENT OF HIGHWAYS
Commonwealth of Kentucky

June 1969

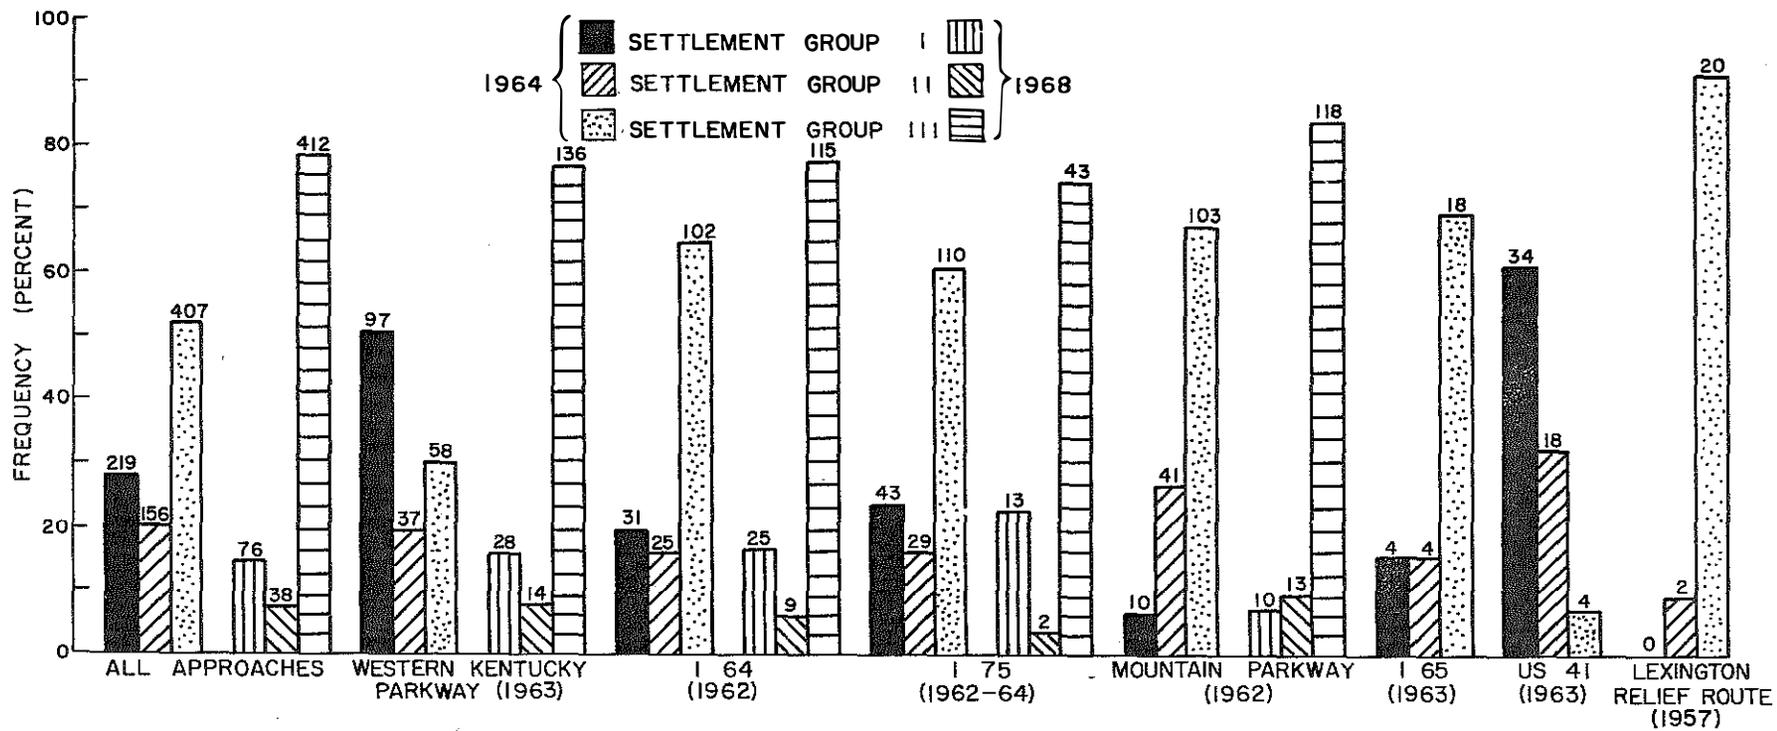
FIGURE 3. COMPARISON OF BRIDGE APPROACHES BY ROUTES

The criterion used to distinguish between Groups I and II was whether or not a 'bump' was evident when an automobile passed onto or off the bridge deck. Additional information was obtained by visually inspecting each approach. Figure 3 summarizes the 1964 and 1968 data, showing the total number and percentages of approaches classified in accordance with each settlement group. In addition, the ages (approximate dates opened to traffic) of the approaches are shown. The majority of approaches were at least two years old in the 1964 survey. From these data, it is evident that present design and construction procedures are not sufficient to obtain smooth bridge approaches.

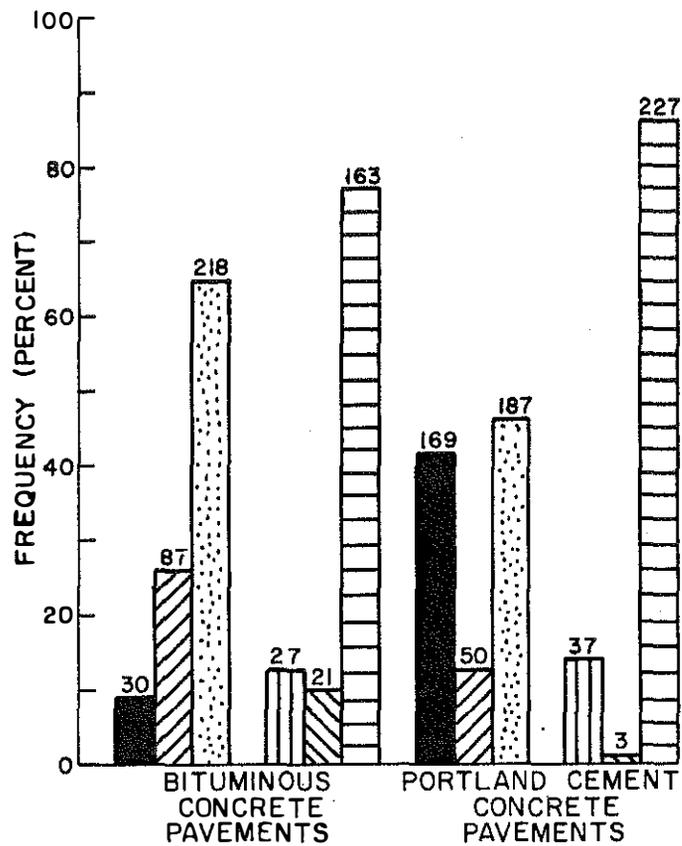
FIGURE 4. COMPARISON OF BRIDGE APPROACHES BY PAVEMENT TYPE

A comparison of portland cement concrete and bituminous concrete approaches, Figure 4, shows a markedly higher percentage of bituminous concrete approaches with patching than rigid approach pavements with mudjacking in 1964. In addition, there was a much greater percent of smooth approaches (Group I) for concrete approaches than for bituminous approaches. However, in 1968, the difference in percentage of mudjacked and patched approaches, as well as smooth approaches, was almost insignificant. Furthermore, the 1968 data, when compared to 1964 data, showed that there was an appreciable percentage decrease in smooth approaches and an increase in maintained approaches for both types of pavements. Apparently, at least for a short period of time, the rigidity of portland cement concrete pavement reduced the occurrence of the approach fault by bridging the presumed depression behind the abutment. Generally, the approach settlement appeared to be confined within 100 feet of the end of the

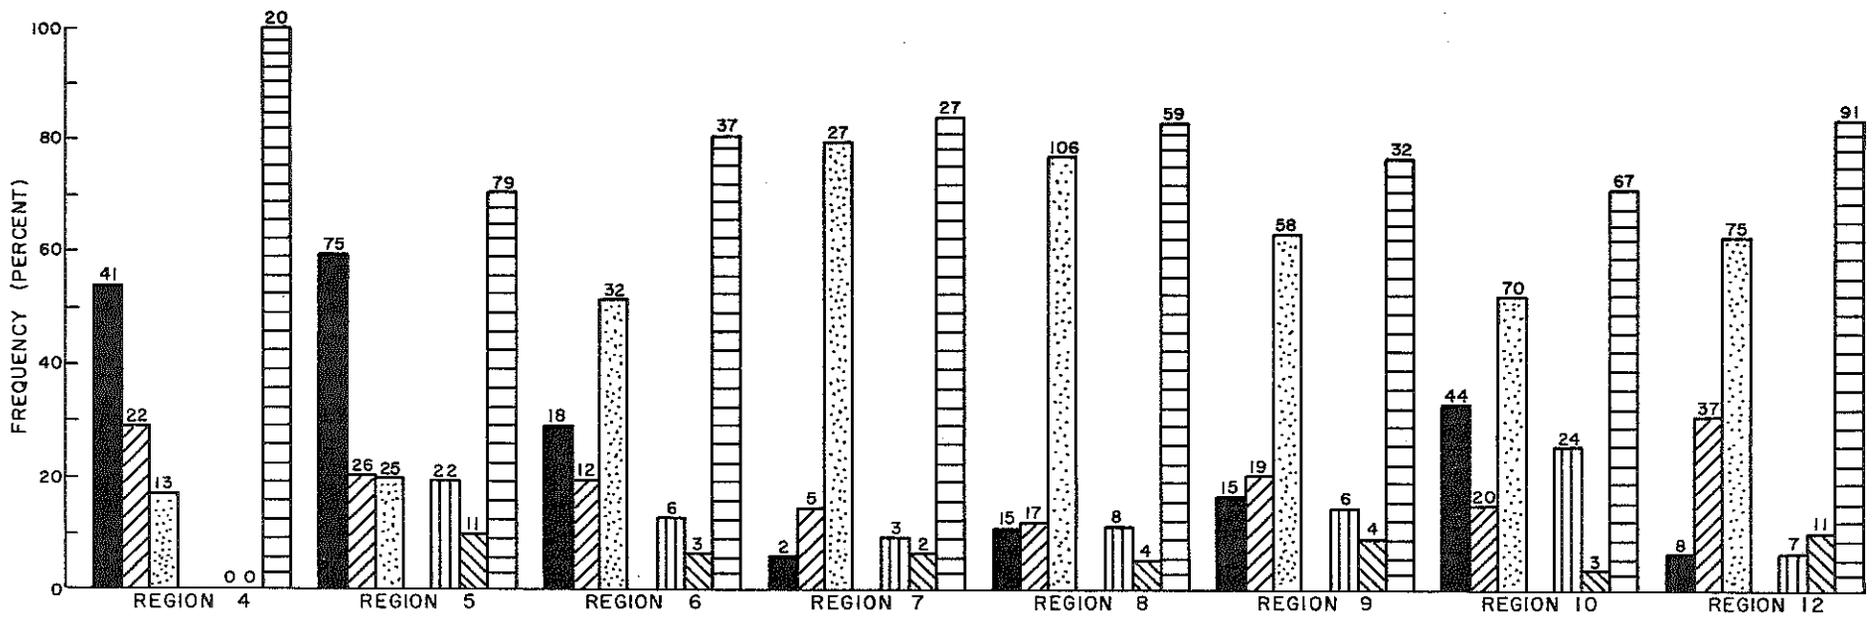
FIGURE 5. COMPARISON OF BRIDGE APPROACHES BY PHYSIOGRAPHIC REGIONS

Figure 5 shows the distribution of bridge approaches with respect to the three settlement groups in each of eight physiographic regions of Kentucky in which the observed bridges were located. 1964 data show that the best approaches, or the lowest percentages of defective approaches, occurred in Regions 4 and 5 (the Western Coal Field). But by 1968 there was a large increase in defective approaches in both regions. This area is a topographic as well as a structural basin; it is a dissected plateau with rolling hills and moderately wide valleys. An outstanding feature of this area is the broad alluvial bottoms of larger rivers. A large number of approaches studied lie within these recent alluvial deposits. Soils of this area have been formed by weathering of sandstone and shales, and large quantities of silts are present.

The highest percentage of approaches in Settlement Group III in 1964 occurred in Region 7, referred to as the Knobs, and Region 8, commonly called the Outer Blue Grass. The Knobs Region, characterized by conical knobs, erosional remnants of former uplands, is a narrow belt of land surrounding the Blue Grass limestone country. Consequently, a rough topography has emerged with the major stream beds flat and wide. This area contains large amounts of shale and plastic clays. The comparatively impervious and easily eroded shale of the Outer Blue Grass has produced a rough, hilly terrain. This region also contains large amounts of plastic clays derived from limestone and shales. For both 1964 and 1968, the proportion of smooth and defective approaches was about the same.

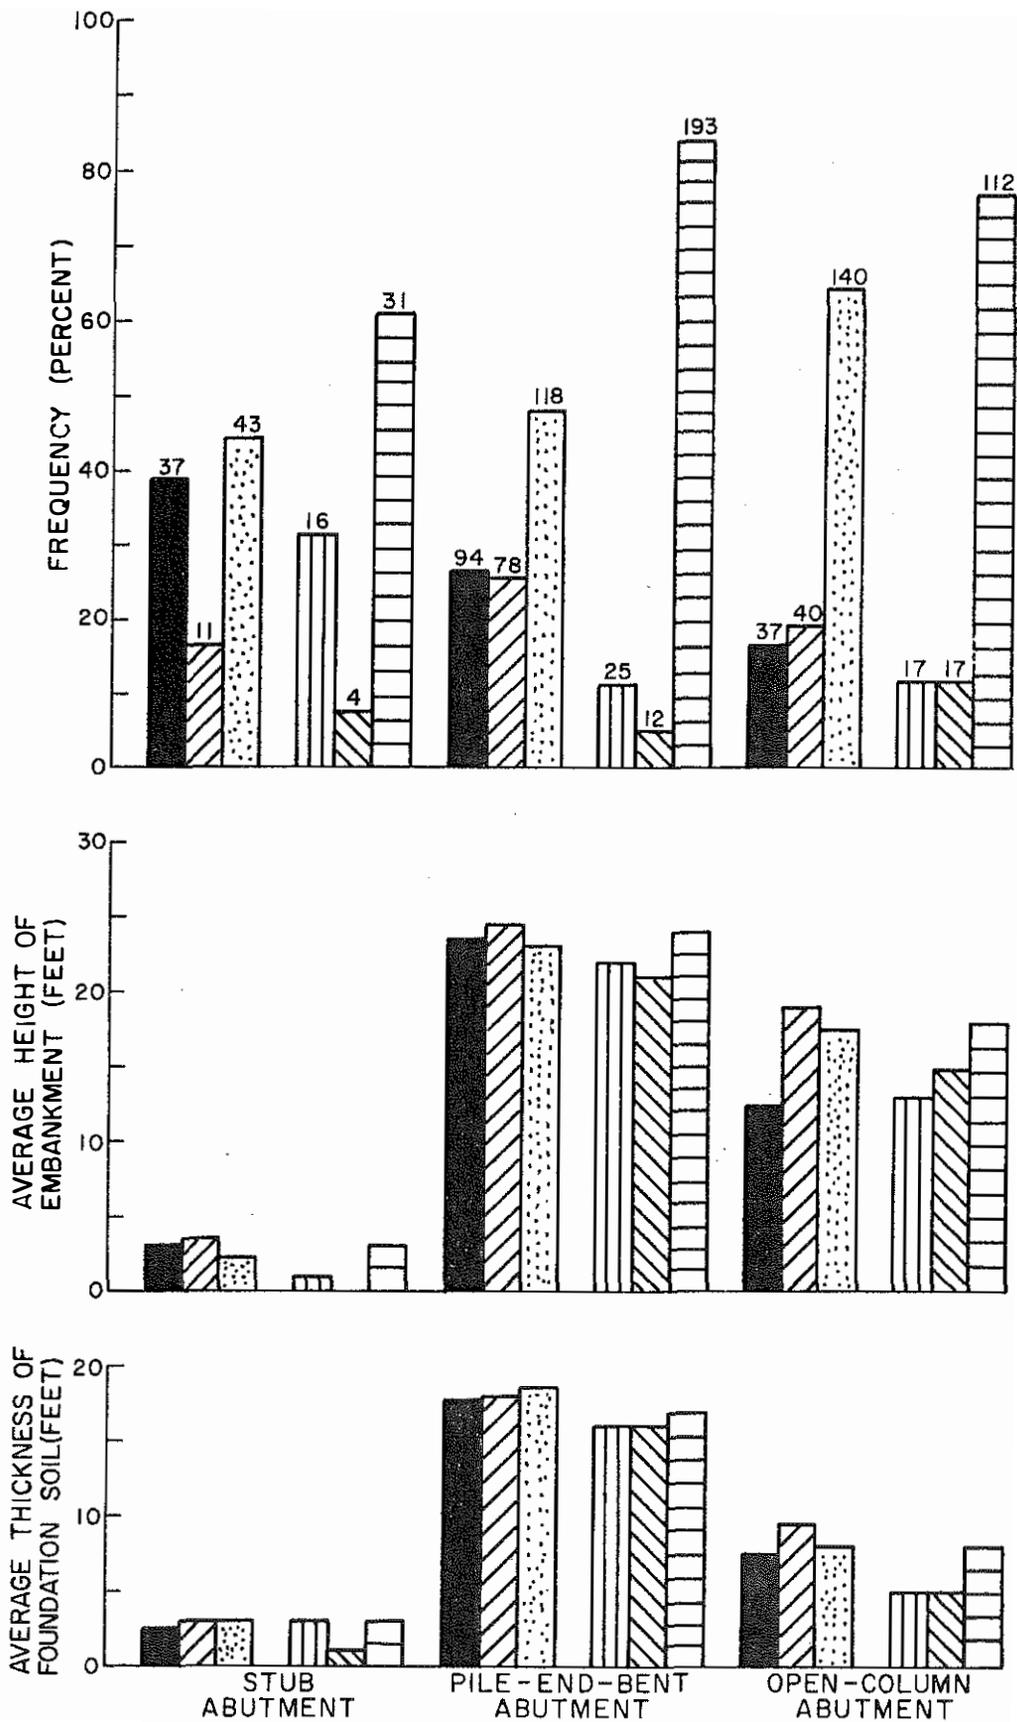
FIGURE 7. COMPARISON OF BRIDGE APPROACHES BY ABUTMENT TYPE

A comparison of the most commonly used types of abutments (see Figure 6), with respect to the three settlement groups, Figure 7a, revealed that the open-column type (open-end) was more commonly

associated with Settlement Group III than either the pile-end-bent (open-end) type or stub type (closed-end) in 1964. The relationship between average height of embankment, average thickness of foundation soil and type of abutment with respect to settlement groups is shown in Figures 7b and c. Notice that stub abutments are associated with smoother bridge approaches, smaller average heights of embankment and thinner foundation soils. The pile-end-bent abutments had greater average heights of embankment and thicknesses of foundation soils than the open-column abutment, but the pile-end-bent abutments had better bridge approaches. The better performance of approaches located behind stub abutments may be attributed to smaller settlements associated with shallower embankments and foundation soils. The comparatively larger time for consolidation before construction of the pavement and the need for less hand compaction near the abutment may account for better performance of approaches associated with pile-end-bent abutments than those approaches at open-column abutments. However, in 1968 there was an increase in percentage of faulted approaches for all types of abutments with the percentage for pile-end-bents increasing the most. There were small differences in percentages between the pile-end-bent and open-column abutments. Although the percentage of faulted approaches increased, stub abutments still had a comparatively high percentage of smooth approaches in 1968. For both surveys, there was a large number of defective bridge approaches associated with all types of abutments.

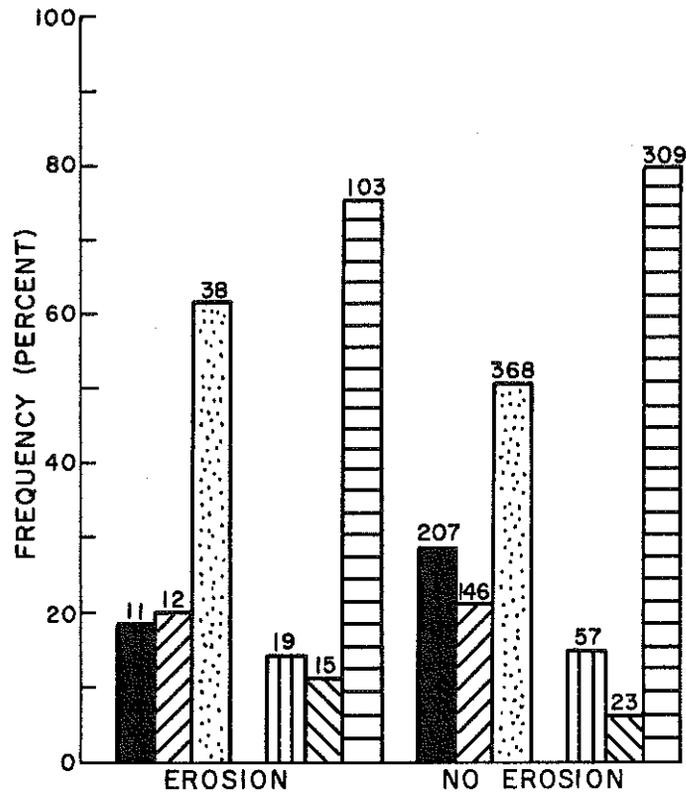
FIGURE 9. COMPARISON OF BRIDGE APPROACHES BY EXTENT OF EROSION AT FACE OF ABUTMENT

In a few cases, the 1964 study indicated that erosion of soil adjacent to the abutment (Figure 8) contributed to the development of the approach fault. In one observed case, grouting material from the mudjacking operation had effused from underneath the face of the abutment. As shown in Figure 9, there was an increase in the percentage of repaired approaches when such erosion occurred. This type of erosion appears to be a result of ground water seepage (including runoff from the pavement) as shown diagrammatically in Figure 10.

Loss of material around the abutment could result in a loss of subgrade material and, consequently, cause the approach to settle. By 1968 the percentage of defective approaches had increased noticeably, and there were no significant differences in percentages of smooth approaches as well as faulted approaches for approaches with erosion and without erosion. However, the number of faulted approaches with erosion at the face of the abutment increased considerably.

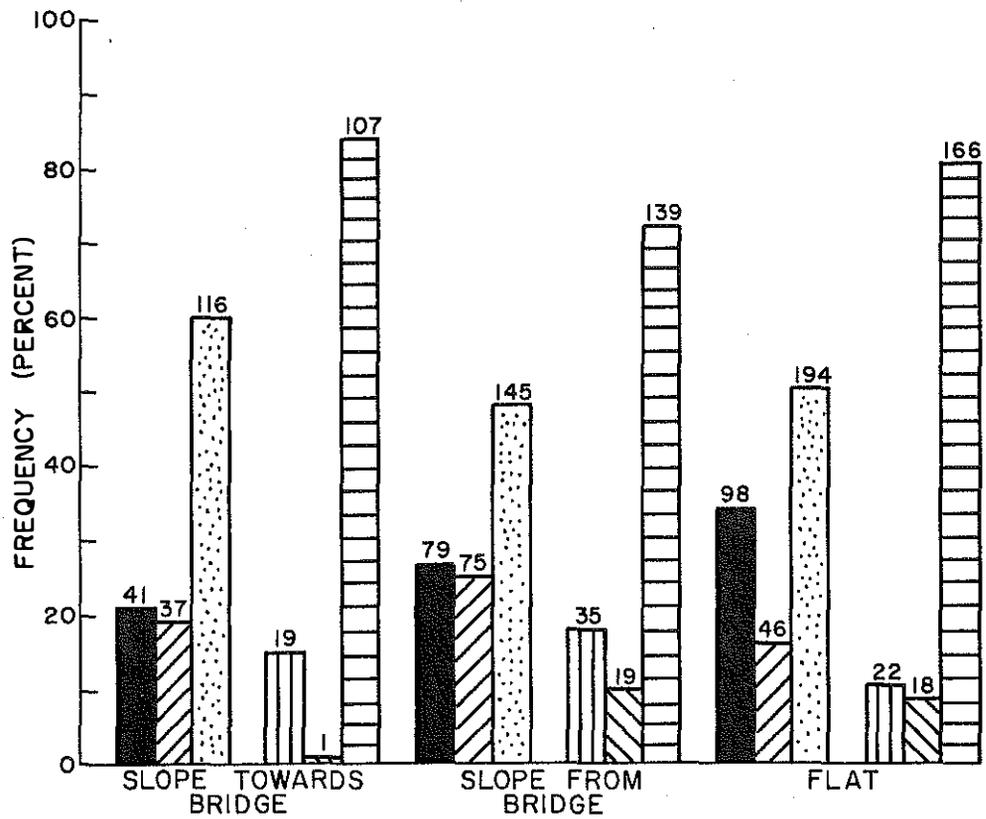
FIGURE 11. COMPARISON OF BRIDGE APPROACHES BY SLOPE OF APPROACH PAVEMENT

Other supporting evidence that seepage may, in some cases, result in settlement of the approach is presented in Figure 11. A comparison was made among those approaches which sloped toward the abutment, those which sloped away and those which were relatively level with respect to the three settlement groups. Those which sloped toward the abutment had a higher percentage of Group III approaches than the other two categories.

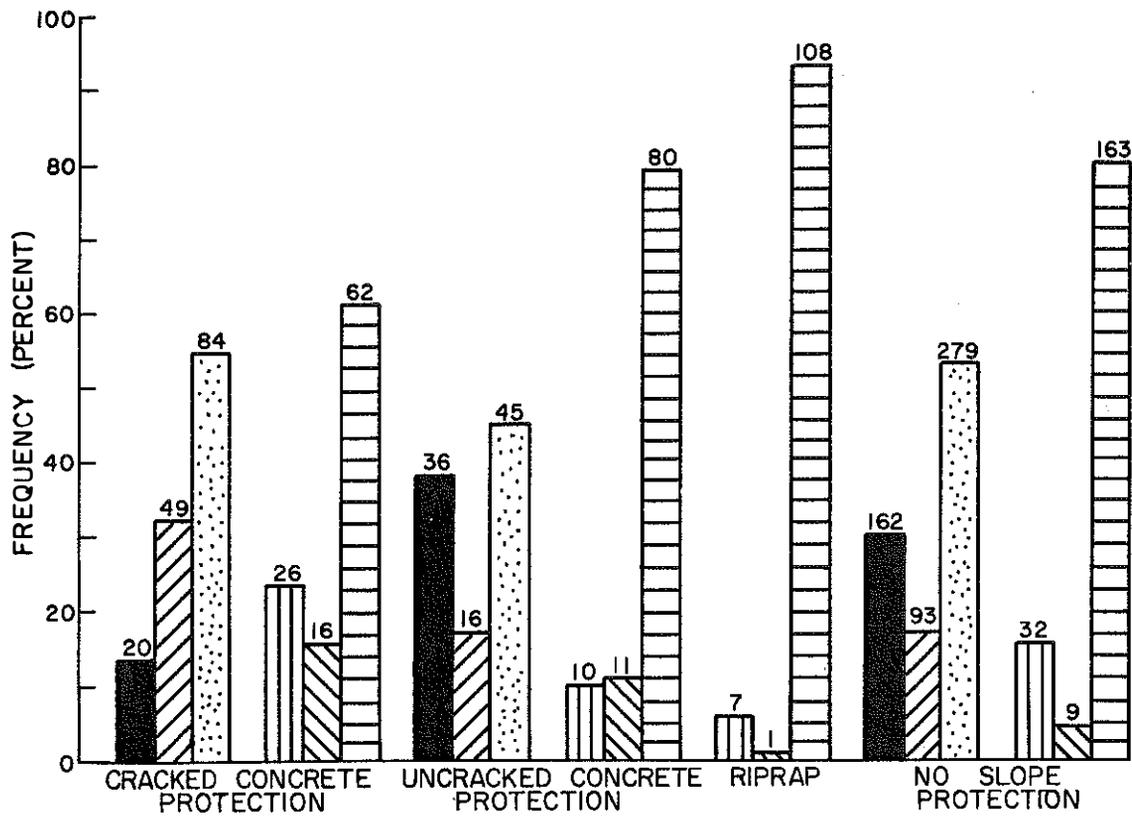
FIGURE 12. COMPARISON OF BRIDGE APPROACHES BY TYPE OF SLOPE PROTECTION

There was suggestive evidence that progressive failure, or creep, of the approach embankment may, in some cases, contribute to development of the approach fault. Figure 12 is a comparison of approach embankments with cracked concrete slope protections, embankments with uncracked concrete slope protections, and embankments with no slope protection, suggesting a relationship between cracked slope protections and bridge approach settlement. One possible explanation for the cracked slope protections could be progressive failure of the embankment, as shown in Figure 13, resulting in a loss of subgrade support. In some cases, slope protections did appear to be bulging outward.

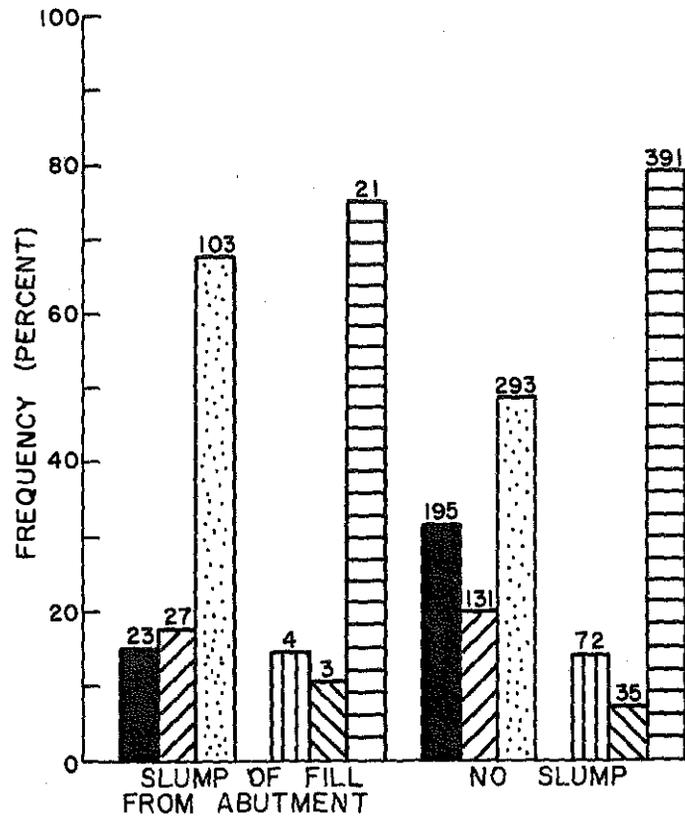
FIGURE 15. COMPARISON OF BRIDGE APPROACHES BY EXTENT OF SLUMP OF FILL FROM FACE OF ABUTMENT

Group III approaches for the former category in 1964. These data are shown in Figure 15. By 1968 the percentage of defective approaches had increased significantly, and both categories exhibited little difference.

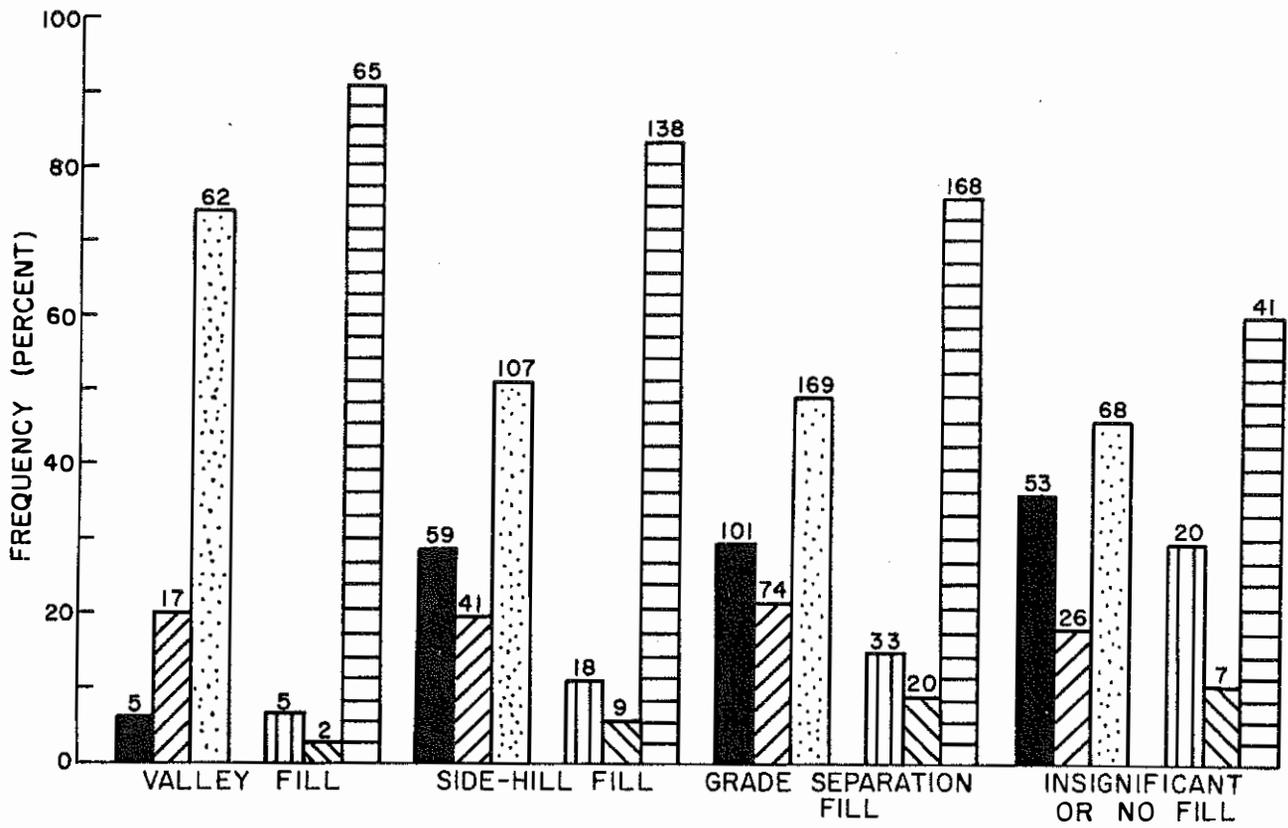
FIGURE 16. COMPARISON OF BRIDGE APPROACHES BY TYPE OF EMBANKMENT

Different types of embankments were studied with respect to the settlement groups. These data, Figure 16, show that embankments located in valleys of major streams had a much greater percentage of Settlement Group III approaches than embankments at other locations. Side-hill fills were considered to be those embankments which were generally part fill and part cut. Grade separation embankments were those considered to be built-up on a relatively flat plain. It is reasonable to assume that valley fills were located on foundations which were thicker than the other types of fills. Hence, these data probably reflect the importance of the foundation as a variable in bridge approach settlement. Those faulted approaches with embankments three feet or less in height may reflect improper backfill placement and compaction and such other causative factors as erosion or swelling and shrinkage.

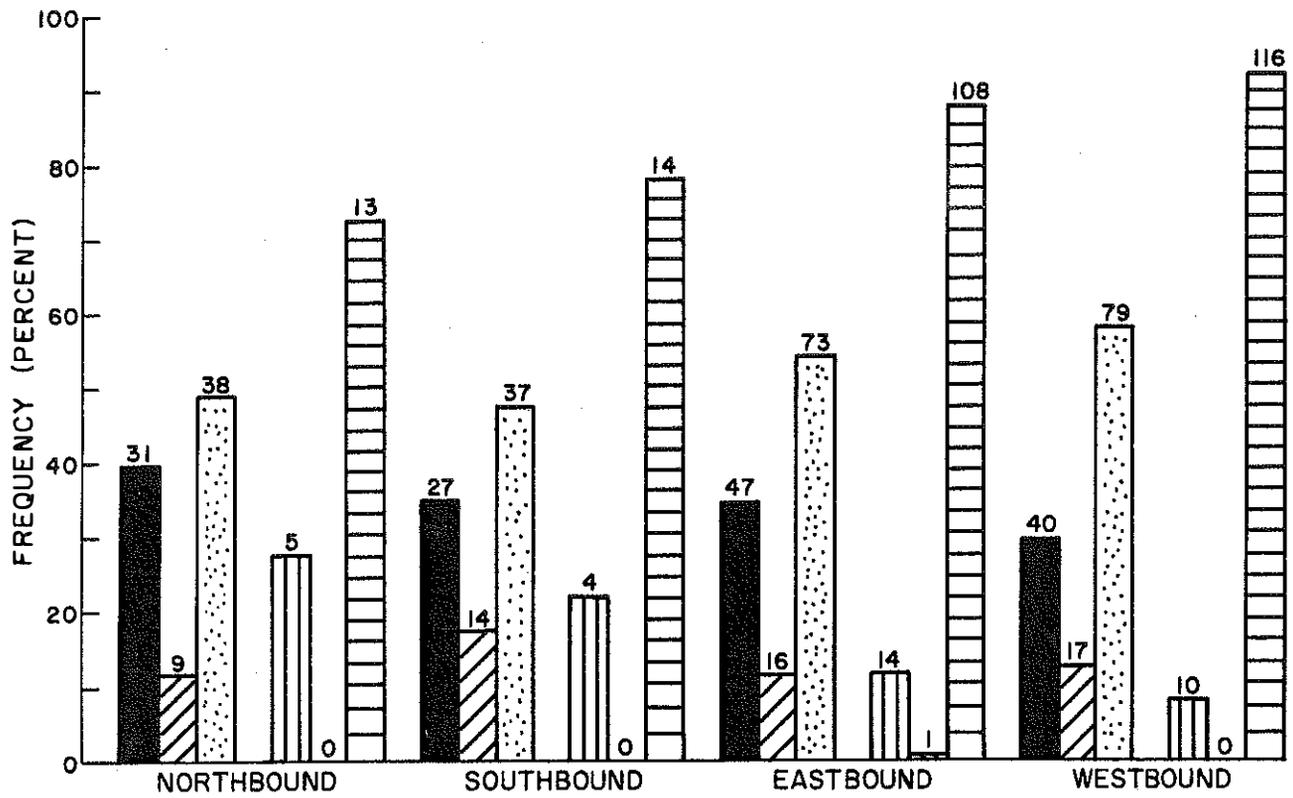
FIGURE 17. COMPARISON OF BRIDGE APPROACHES BY DIRECTION OF TRAVEL

A comparison of bridge approaches (four traffic lanes – two bridges), Figure 17, with regard to direction of travel revealed only a slight difference in settlement between northbound and southbound traffic approaches, and between eastbound and westbound approaches. Furthermore, a comparison between entry and exit bridge approaches, Figure 18, also showed little difference. Also shown in Figure 18, for the purpose of comparison, is the distribution of bridge approaches, located at sites involving only one bridge, with respect to the different settlement groups.

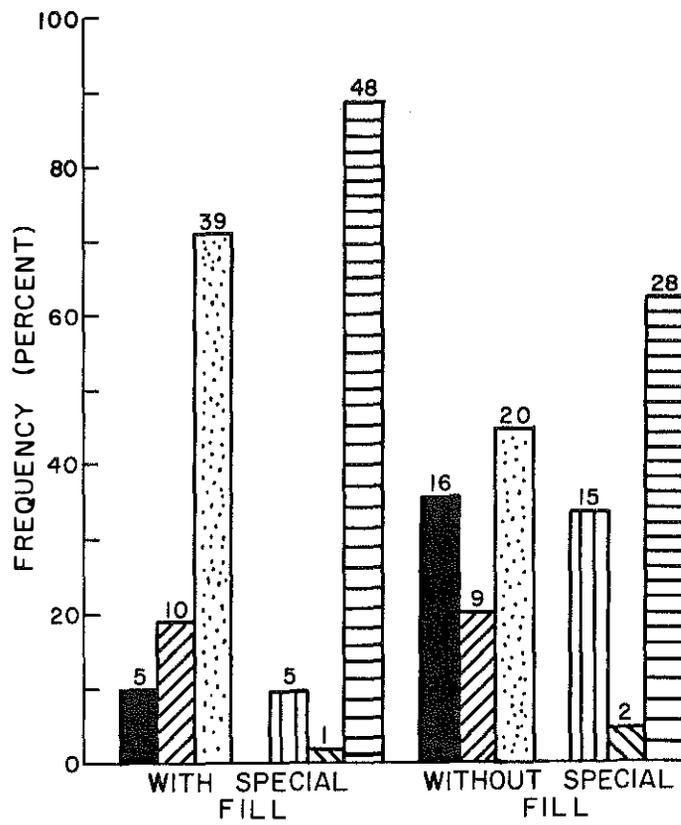
FIGURE 20. COMPARISON OF BRIDGE APPROACHES BY USE OF SPECIAL BACKFILL MATERIAL

The performance of bridge approaches associated with the special granular backfill is shown in Figure 20 and compared with bridge approaches not associated with the special backfill on the same route. The data show that backfilling behind abutments in a manner specified by Kentucky Standard SF-1 did not check the development of faulted approaches. Moreover, for cases involving the special backfill when compared to cases without the special fill, there was an increase in frequency of faulted approaches.
