38 Year-Old Construction Laborer Dies When Trench Walls Collapse

Incident Number: 03KY107

Release Date: November 5, 2004

Subject: 38 Year-Old Construction Laborer Dies When Trench Collapses

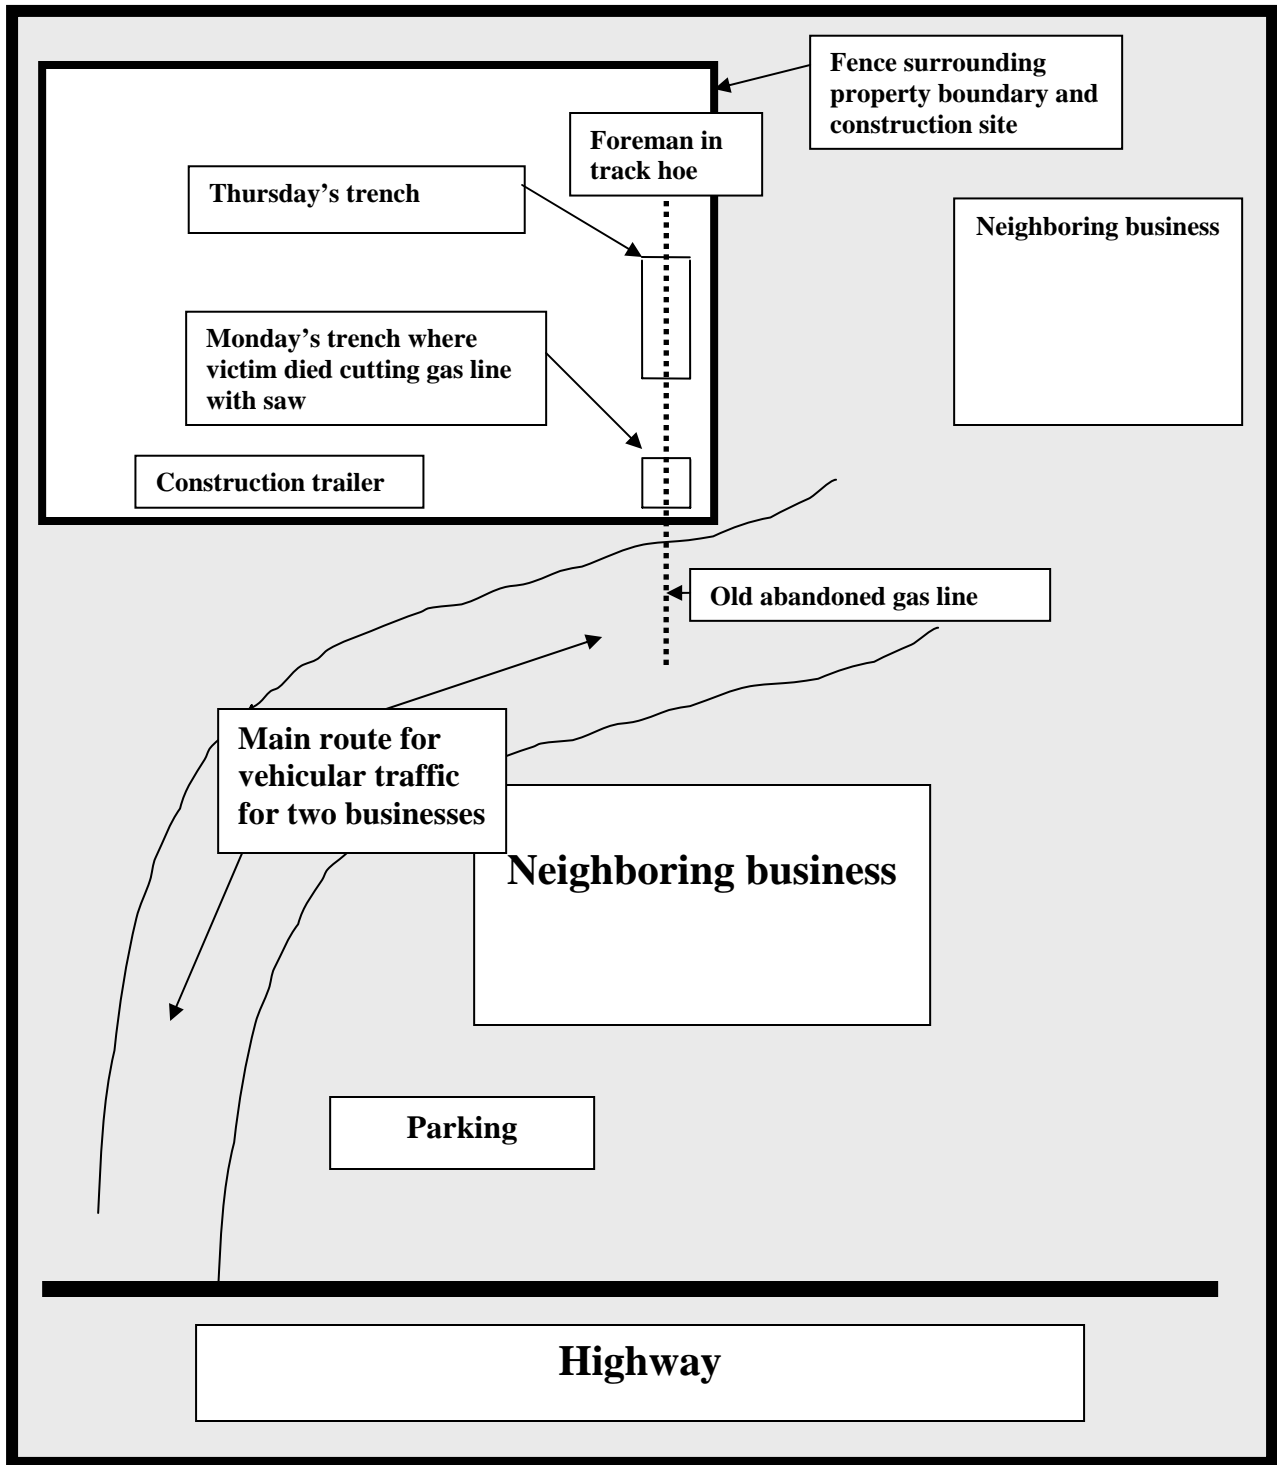
Diagram of construction site and neighboring businesses, driveway and parking lots

The job site was in a commercial area located behind and to the left of existing businesses (see diagram) and was surrounded by chain link fencing. The work was to be performed in a corner where the three properties came together. The two existing businesses shared a driveway which passed from the highway between the business in front and the construction site, around the corner and to the other existing parking lot. Heavy traffic traveled in front of the work site to and from the existing businesses and within 10 feet of the trench where the fatality occurred.

On Thursday (October 30), before the accident, the subcontractor's crew dug a trench that was inside the fence about 20 feet from the corner shared by the existing businesses. Thursday's trench was approximately 5 feet deep, 16 feet long, with appropriately compacted and sloped sides. The subcontractor's crew worked in that trench for 4 days.
