Research Report
KTC-90-23

GROUND MODIFICATION SYSTEMS
(STONE COLUMNS AND WICK
DRAINS IN JEFFERSON COUNTY)

Bobby W. Meade
Research Investigator

David L. Allen
Chief Research Engineer

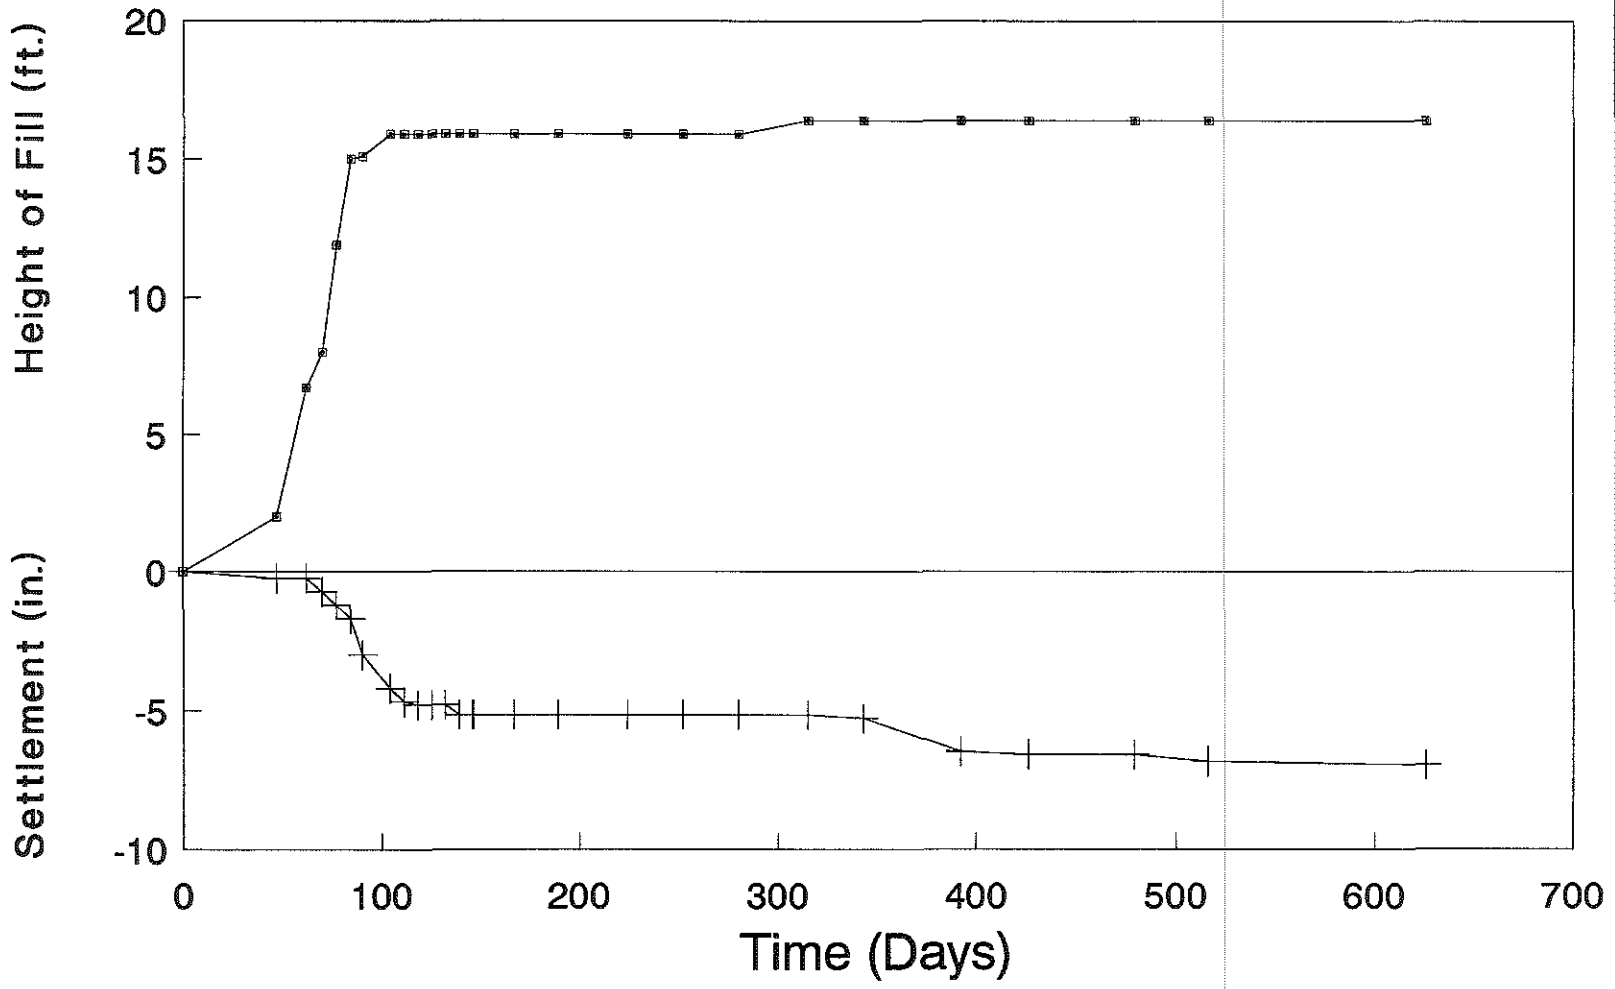
Figure 11. Foundation Settlement and Embankment Height at Station 2008+00.

Settlement platform data indicate foundation settlement of 12.5 in. and 7.0 in. at Stations 2013+00 and 2008+00, respectively. Ninety percent settlement occurred in approximately 90 and 50 days after the embankment was completed at these respective locations. Settlement and embankment height are plotted versus time in Figures 11 and 12.

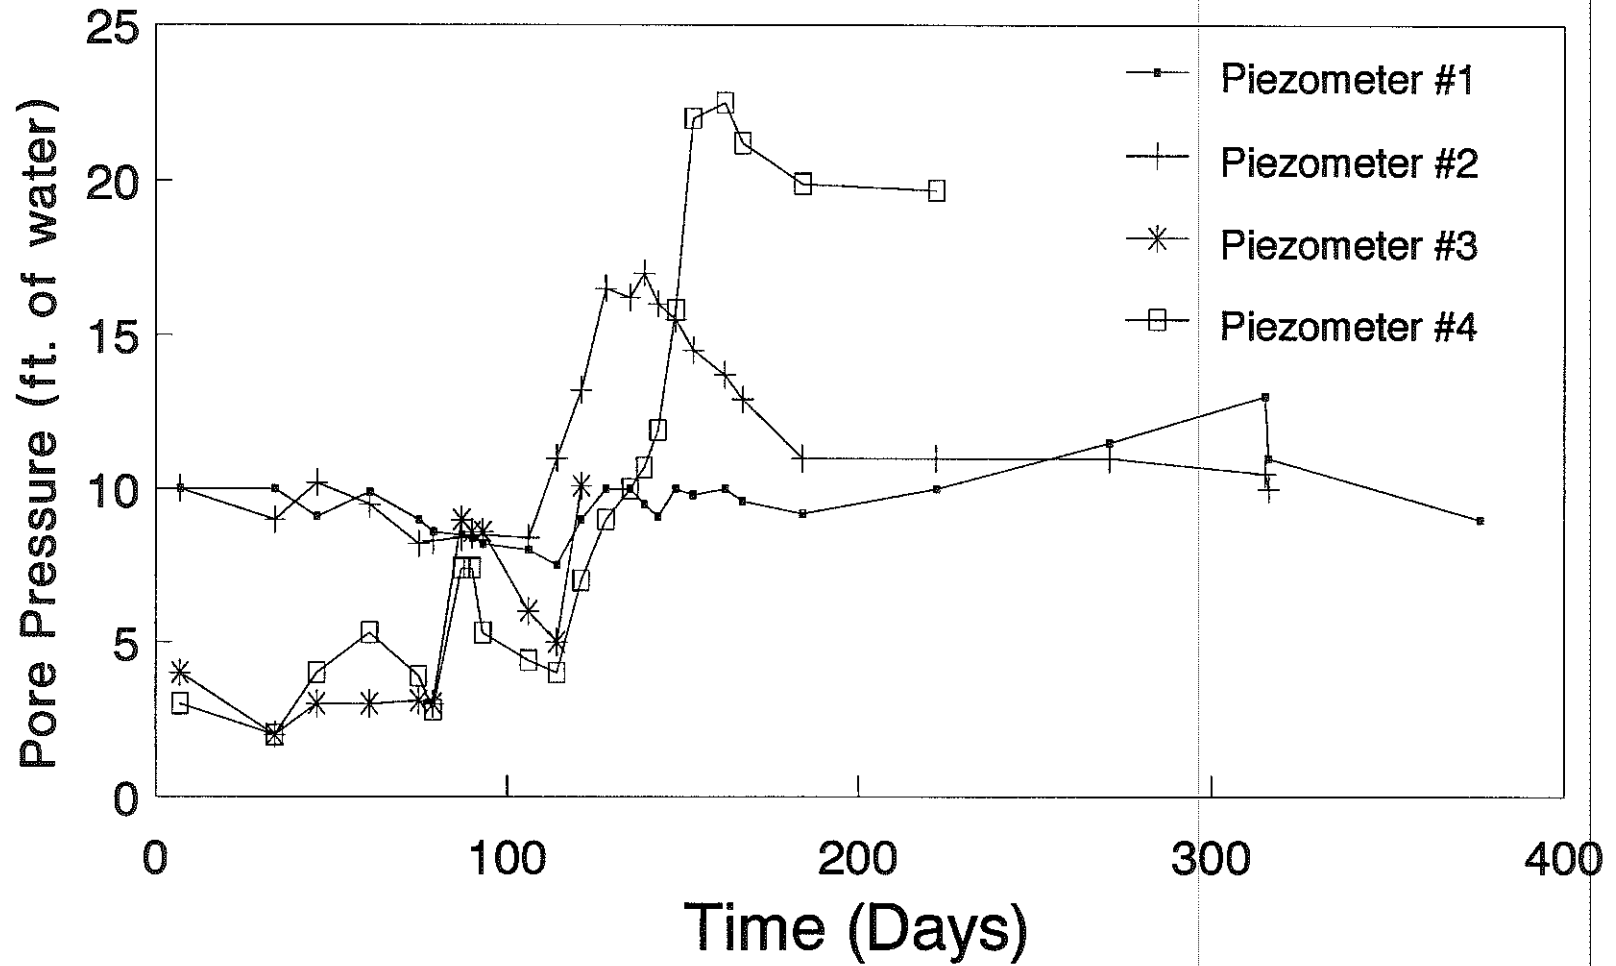
Figure 13. Foundation Pore Pressure at Station 2008+00.

Piezometers 1 through 4 are located at depths of 5 to 10 ft in the wick drained foundation south of the bridge. Piezometers 9 through 12 are located at depths of 20 to 25 feet in the in the same approach foundation. All piezometers show foundation pore pressure changes that appear to reflect construction activity. All piezometers that operated past the time the embankment was completed indicate foundation pore pressure returned to preconstruction levels except at Piezometer 4. South approach foundation piezometer data are shown in Figures 13 and 14.

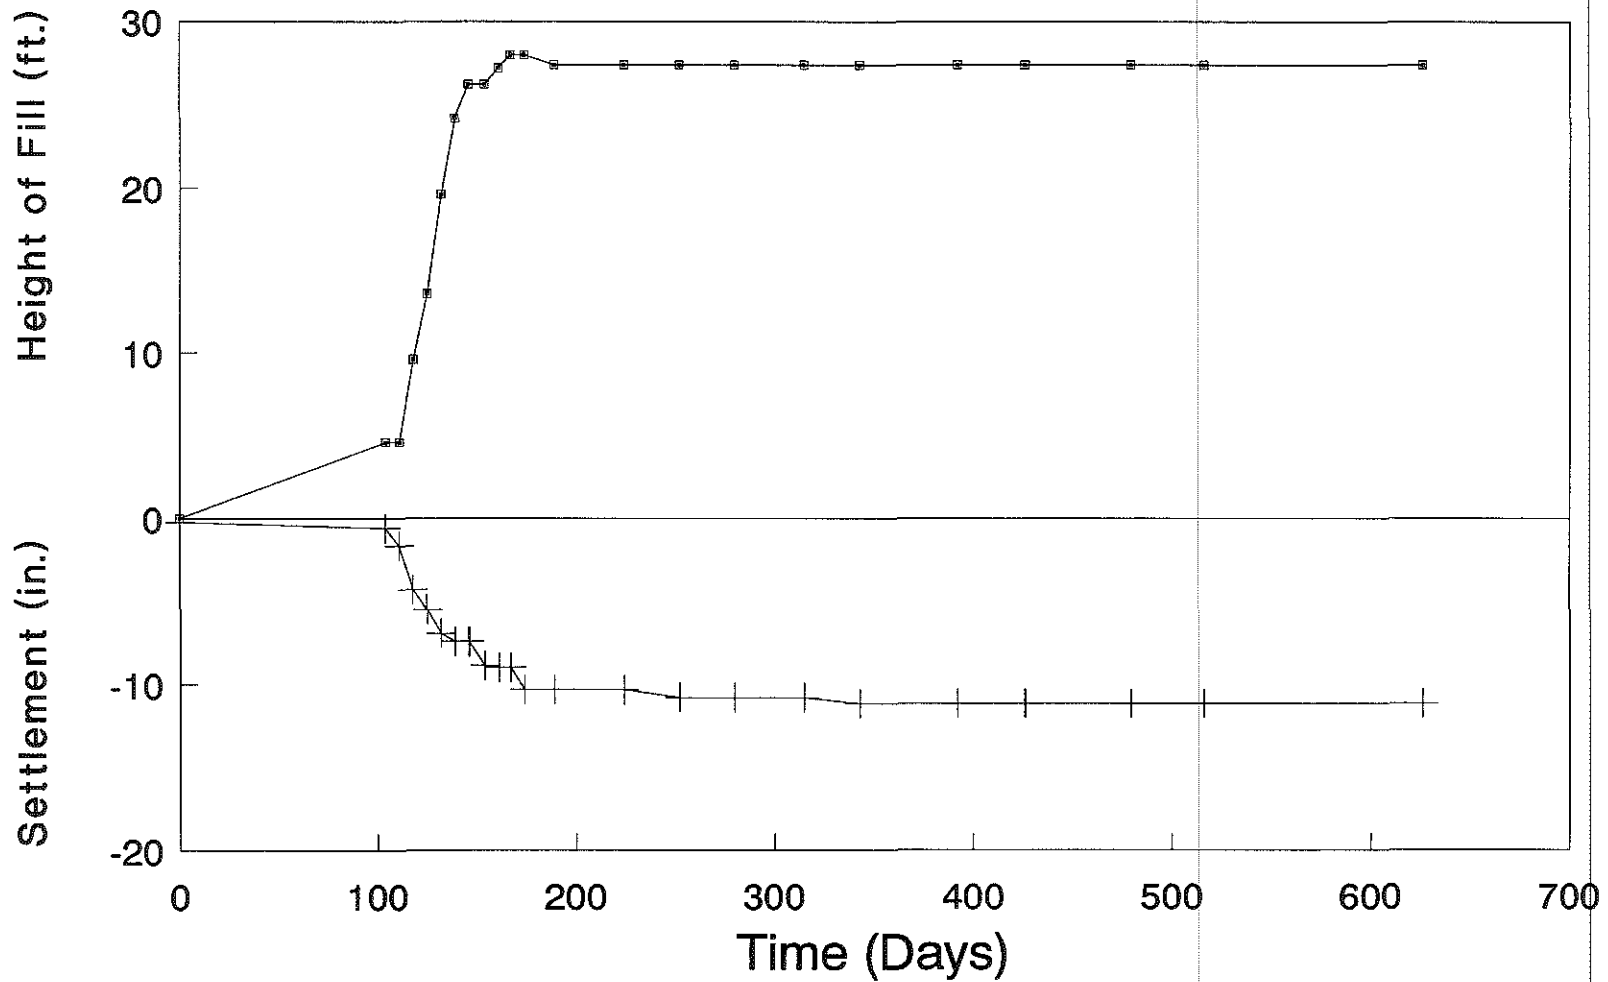
Figure 15. Foundation Settlement and Embankment Height at Station 310+00 (Ramp C).

Foundation settlement at the north approach was 11.2 in. at Station 310+00 and 4.2 in. at Station 315+00. Ninety percent settlement occurred approximately 60 days after the embankment was completed at Station 310+00 and 20 days at Station 315+00. Embankment height and foundation settlement for both locations are plotted versus time in Figures 15 and 16. A settlement gage at Station 315+60 indicated settlement of 4.5 in. at centerline.

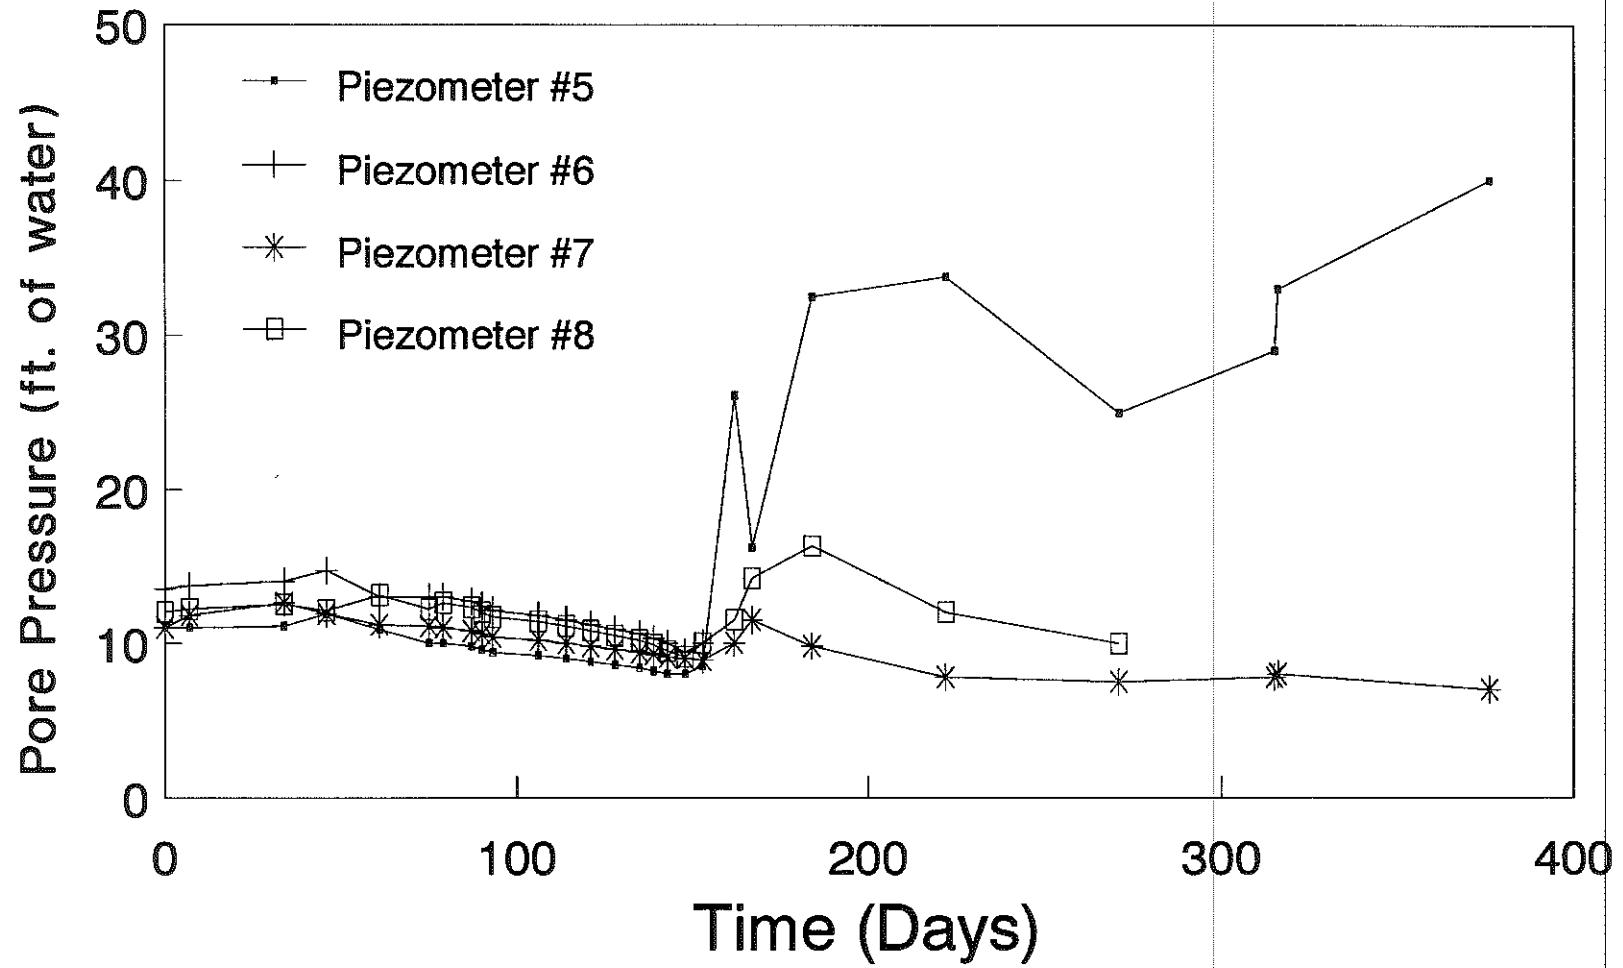
Figure 17. Foundation Pore Pressure at Station 310+00 (Ramp C).

Foundation pore pressure in the north approach followed the same pattern as in the south approach foundation. All piezometers, except Piezometer 5, indicated pore pressure increases with embankment construction and pore pressure returning to initial levels or lower after the embankment was complete. Piezometer 5 is the nearest piezometer to the north abutment stone columns. Piezometer 5 indicated an elevated pore pressure until it ceased operating in May 1986. The north reinforced soil wall was not removed until September 1986. North approach piezometer data are shown in Figures 17 and 18.
