Research Report
KTC-89-61

EVALUATION OF WICK DRAIN STABILIZATION OF APPROACH
FILL FOUNDATION (CARROLL COUNTY)

December 1989

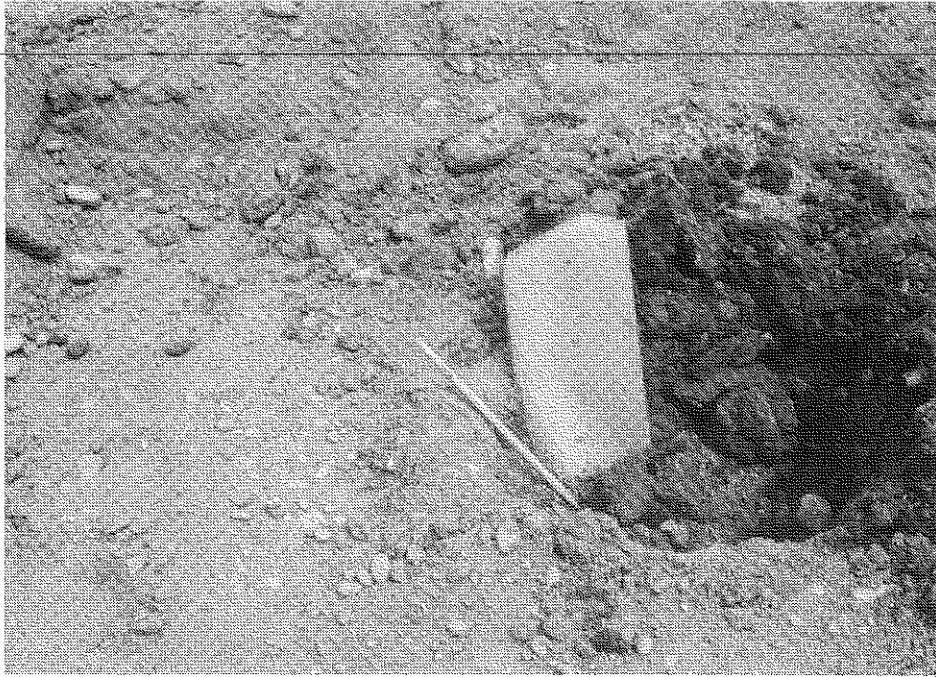
Figure 9. Installed Wick Drain Extending through Drainage Blanket.

The procedure involves pushing a prefabricated wick drain through the soil to a desired depth and extending the top of the drain into a drainage blanket. This is accomplished by threading the wick drain through a hollow mandrel and driving the mandrel into the soil. The wick drain is looped around an anchor plate or pin at the leading end. Figure 6 shows the drain being looped and inserted into the leading tip of the mandrel. Figure 7 shows the mandrel with the wick drain and anchor pin in place being placed at the next location. A crane is used to place the mandrel at a previously flagged drain location and the mandrel is driven with a vibratory force. In Figure 8, a reel of drain may be seen mounted on the bottom of the tower and extending to the top of the mandrel. When the desired depth is reached, the mandrel is withdrawn with the anchor device holding the wick drain at that depth. The wick drain is severed at the surface and the process is repeated at the next drain location. An installed wick drain extending through the sand drainage blanket is shown in Figure 9.

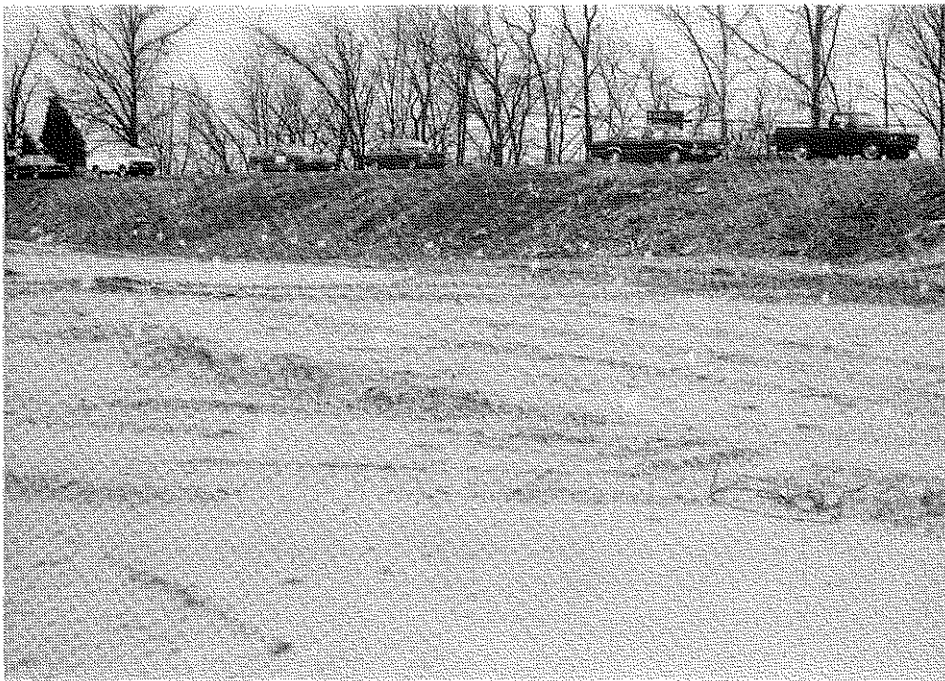
Figure 10. Flagged Wick Drain Layout.

Clearing and grubbing commenced in November of 1984. Piezometers were installed in January of 1985. A geotextile fabric was placed on the west approach foundation and a sand drainage blanket, approximately one foot thick, was placed on the fabric in February 1985. This procedure was repeated on the east approach. High water level of the Little Kentucky River delayed completion of drainage blanket construction until mid March. Wick drain locations were flagged in accordance with the design layout after the sand was in place. Figure 10 shows a portion of the west approach with wick drain locations flagged on the sand drainage blanket.

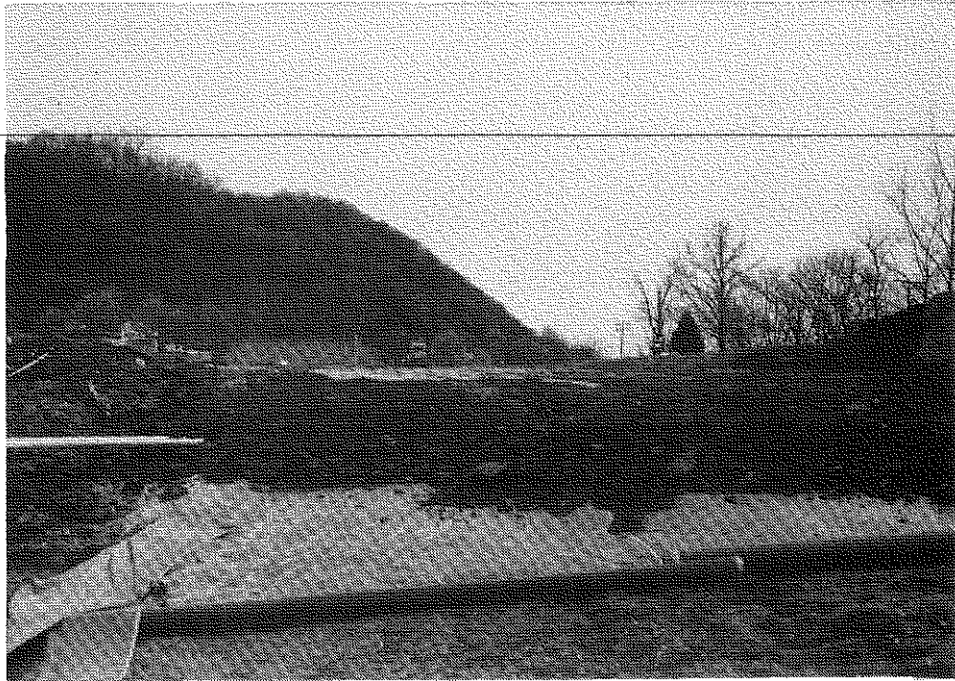
Figure 11. Drainage Blanket Separated by Filter Fabric from Embankment.

A second layer of geotextile fabric was placed on the sand to complete the drainage blanket after the drains were in place. The edges of the bottom layer of fabric were pulled over the sand and lapped by the top layer of fabric. The sand drainage blanket was cleaned of deleterious material and returned to a minimum thickness of one foot prior to placement of the top fabric. Settlement monitoring instrumentation was placed on the completed drainage blanket. In Figure 11, the top layer of fabric is being placed on the sand blanket and the embankment material is being placed on the fabric. The bottom layer of fabric lapped over the top fabric and the tubes extending from the embankment house settlement monitoring instrumentation may be seen in the left foreground.
