Research Report
KTC-89-45

CONSTRUCTION AND INSPECTION
REPORT ON CORRUGATED
POLYETHYLENE PIPE, N-12

October 1989

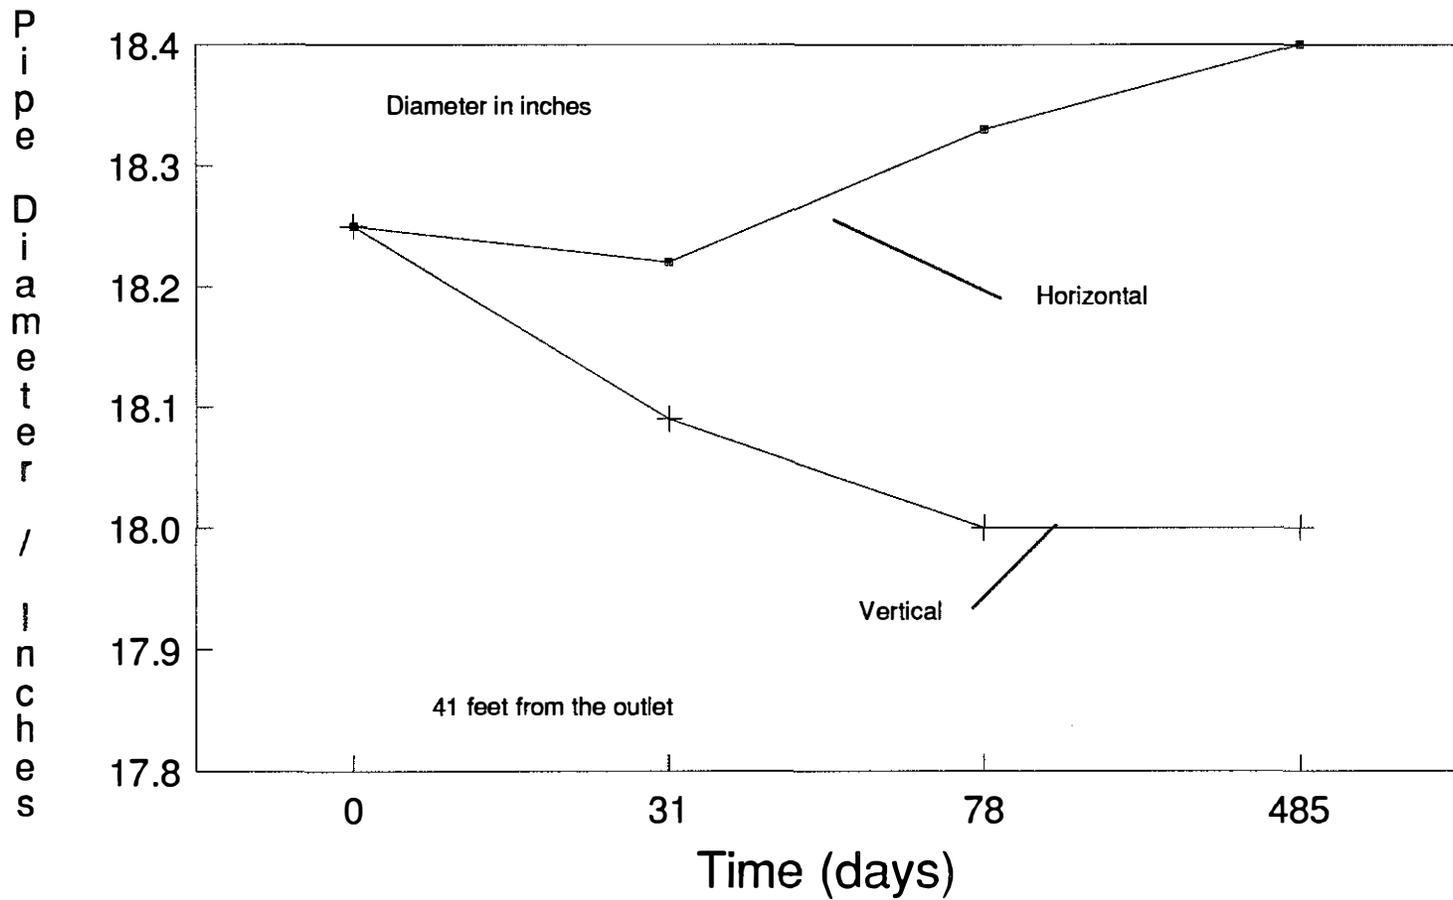
Figure No. 3: 18-Inch N-12 Ky 54, Daviess County, Station 126+00

Monoritoring points were also placed at Station 122+50. Since installation, the interior of the 18-inch pipe has deflected 0.34 inch (Figure 3). Eight additional monoritoring points were placed in the pipes prior to installation. Due to water and mud, the monoritoring points could not be accessed during the last inspection.
