Research Report  
KTC-89-17

EARTHQUAKE HAZARD MITIGATION OF  
TRANSPORTATION FACILITIES  
FOR HOPKINS COUNTY

June 1989

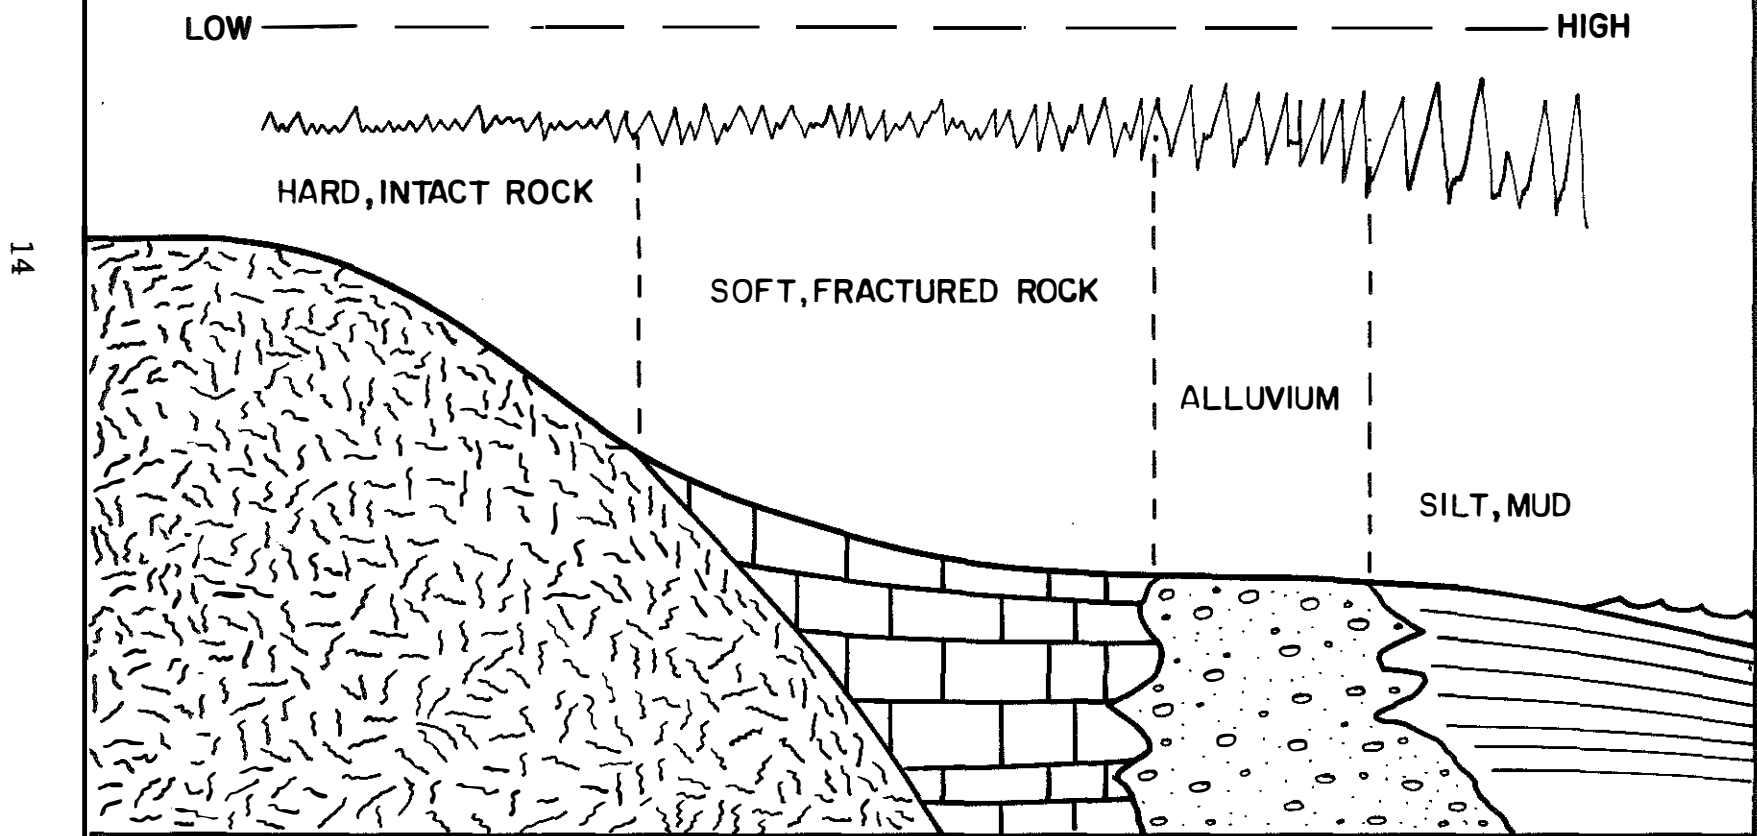
Figure 2 : Amplification of shaking in softer rock & soil during an earthquake.

# AMPLIFICATION OF SHAKING AND DAMAGE DUE TO SHAKING

Soil maps for Hopkins County indicate that there are large amounts of alluvium present throughout the county. Alluvium is a loose, fine-grain soil which is deposited by flowing water such as creeks and rivers. Due to the nature of the alluvium, ground motions at the surface of the soil can be many times greater than those within the underlying bedrock and temporary liquefaction can occur (Figure 2). An alluvium map for Hopkins County is shown in Figure 3.
