Research Report
KTC-89-4

EARTHQUAKE HAZARD MITIGATION OF
TRANSPORTATION FACILITIES
FOR McLEAN COUNTY

March 1989

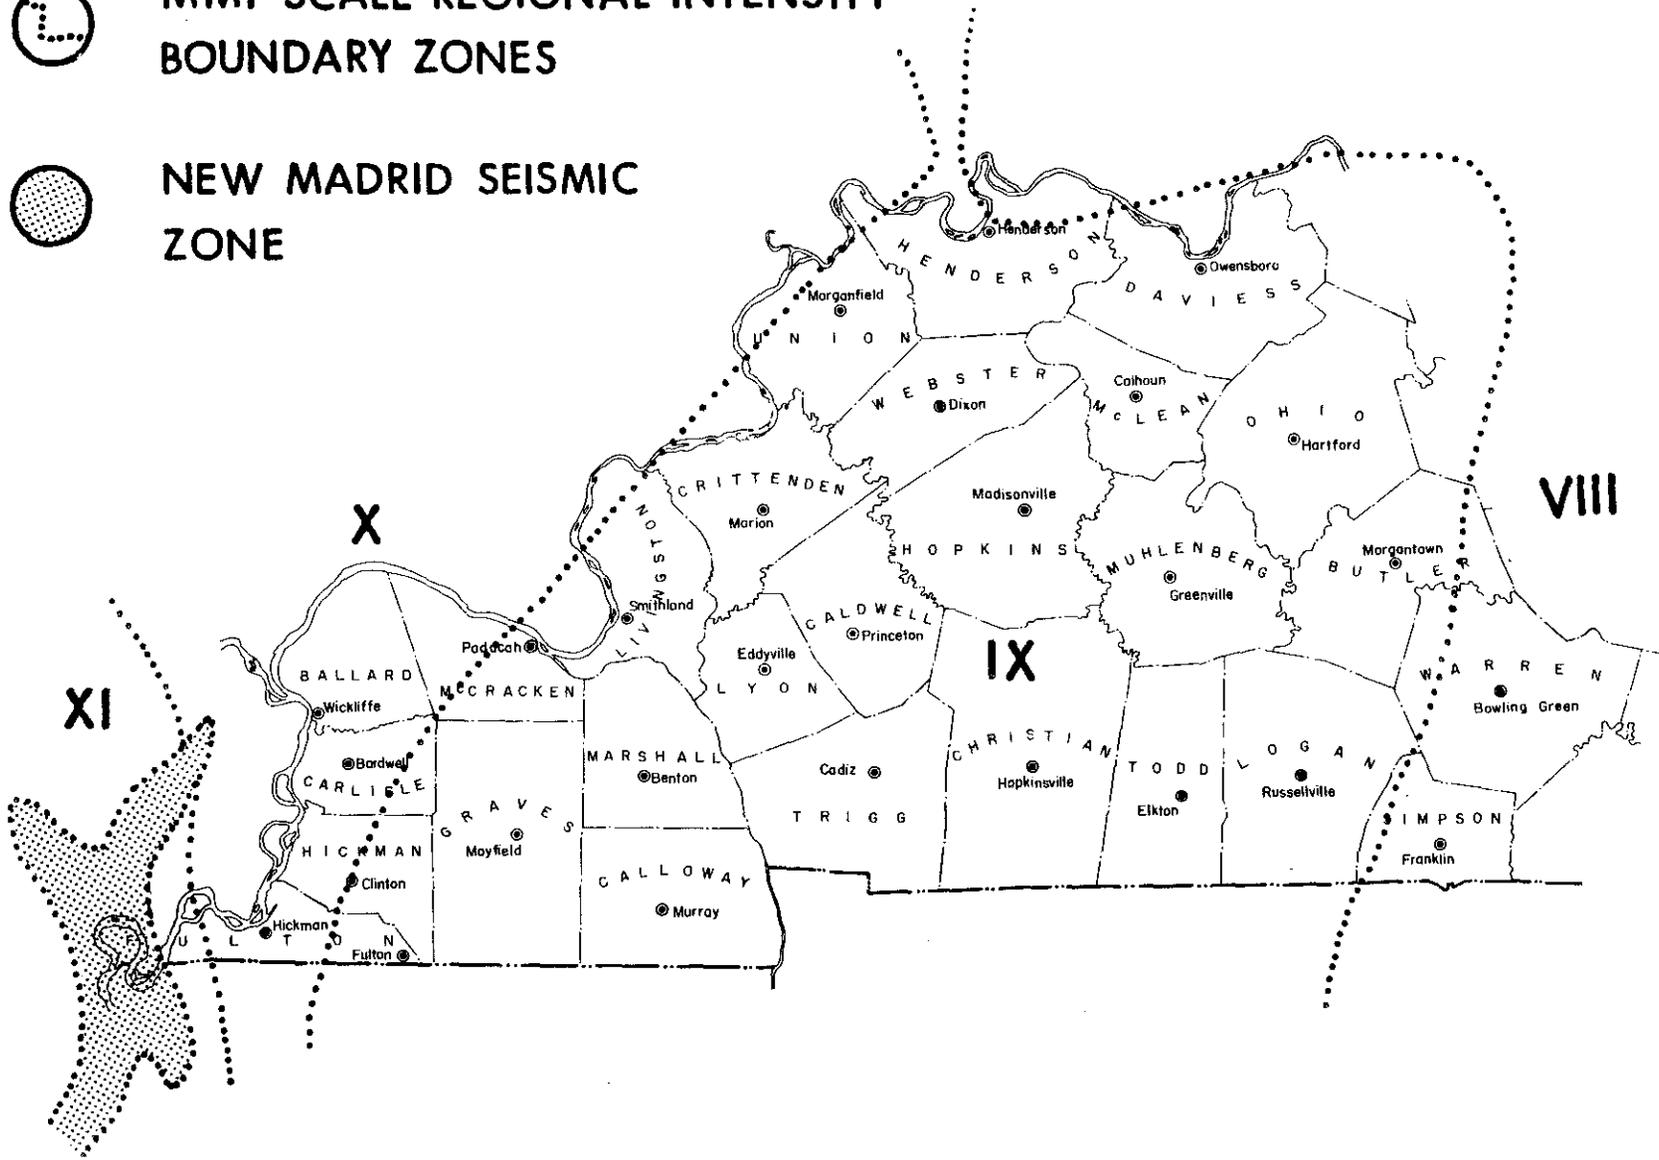
NEW MADRID SEISMIC
ZONE

Figure 1: The twenty-six counties included in this study area.

For a given earthquake, effects at a given location are described by the Modified Mercalli Intensity (MMI) scale (2) which ranges from I (no damage and felt only by instruments) to XII (total destruction). Details of the MMI scale are given in Table 1. Values of MMI associated with the 1811-1812 earthquakes are shown in Figure 1. The potential for damage and destruction from earthquakes in the region is significant.

McLean County is located approximately 129 miles east-northeast of the center of the New Madrid Seismic Zone. Figure 1 indicates McLean County is in the IX band of the MMI scale. This indicates considerable damage could occur in McLean County in the event of a major earthquake.

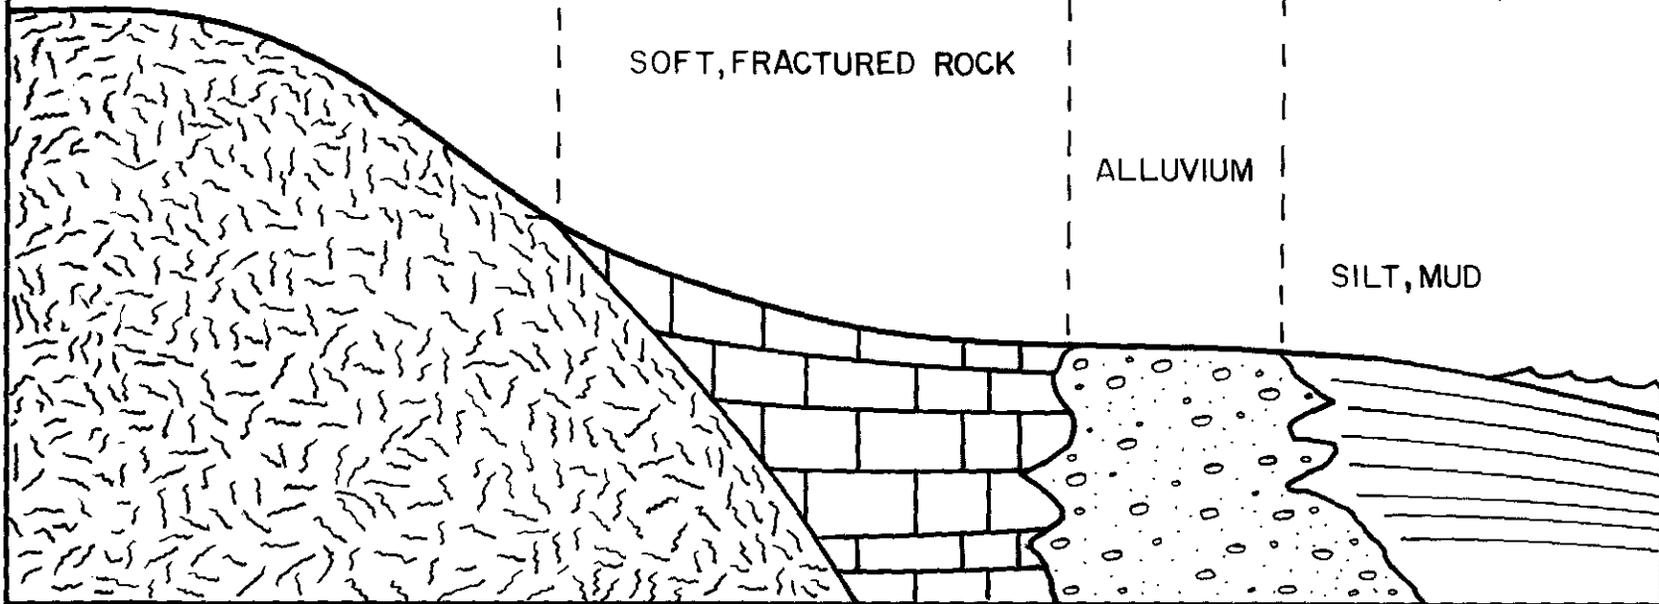
ALLUVIUM

SILT, MUD

Figure 2 : Amplification of shaking in softer rock & soil during an earthquake.

Soil maps for McLean County indicate that there are large amounts of alluvium present throughout the county. Alluvium is a loose, fine-grain soil which is deposited by flowing water such as creeks and rivers. Due to the nature of the alluvium, ground motions at the surface of the soil can be many times greater than those within the underlying bedrock and temporary liquefaction can occur (Figure 2). An alluvium map for McLean County is shown in Figure 3.
