# **Truck Driver Dies When Tractor-Trailer Leaves The Road And Plunges Into A Creek-Bed**

**Incident Number: 13KY039**

**Kentucky Fatality Assessment and Control Evaluation (FACE) Program  
Incident Number: 13KY039  
Release Date: November 20, 2013  
Subject: Truck Driver Dies When Tractor-Trailer Leaves The Road And  
Plunges Into A Creek-Bed**

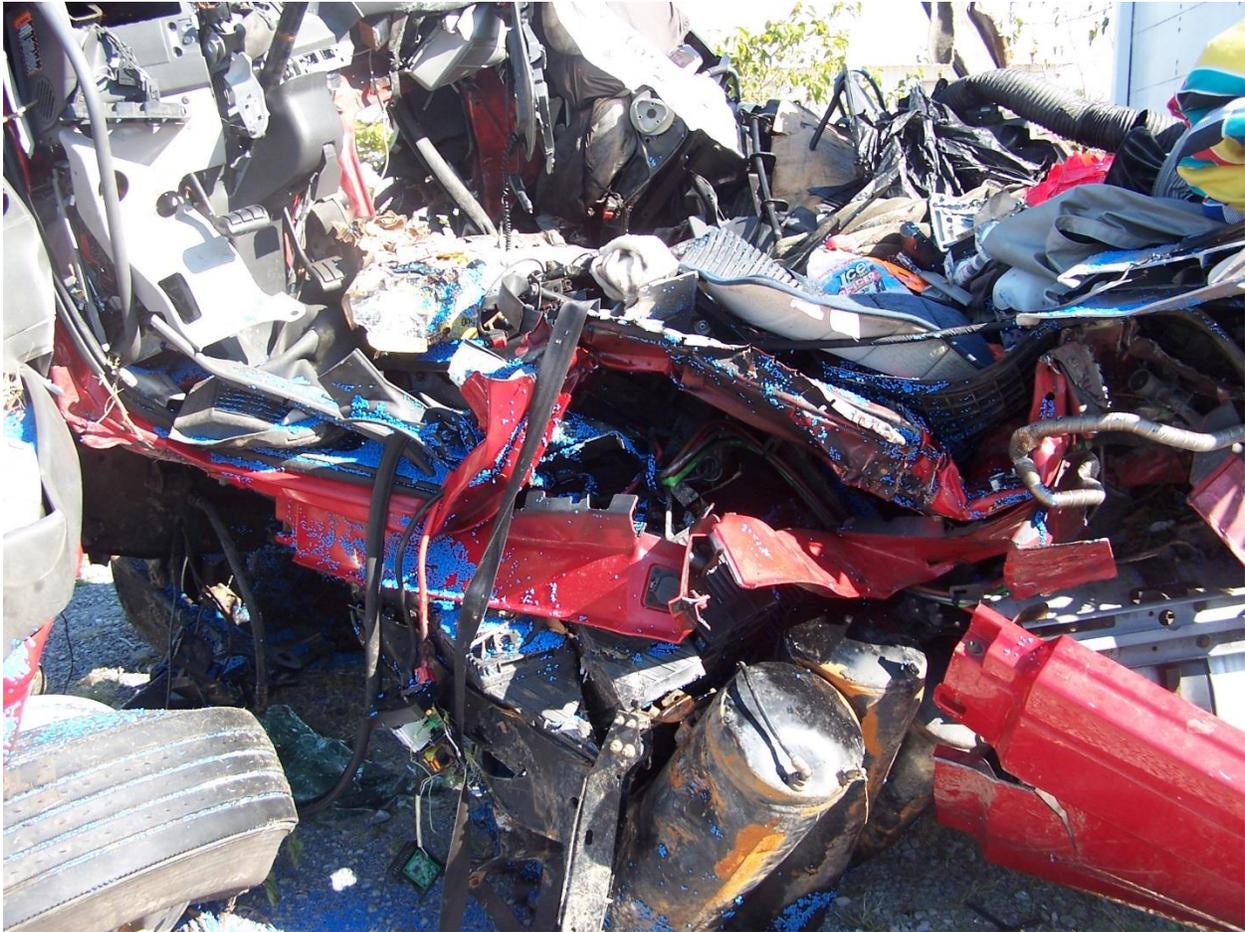
**The Tractor involved in the crash. Photograph property of KY FACE program**
