Team Semi Driver Dies after Rig is Struck by Impaired Driver

Incident Number: 07KY091

Kentucky Fatality Assessment and Control Evaluation (FACE) Program
Incident Number: 07KY091
Release Date: February 17, 2010
Subject: Team Semi Driver Dies after Rig is Struck by Impaired Driver

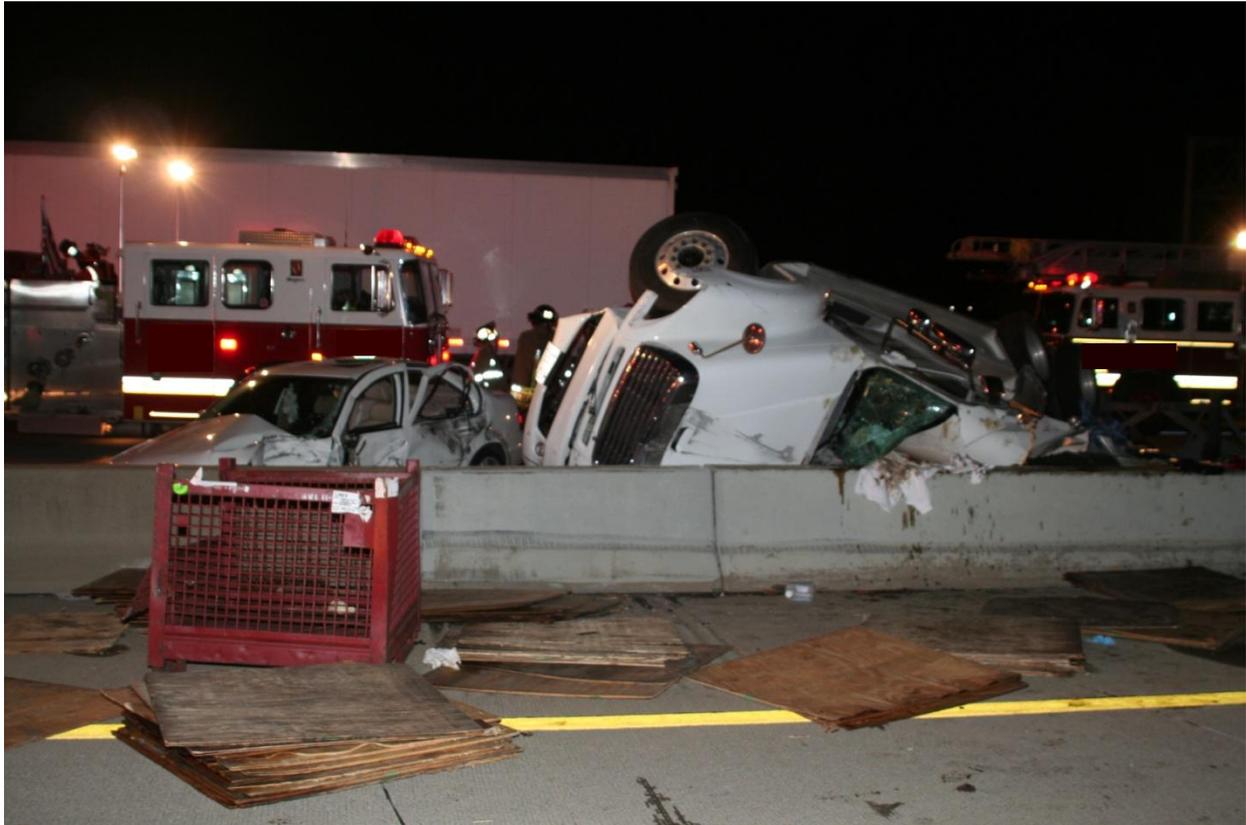
Photograph of semi and car involved in fatal crash. Photograph courtesy of law enforcement.

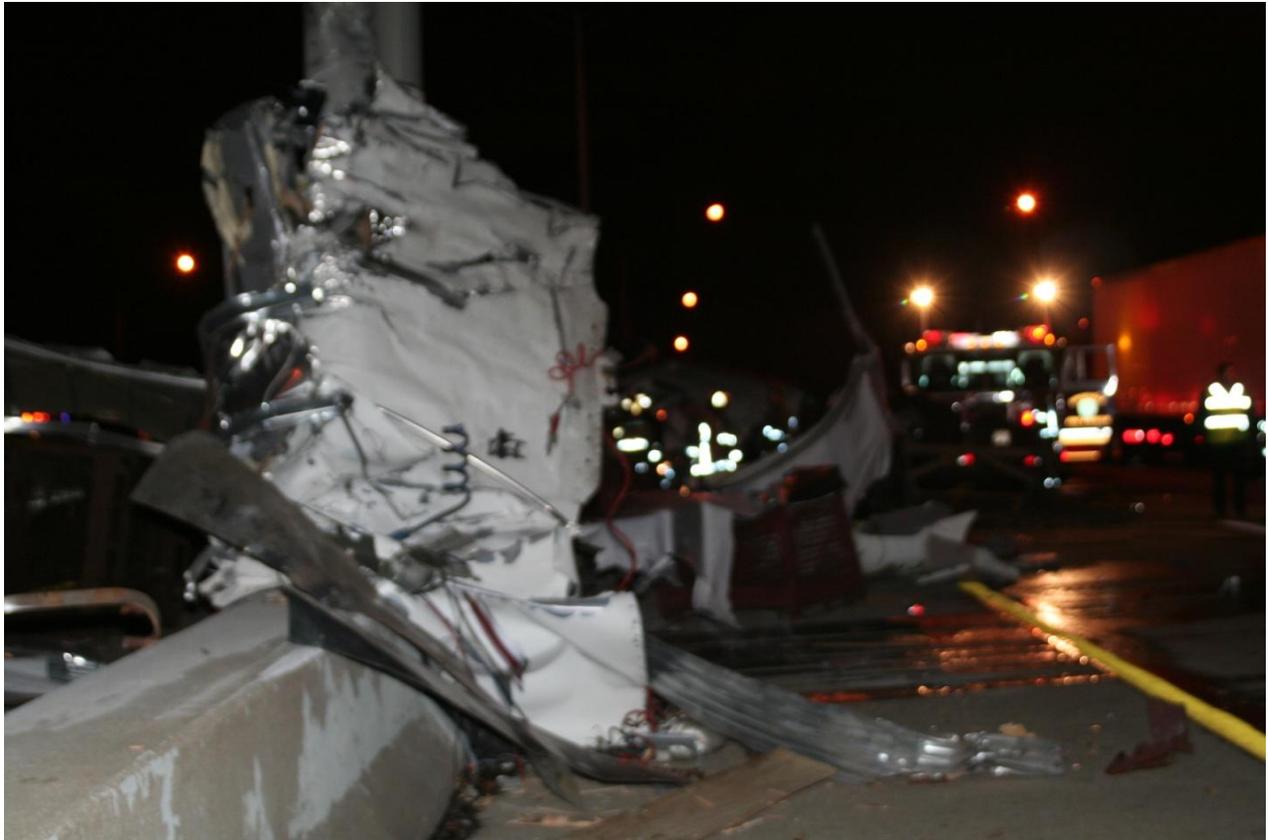
When the semi struck the wall, the trailer jackknifed, slid over and down the concrete barrier wall, and struck a sign post and breaking apart discharging the contents of the trailer onto the highway. The semi tractor rolled upside down in a barrel roll, slid along the pavement and down the side of the wall breaking apart. The passenger car, stuck in the right steering wheel, was pushed by the semi along the concrete barrier wall. The semi and the passenger car came to rest with the passenger car 20 feet in front of the semi. The bunk in the sleeper berth came loose and the husband was ejected from the semi. He was found on the pavement by the barrier wall under wire crates from the trailer. The semi driver was found buckled upside down in the driver's seat.

Photograph of trailer wrapped around sign pole. Photograph courtesy of law enforcement.

This incident occurred in a high traffic area where there was a 32 inch high concrete barrier wall to separate the two traffic directions. Trailer heights are usually 13 feet to 13.5 feet high. Concrete median barriers should be designed to prevent semis and trailers from flipping over the barrier. In this case, if the wall had been higher, the trailer could not have flipped over the wall, twisting the semi into a rollover.

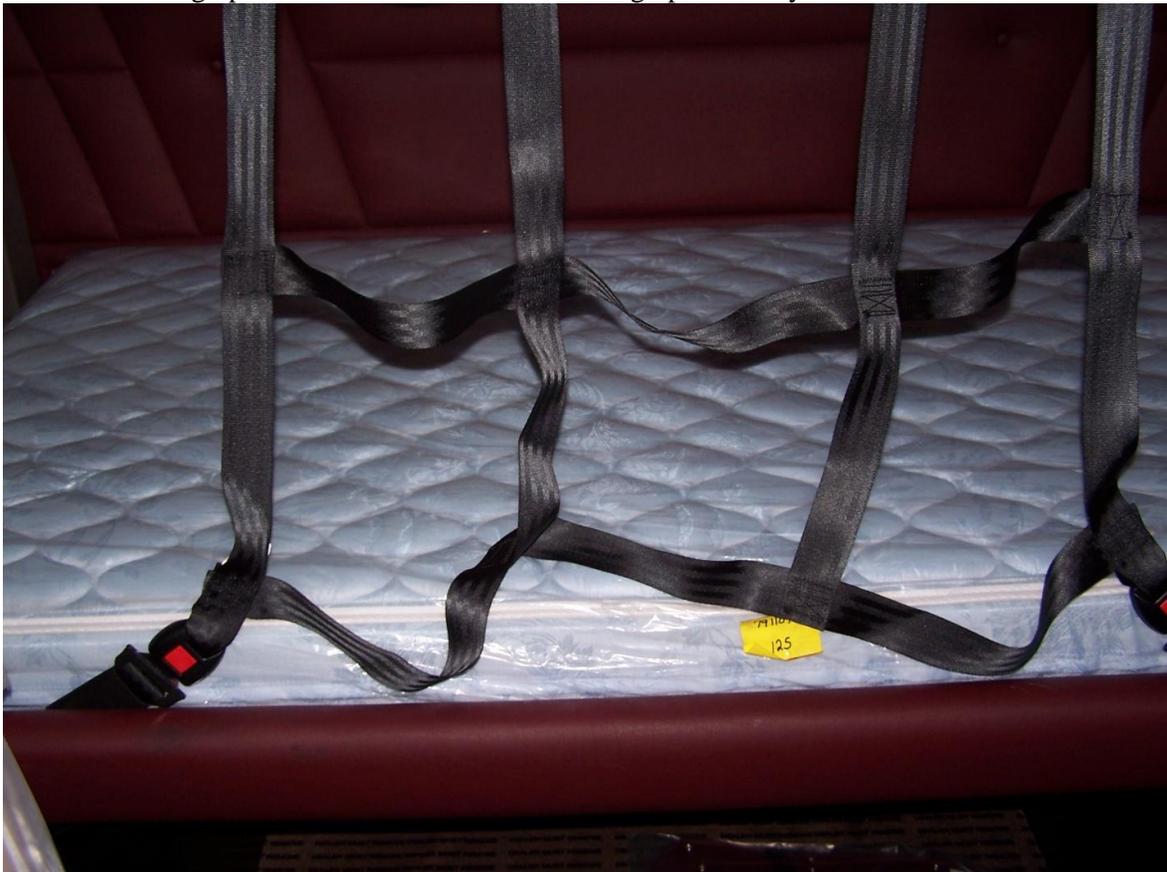
Sleeper berth occupant restraint systems manufactured by three different companies were evaluated for this report. All three manufacturers used a nylon webbing strap that snapped over the occupant in the sleeper berth. In two of the designs, the webbing strap created a triangle from the top of the sleep berth to the underside of the sleeper berth with the webbing as the hypotenuse. One design used the sleeper berth above to create a rectangle for the occupant to sleep in. Both designs allow for the occupant to be loosely restrained in the sleeper berth, thereby permitting movement of the occupant.

Photograph of a restraint system in a similar sleeper berth. Photograph by KY FACE.

Possible solutions to restrain occupants in sleeper berths might include the fabrication of a privacy curtain/restraint system in the sleeper berth, installing an air bag above the mattress that would deploy toward the occupant upon certain conditions, or the use of heavy foam within the sleeper berth to insulate from noise and protect the sleeping occupant.
