TRUCK ROUTE ACCESS EVALUATION

Dow Corning, Varsity Dayton Walther and Ghent Generating Station
Carroll County
Site # 33 & 51

KTC Report No.99-25

“Freight Movement and Intermodal Access in Kentucky”
Project No. SPR 98-189

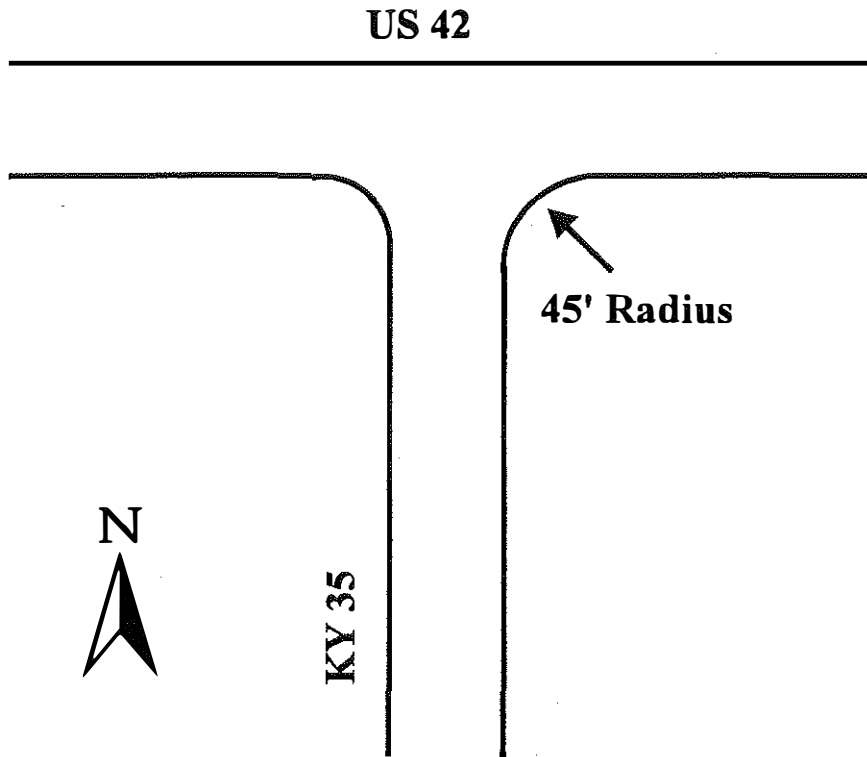
Figure 8: Approximate Turning Radius at KY 36 and US 42

The turning radii of two intersections were approximated in the field. The right turn from KY 36 onto US 40 in Carrollton (45-foot radius) was rated “less than adequate” because trucks must turn into opposing traffic lanes. The approximate layout of the intersection is shown in Figure 8 and a truck making the turn is shown in Figure 9. The 15-foot turning radius of the turn from US 42 onto KY 35 in Warsaw was also rated “less than adequate” because trucks must turn into opposing lanes. The approximate layout of this intersection is shown in Figure 10.

The recommended improvements are remove sign and widen pavement at the intersection of KY 36 and US 42 and add directional signing at the intersection of KY 35 and US 42. Reconstruction of the Gallatin County route might be considered however, at this time traffic and truck volumes are relatively low and the facilities have the good alternative route in Carroll for access.

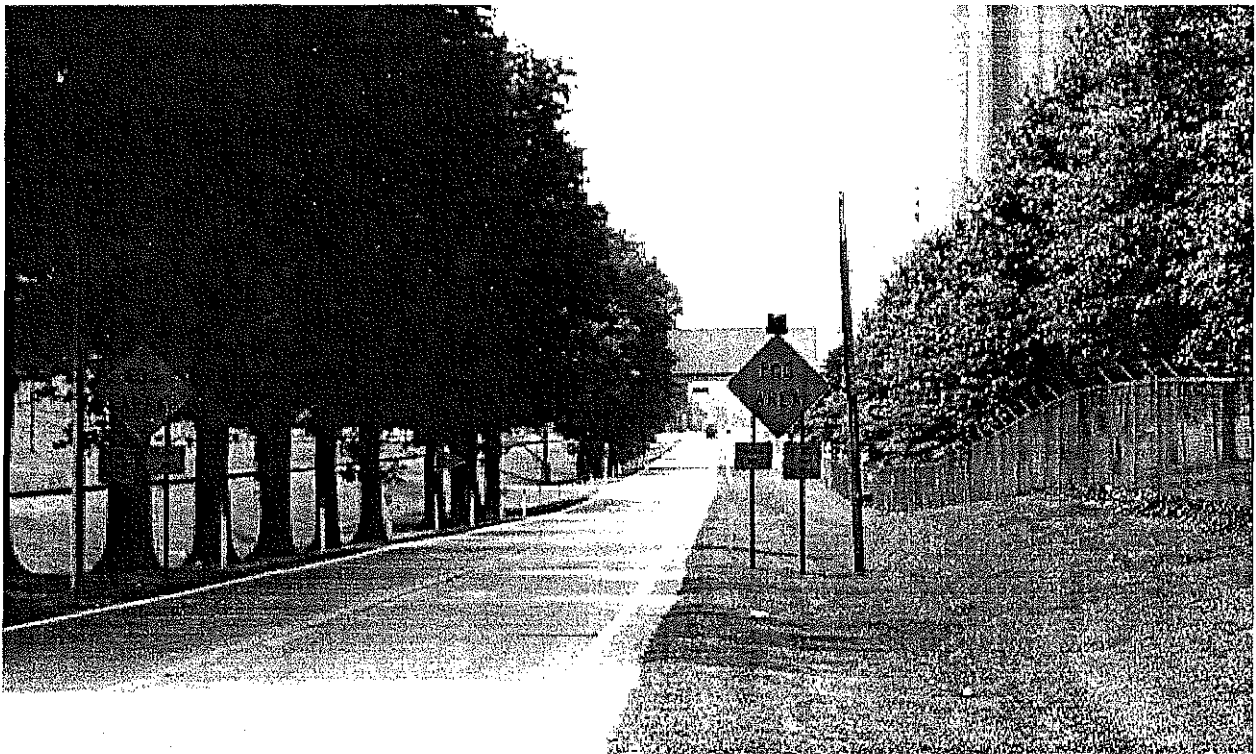
Figure 12: Fog Area at Ghent Generating Station

There is a lack of directional signing at the intersection of KY 35 and US 42. Heavy fog is a potential problem in the vicinity of the Ghent Generating Station. As shown in Figure 12, warning signs and flexible delineator posts have been installed in the area.
