**Construction Laborer Dies from Heat Stroke  
at End of Workday  
Incident Number: 03KY053**

**Incident Number:** 03KY053

**Subject:** Construction Laborer Dies from Heat Stroke at End of Workday

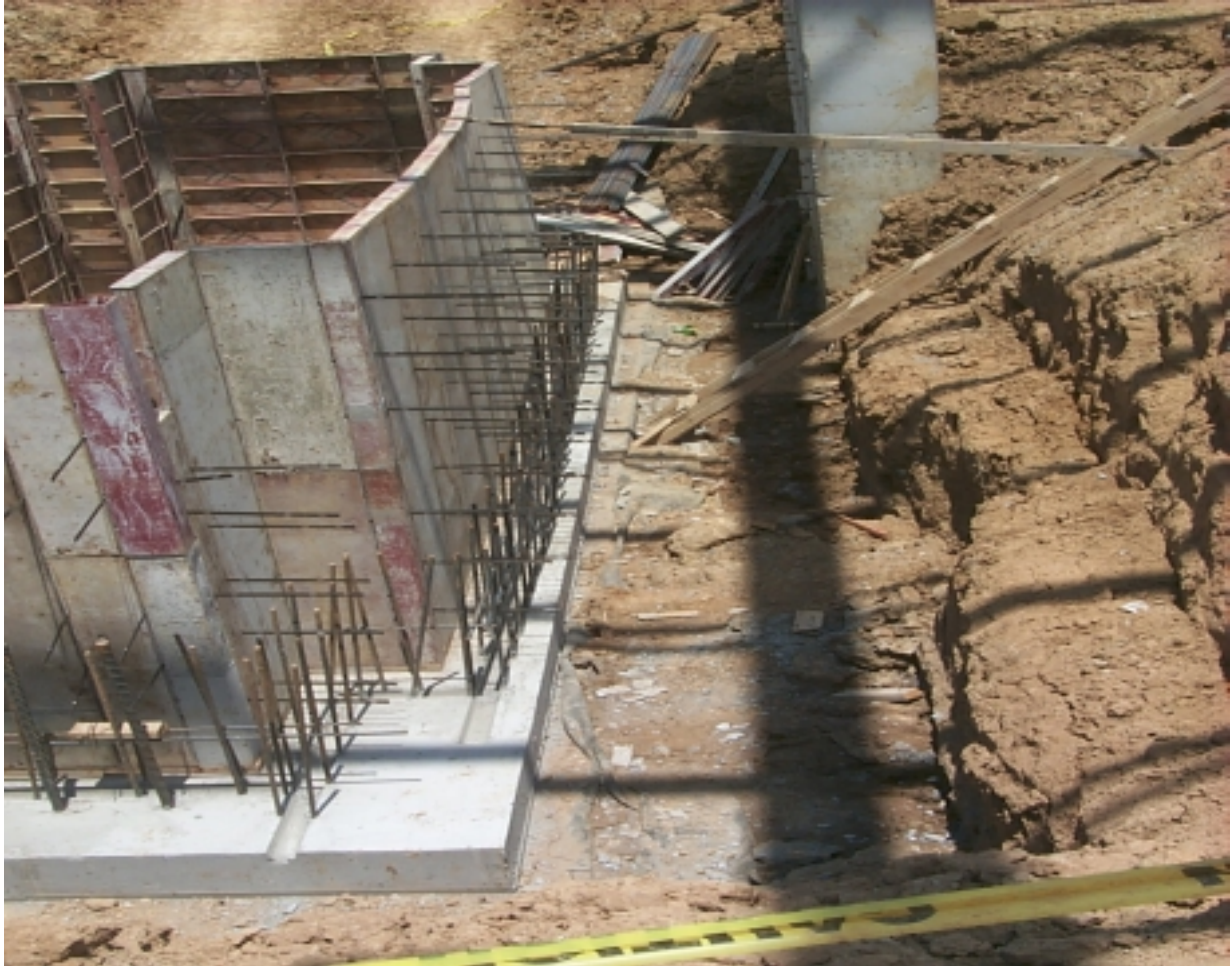
**Victim helped make wooden forms for concrete pad.**
