PROGRESS REPORT ON CALCIUM CHLORIDE
MAINTAINED TRAFFIC BOUND ROADS

George R. Laughlin
Research Engineer

Highway Materials Research Laboratory
Lexington, Kentucky

May, 1959

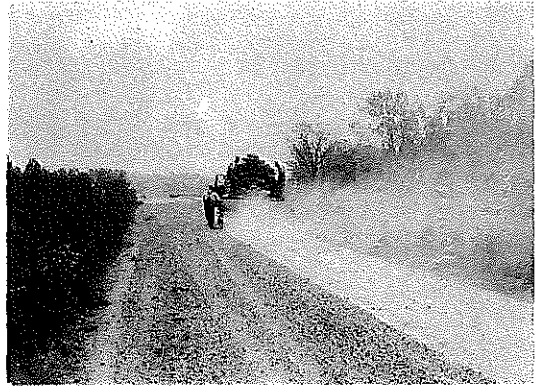
Fig. 8 - Champion Spreader in Operation, Excessive Application .

those used, the Champion was unsatisfactory, while the others may be classed as giving fair satisfaction. The Shunk spreader gave the most even application (See following figures of equipment).

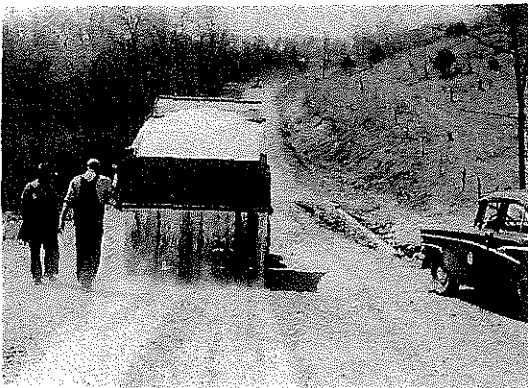
Fig. 11 - Gibbs Spreader in Operation, Uneven Application.

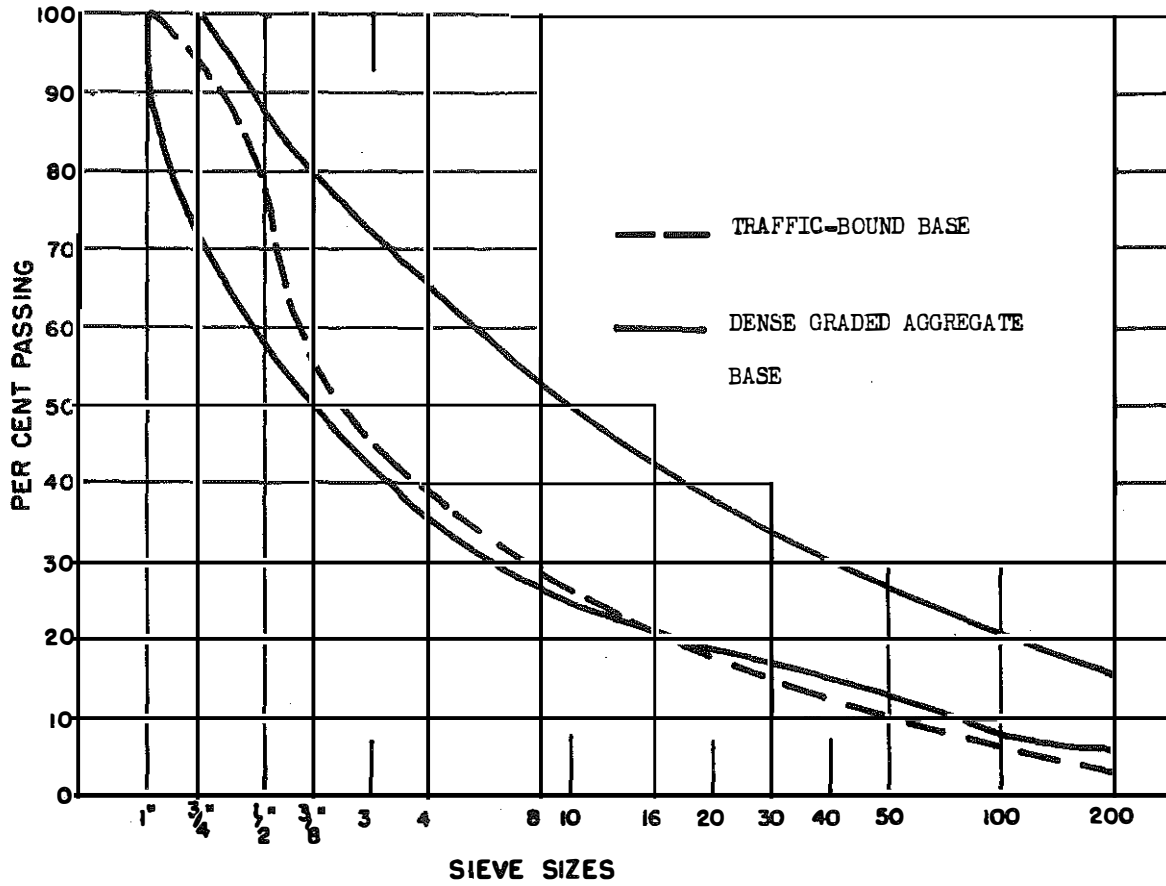
A gradation analysis of the base material was performed on each project under study. The graph included here as page 14 shows the gradation of base material from one project in comparison with dense-graded aggregate base currently in use.

Gradation of Traffic-Bound Macadam Base Sampled from M.P. 101-161-B and Gradation of Dense-Graded Aggregate Base.

The graph on page 14 shows the similarity in gradation for dense-graded aggregate base and traffic-bound surface from the Robertson County project. The use of dense-graded aggregate base on traffic-bound roads maintained with calcium chloride would require less soil binder.

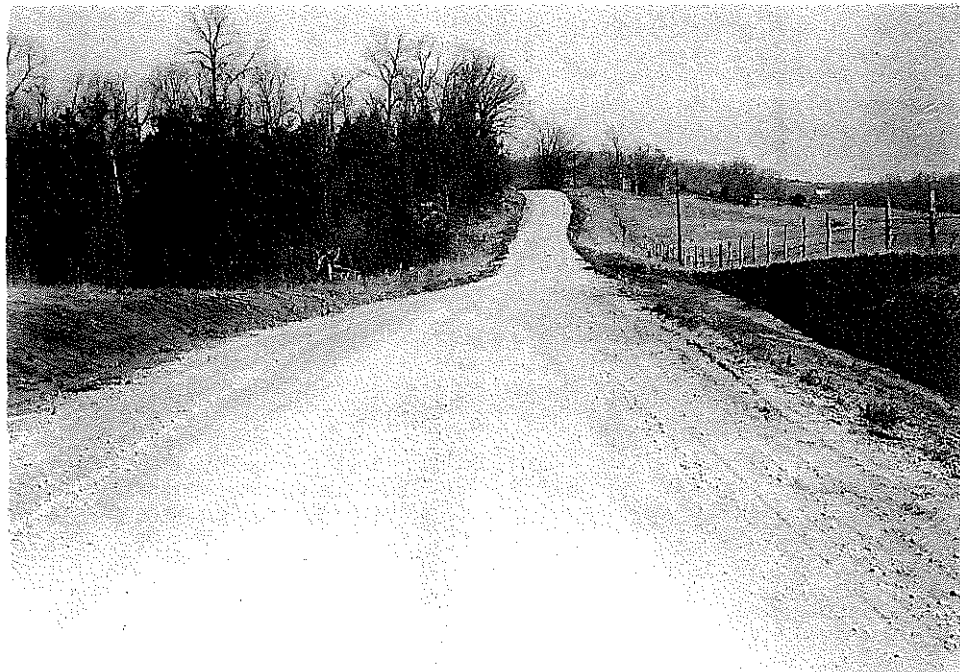
Fig. 14 - M.P. 100-25-C, Result of Sufficient Binder and High Crown, April, 1959.

From regular inspections of the test projects, the roadway surfaces that have fared the best were those having high crowns and good surface drainage. In every case where there was an absence of crown the surface had chuckholes.

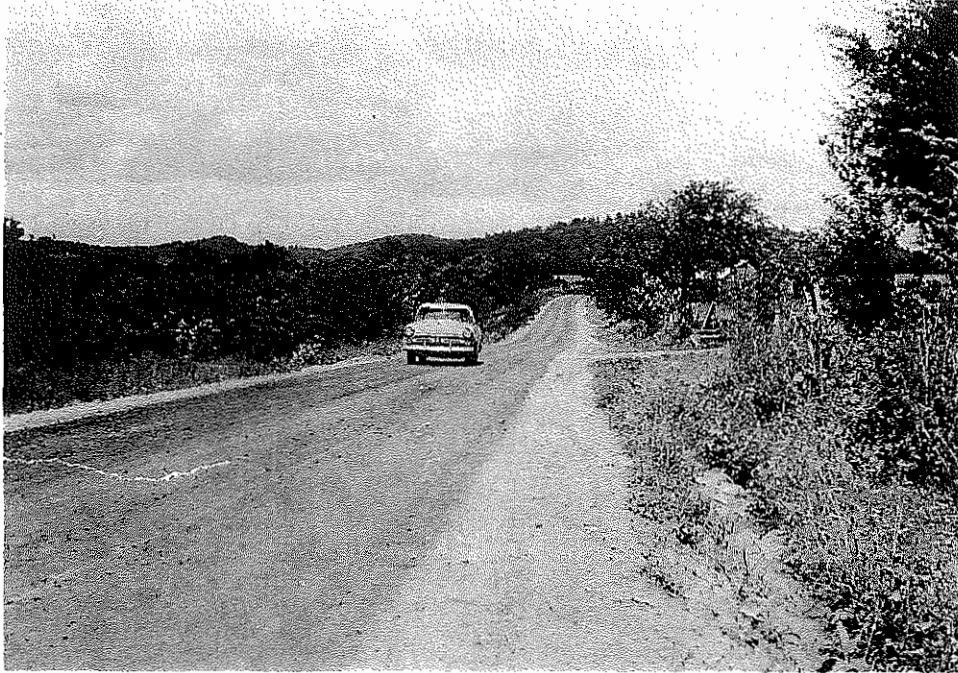
Fig. 15 - M.P. 100-855-E, Absence of Crown, August, 1958.

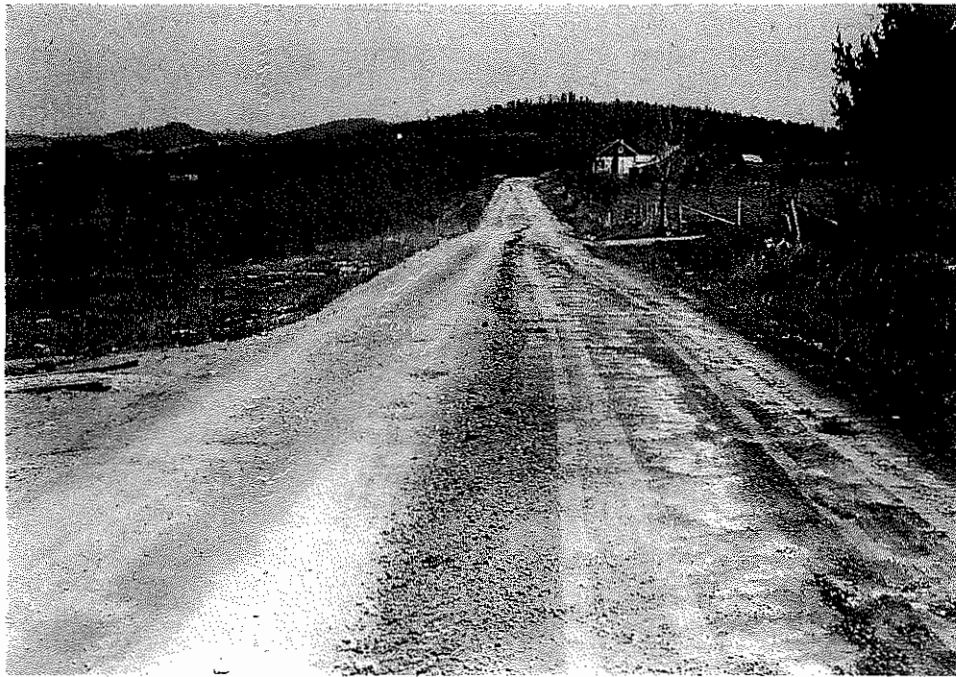
Fig. 16 - M.P. 100-855-E, Result of Absence of Crown, April, 1959.

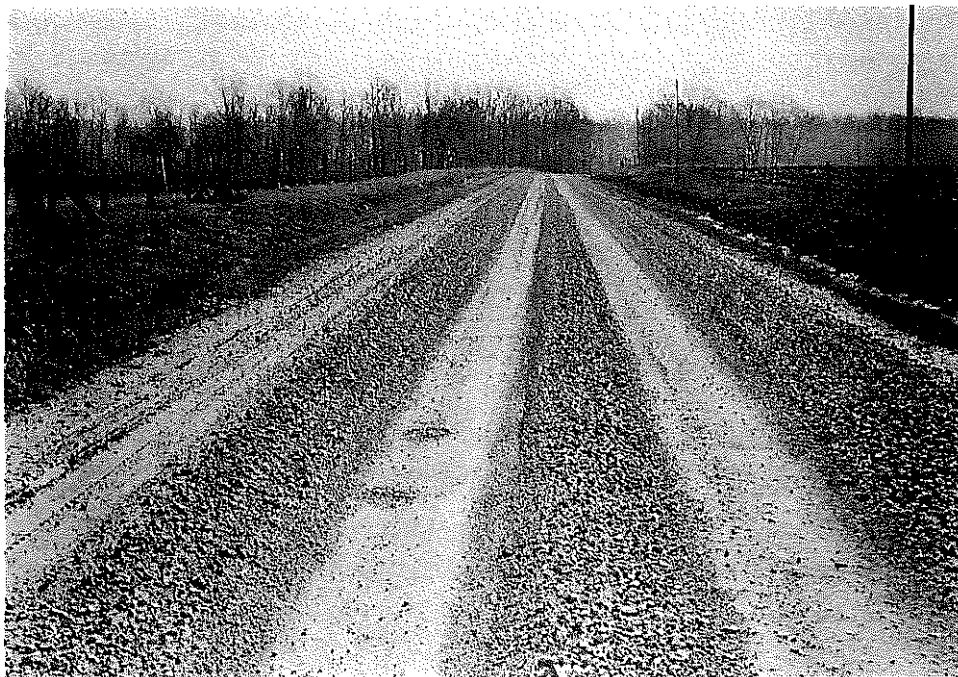
Fig. 18 - M.P. 069-450-B, Excessive Metal Which Can Not be Tied Down, April, 1959.
