Research Report
KTC-22-06/RSF19-71-1F

Evaluation of Manual Infrared Brake Screening Technologies

Kentucky Transportation Center
College of Engineering
University of Kentucky
Lexington, Kentucky

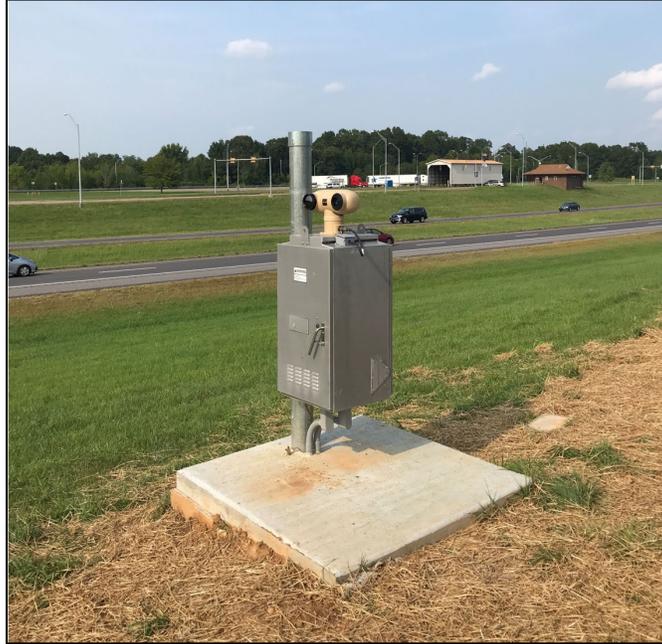
Figure 2.1 Lyon County Installation

Figure 2.1 shows the external equipment installation at eastbound Lyon County.

- FLIR Ranger MS-UC DefendIR™ 640 camera
- Traffic cabinet
- Electrical power to cabinet
- Fiber optic lines from building to cabinet
- Fiber optic converters
- Power conditioner

- Each individual user will want to set it up for his/her preferences.
- With the Lyon County setup, one evaluator found himself wanting to zoom out further than the system would allow. Even zoomed all the way out, the truck would fill up the whole screen, and it would move across the screen very quickly. The evaluator questioned whether this can be changed in the camera settings, or if the installation is perhaps too close to the ramp.
